ATSB TRANSPORT SAFETY INVESTIGATION REPORT

Aviation Occurrence Report –200404085

**Collision with terrain
20 km SW St George, Qld
19 October 2004
VH-ZXZ
Gyroflug Speed Canard**

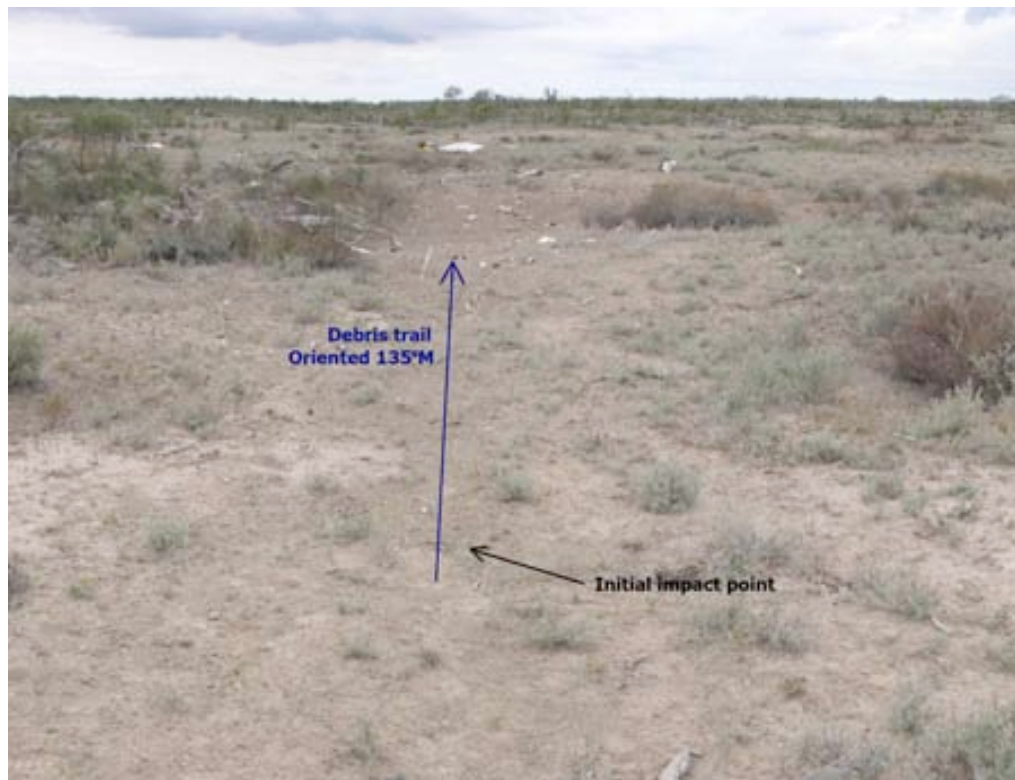
Figure 2: Initial impact point and debris trail

The accident site was located 20 km south-west of St George. The terrain was largely level, with occasional grass and small scrub vegetation, and the remnants of pulled timber. The aircraft impacted the ground slightly left wing low, and in an approximately level pitch attitude. It disintegrated on impact, leaving a wreckage trail of approximately 150 m in length, and oriented 135 degrees M (Figure 2). An empty box and empty blister pack of pain relieving tablets were located with the pilot's personal effects. It could not be determined when the tablets had been used.

An examination of the wreckage and accident site established that the propeller impact marks and the damage to the propeller blades were consistent with the engine delivering power at the time of impact. There was no evidence of any pre-existing cracks or leaks in the exhaust system within the cabin heater manifold/heat exchanger. The firewall was extensively damaged, however there was no evidence of any pre-existing cracks or defects that could have allowed air from the engine compartment, or engine exhaust, to enter the cabin. The investigation did not locate a 'spot'-type carbon monoxide detector at the accident site.
