# Collision with terrain involving Robinson R22, VH-HEP

40 km NE of Hughenden, Queensland, 13 May 2014

**ATSB Transport Safety Report**  
Aviation Occurrence Investigation  
AO-2014-087  
Final – 3 September 2014

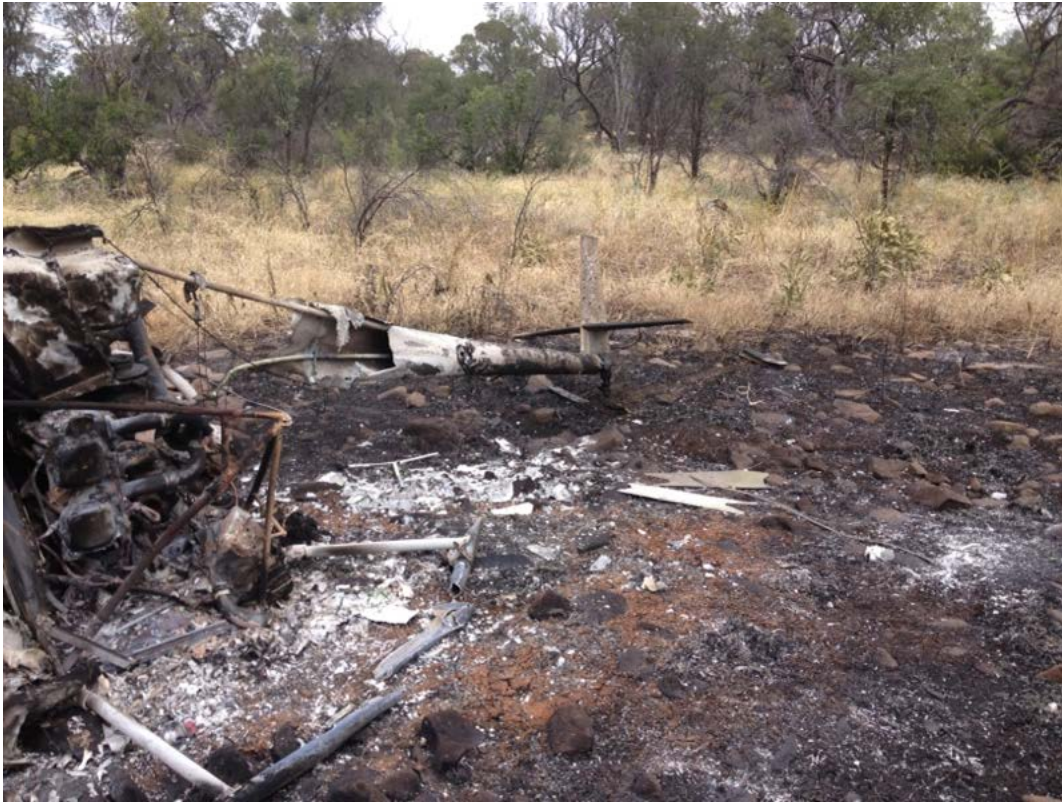
After the helicopter settled on the ground, the pilot applied control friction, unstrapped, and stepped onto the skid to assess the damage. At about that moment, he became aware of a fire in the grass beneath the engine behind the cockpit area. The pilot commented that the fire appeared to be growing rapidly. He vacated the helicopter and retreated to a safe area, as the flames spread quickly up the side of the helicopter and into the cockpit area. The helicopter was subsequently destroyed by the fire (Figure 1).

**Figure 1: Accident site showing long, dry grass and ‘gidgee’ trees in the background**
