# Collision with terrain involving a Bell 206, VH-KSV

200 km SW Kalumburu, Western Australia, 13 June 2014

**ATSB Transport Safety Report**  
Aviation Occurrence Investigation  
AO-2014-108  
Final – 3 September 2014

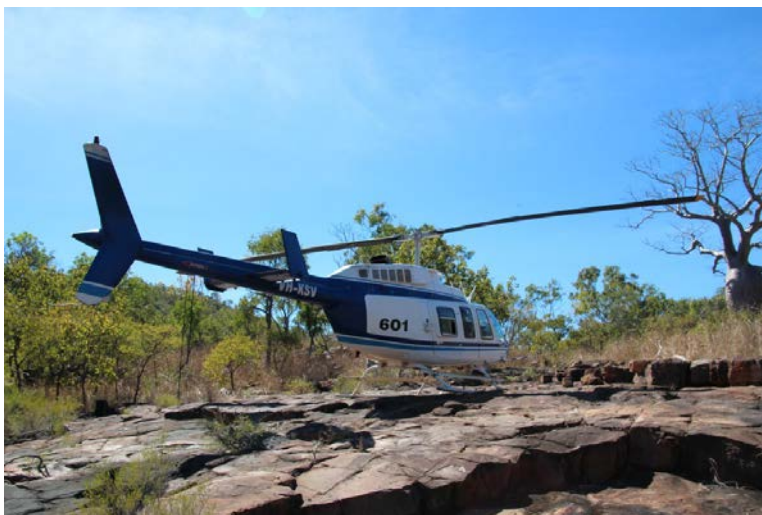
**Figure 1: Landing site and KSV**

As the helicopter descended over trees, the pilot observed that the helicopter was slightly higher than optimal for the approach, but still within limits for a safe approach. From a high hover, at about 10 ft AGL, the pilot continued to lower the helicopter slowly, and assess the landing area. The passengers were standing immediately behind the tree line, and the pilot elected to land towards the rear of a rocky sandstone platform to remain clear of the passengers. Behind the platform the ground sloped away, and from the air, during the approach, the pilot did not observe the slope to be overly steep (Figure 1).

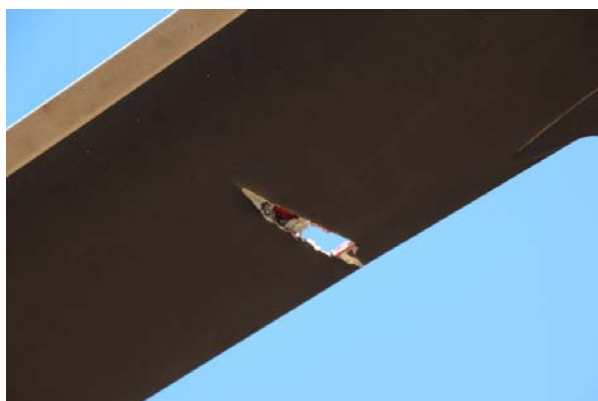
**Figure 2: Hole in the main rotor blade**

The pilot opened the door, observed that the helicopter was on backwards sloping ground and did not see any damage to the helicopter. He then confirmed that there were no abnormal indications, vibrations or oscillations and he slowly raised the helicopter back up into the hover, moved it forwards a few metres and landed on a more level surface. After shutting down the engine, the pilot inspected the helicopter and found substantial damage to the landing skid, a hole in the main rotor blade (Figure 2) where it had struck the wirestrike cutter (Figure 3), and damage to the tail boom.
