# Collision with terrain involving a Bell 206, VH-NKW

near Taroom, Queensland, 20 June 2014

**ATSB Transport Safety Report**  
Aviation Occurrence Investigation  
AO-2014-113  
Final – 3 September 2014

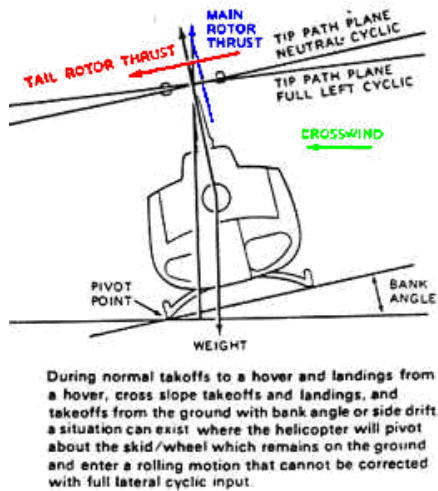
Figure 3: Dynamic rollover

Dynamic rollover is usually the result of the helicopter pivoting about a skid which remains in contact with the ground. In this incident, the long-line pulled taut under the skid and became the support under the pivot point resulting in a dynamic roll over (Figure 3).

The pilot reported that, in hindsight, he would have lifted the bags up and moved them to a flat piece of grass to land and untangle them. Industry best practice is to use a carousel bag picker to drop the bags one at a time rather than the runner, as the lanyards are separated and the bags are unlikely to tangle. The runner is better suited for operations where the bags are picked up and then returned to a central location, where, if they become entangled, a member of the ground crew can assist in releasing them.
