ATSB TRANSPORT SAFETY REPORT

Aviation Occurrence Investigation – AO-2007-009

Collision with terrain
2 km west of Esperance Aerodrome, WA
26 May 2007
VH-FTT
Piper Aircraft Corp PA-28RT-201

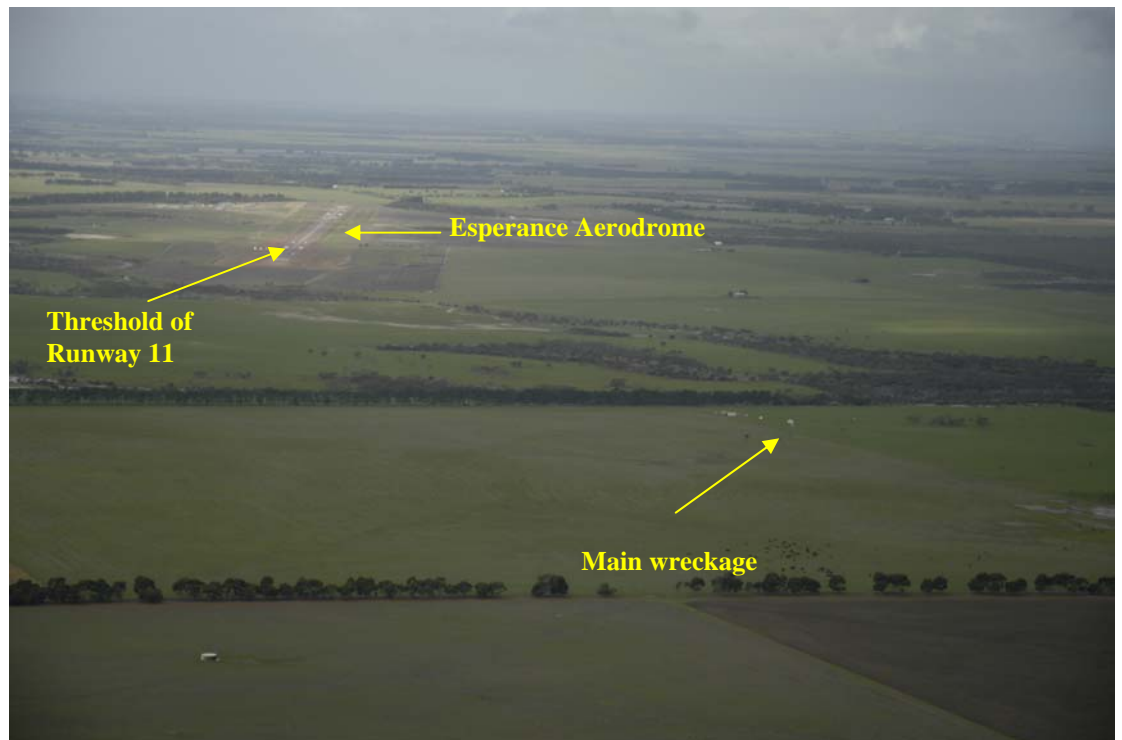
Figure 1: Main wreckage location in relation to Esperance Aerodrome

On arrival at the accident site, rescue personnel confirmed that there were no survivors. The aircraft was destroyed. There was no fire.

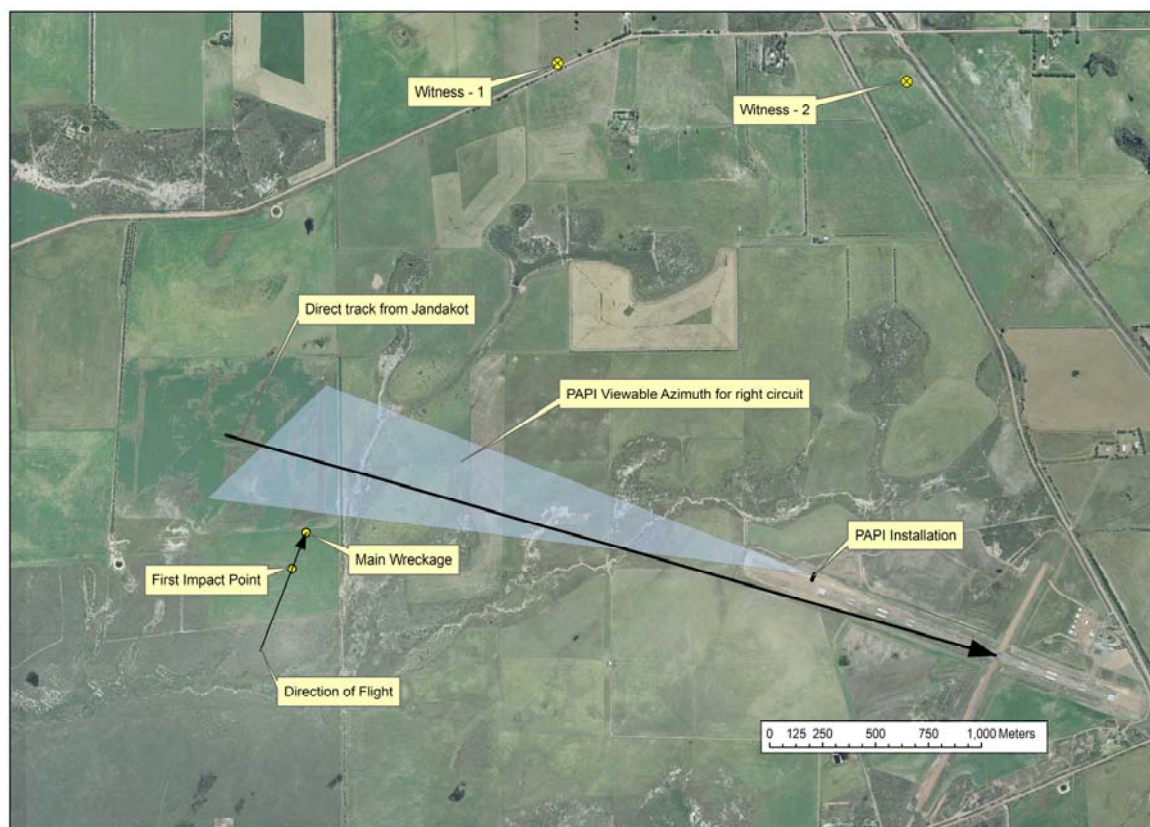
Figure 2: Runway 11 PAPI azimuth and accident location¹⁷

The horizontal splay or azimuth of the PAPIs was about 15 degrees either side of the relevant runway centreline. That placed the accident location outside the viewable azimuth for the runway 11 PAPI (Figure 2). In that case, the PAPI would not have been visible to the pilot immediately prior to, or from overhead the site of the accident.

The remote location of the aerodrome and reported low cloud base would have combined to produce 'dark night' conditions for the pilot's approach and landing. In addition, the location of the accident outside the splay of the precision approach path indicator (PAPI) meant that the right base was carried out with little or no ground or approach lighting. That was, in conditions that were conducive to the existence of a 'black hole' illusion.

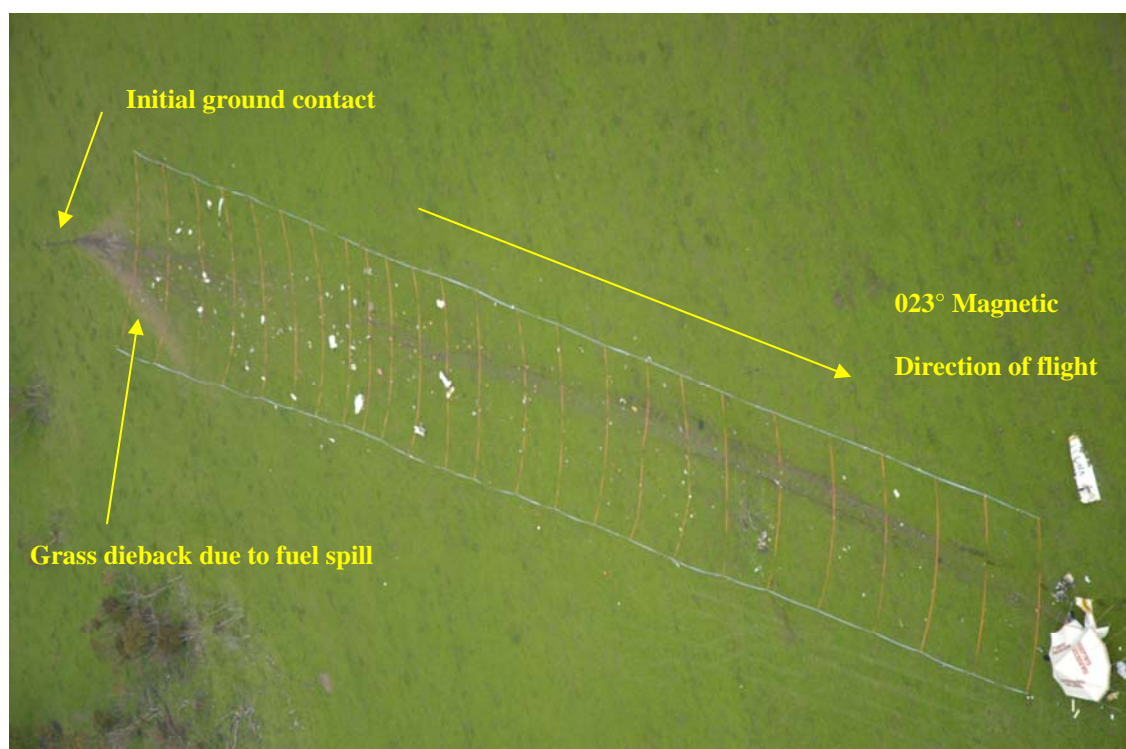
Figure 3: Aerial photograph of wreckage trail

The aircraft impacted the terrain on a heading of 023 degrees magnetic in a right wing-low, nose-down attitude. The right wing separated from the fuselage and both wings' integral fuel tanks were ruptured during the initial impact. That was consistent with the evidence of fuel spillage early in the debris trail (Figure 3).

The left wing and remnant fuselage came to rest approximately 166 m from the initial ground impact point. The engine was the final large piece of wreckage in the debris trail. The undercarriage was extended. The flap lever appeared to be in the first detent or stage of flap deployment but, due to the severe impact damage to the system, the position of the aircraft's flaps could not be verified.
