Ditching – Brampton Island – 03 April 2008

Abstract

On 3 April 2008, a Piper PA-32-300 Cherokee Six aircraft, registered VH-ZMP, lost engine power shortly after takeoff from Brampton Island, Qld and ditched into the sea. The pilot and the four passengers evacuated the aircraft before it sank and were later recovered by rescue helicopter. The engine power loss was consistent with fuel starvation.

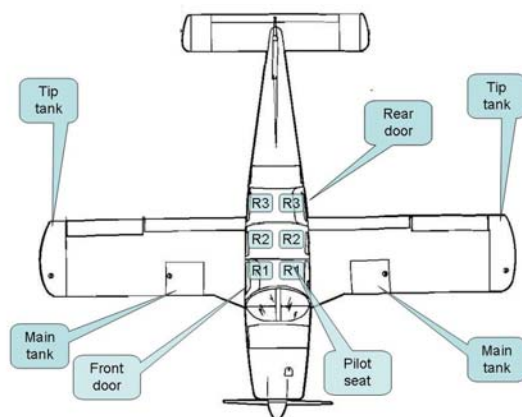
Figure 1: Plan view of aircraft

Before ditching, the pilot attempted to regain power by manipulating the throttle and mixture, and switching on the electric fuel pump. The pilot transmitted a MAYDAY¹ broadcast, opened the front door (Figure 1), instructed the passengers in row 3 to open the rear door, assessed the best direction for a ditching, turned the aircraft in that direction, and 'conducted a normal landing' approach until contact with the water.

The pilot sustained a soft tissue injury to one eye from an impact with the glare shield during the deceleration. The passengers in row 2 stated that their forward movement was largely cushioned by a powerful rearward inrush of water from the forward edge of the front door, which was ajar at the time. The passenger in the left seat of row 3, adjacent to the rear door, described a similar effect from the inrush of water from the forward edge of the rear door. The passenger in the right seat of row 3 was not in line with a door, and did not experience this effect. This passenger reported that a large suitcase that was unsecured behind the row 3 seats moved forward on top of the passenger, pushing the passenger down over the lap belt. This passenger stated that it was then difficult to release the lap belt while being held down by the weight of the suitcase and that, once the lap belt had been released, the suitcase also obstructed the exit route, leaving little time to vacate the aircraft before it sank. This passenger

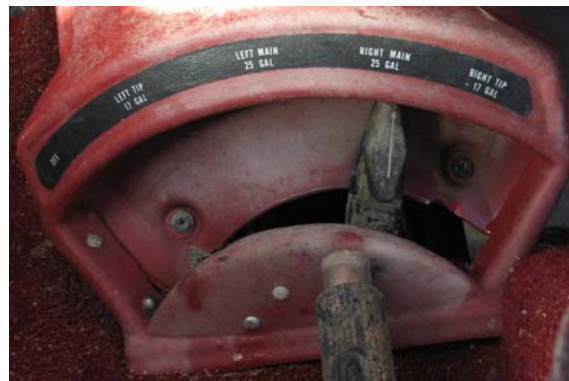
Figure 2: Fuel selector

The aircraft had an inner fuel tank and an outer fuel tank in each wing. Each fuel tank independently fed a fuel selector. Fuel was then fed from the selector via an electric fuel pump and an engine driven fuel pump in series to the engine fuel injection system. The fuel selector control (Figure 2) was located at floor level under the centre of the instrument panel and had 5 settings. From left to right, the settings were OFF, LEFT TIP, LEFT MAIN, RIGHT MAIN and RIGHT TIP. Selection of the OFF setting also required movement of a sprung interlock to prevent inadvertent selection. Positive sprung detents for each selection in the fuel selector valve also provided tactile sensation to the pilot indicating that a proper selection had been made. The tip tanks had a usable fuel capacity of 64 L each, and

The next leg was intended to fly to Mackay, and to be the last leg before refuelling again at Mackay. Correct fuel tank selection would have meant that this flight should have been flown using fuel from the right tip tank. The fuel tank selector was found in the right main tank position when the aircraft had been recovered from the sea. However, it was possible that the fuel selector had been inadvertently moved from the right tip tank position during the evacuation by one of the three occupants who vacated the aircraft through the front right door.

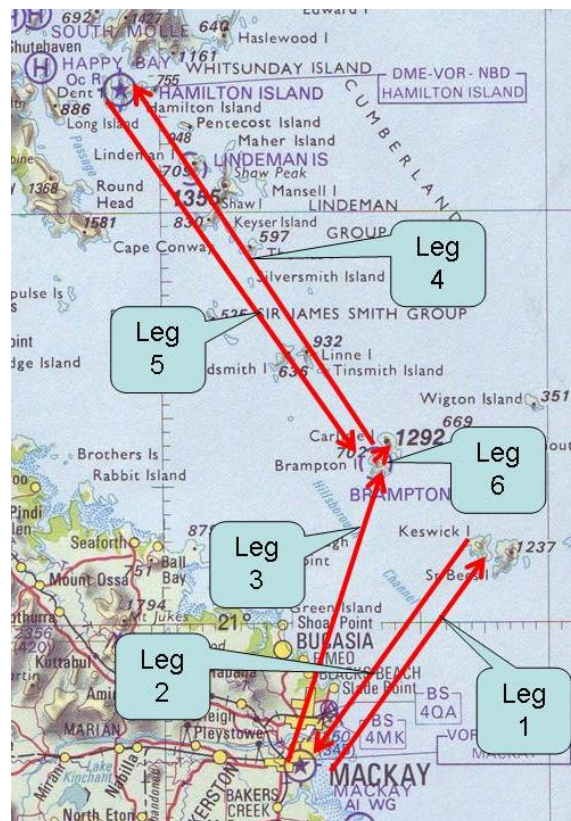
Figure 3: Legs flown since last refuelling

There were sufficient landing sites in the vicinity of the Whitsunday Islands to allow a wide range of different flight routes, and while the aircraft was flown regularly over the individual legs of the flight sequence since the last refuelling (Figure 3), it would rarely have flown that particular flight sequence. The nature of operations in that area was characterised by numerous short legs. This could lead to greater opportunity for variability of flight time and fuel consumption for any given fuel load. The operator's fuel management policy was to use the tip tanks for flight fuel² and to use the main tanks for reserve fuel. Sixty litres of reserve fuel was distributed equally across the two main tanks and both tip tanks were normally filled at Mackay for flight fuel as a standard procedure. The aircraft operator also used a standard procedure for fuel tank selection to ensure even fuel usage. The procedure stated:

The pilot had flown all the flights since the aircraft had been last refuelled and stated that the first leg was flown on the left tip tank and that the aircraft fuel tank selector was changed to the opposite tip tank after landing before shut down at the end of each leg. Fuel tank selection was not changed again until the end of the next leg.

Leg	From	To	Left tip tank (litres)	Right tip tank (litres)
1	Mackay Airport	Keswick Island	64	64
2	Keswick Island	Mackay Airport	49	64
3	Mackay Airport	Brampton Island	49	49
4	Brampton Island	Hamilton Island	19	49
5	Hamilton Island	Brampton Island	19	19
6	Brampton Island	Mackay Airport	4	19

flight times based on previous flight logs, the aircraft would have probably used about 108 L of flight fuel soon after takeoff from Brampton Island on the sixth leg, and the remaining flight fuel would have been consumed around the time of landing at Mackay. Operational variations based on previous flight logs indicated that up to 128 L of flight fuel may have been occasionally consumed during repeated operation of the same flight sequence since the previous refuelling. Both the company fuel management policy and an assessment of recent flight records indicated that the aircraft should have had sufficient flight fuel to complete the flight, albeit with little flight fuel remaining. The quantity of fuel remaining in the selected tank could have been affected by increased fuel flow or increased flight durations or incorrect fuel tank selection. While it is not possible to determine which of these factors might have contributed to the aircraft's fuel state at the time of the power loss, any of them, possibly in combination, could have reduced the margin between available fuel in the tip tanks and fuel used. It is likely that the engine was operating on the right tip tank at that time. As such, given the nature of the power loss and in particular the reported engine surging, it is likely that the fuel in the right tip tank was exhausted, leading to the power interruption.

The aircraft operator has advised the Australian Transport Safety Bureau that it has changed the fuel management procedures for Cherokee Six operations based at Mackay. The changed procedures are designed to ensure that there is a minimum of 30 L of fuel in the selected fuel tank for any takeoff.
