Aviation Occurrence Investigation AO-2008-053

Preliminary

**Depressurisation
475 km north-west of Manila, Philippines
25 July 2008
Boeing Company 747-438, VH-OJK**

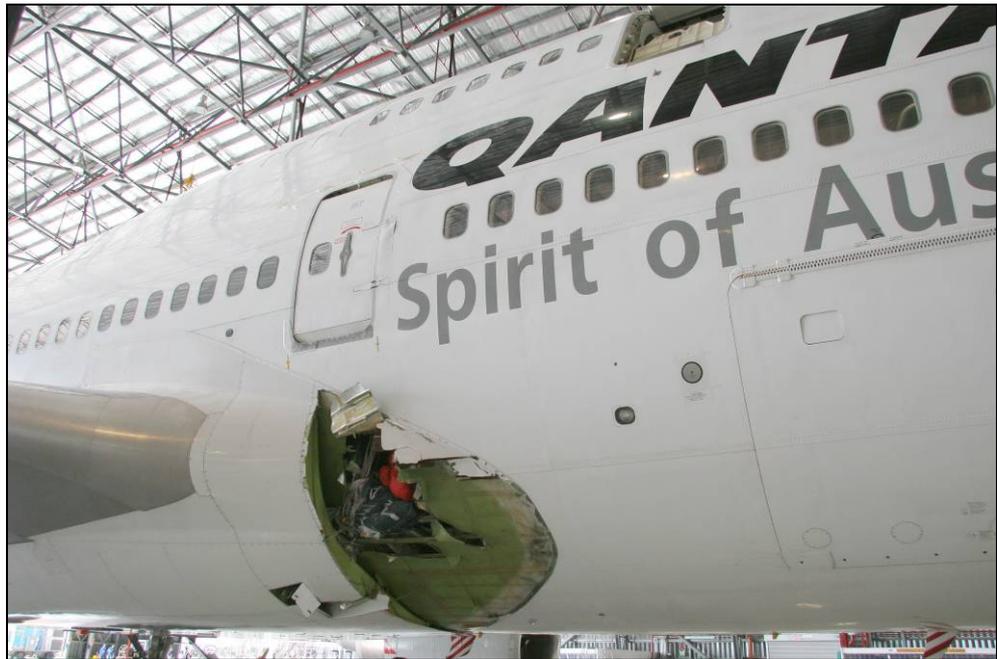
An initial inspection of the external aircraft surfaces on the ground in Manila revealed the complete loss of the right wing forward leading edge-to-fuselage fairing, with separation occurring along the lines of interconnection between the fairing and fuselage skins (Figure 1). In the area exposed by the fairing loss was an inverted T-shaped rupture in the fuselage skin, with several items from within the forward cargo hold partially protruding from the rupture (Figure 2). The approximate vertical centreline of the skin rupture was positioned at fuselage station⁵ (STA) 820, with skin damage extending longitudinally for 79 inches (201 cm), from STA 777 to STA 856. Vertically, the rupture extended for approximately 60 inches (152 cm) between fuselage stringer⁶ 31 at the top, to stringer 38 at the lower extent of the damage. While some of the fuselage skin had folded outward and away from the rupture, it was evident that an area of skin and structure equal to approximately one-half of the total ruptured area had separated from the aircraft and was not recovered. On the basis of measurements taken around the ruptured areas, the total area of the skin rupture was estimated at around 1.74 square metres (2,700

Figure 1: Fuselage rupture – external view

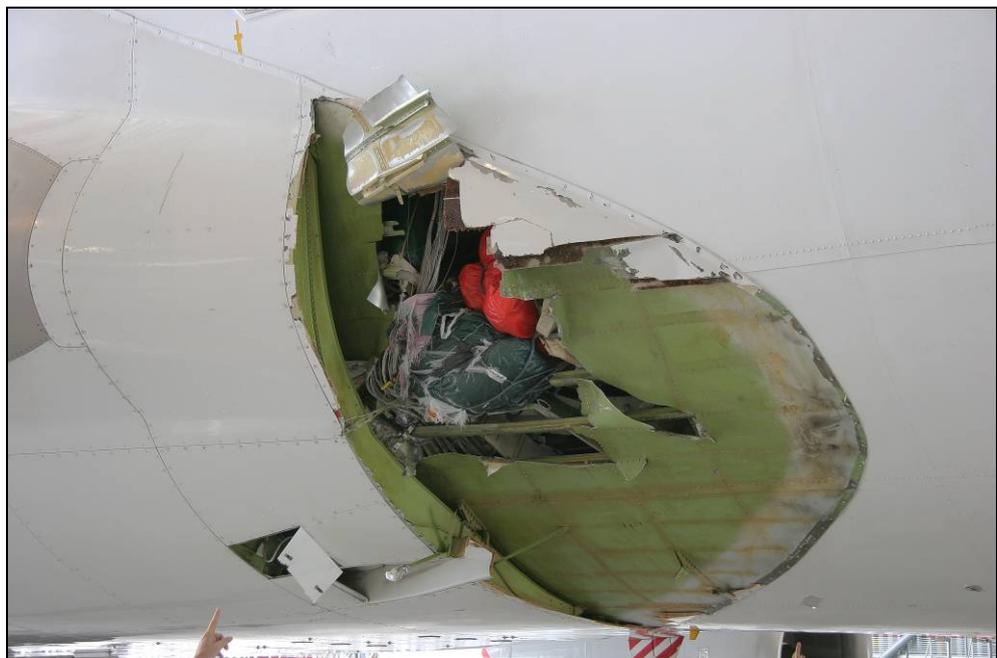
Figure 2: Fuselage rupture with protruding cargo

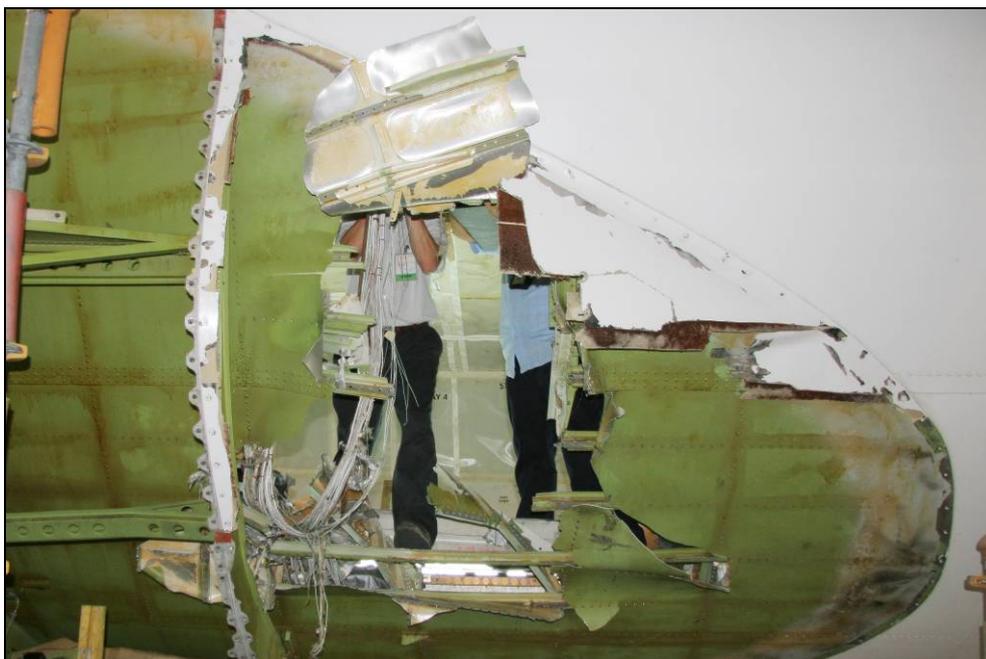
square inches). Figure 3 illustrates the extent of the fuselage rupture as viewed from outside the aircraft.

Figure 3: Extent of the fuselage rupture, after removal of further transition fairings

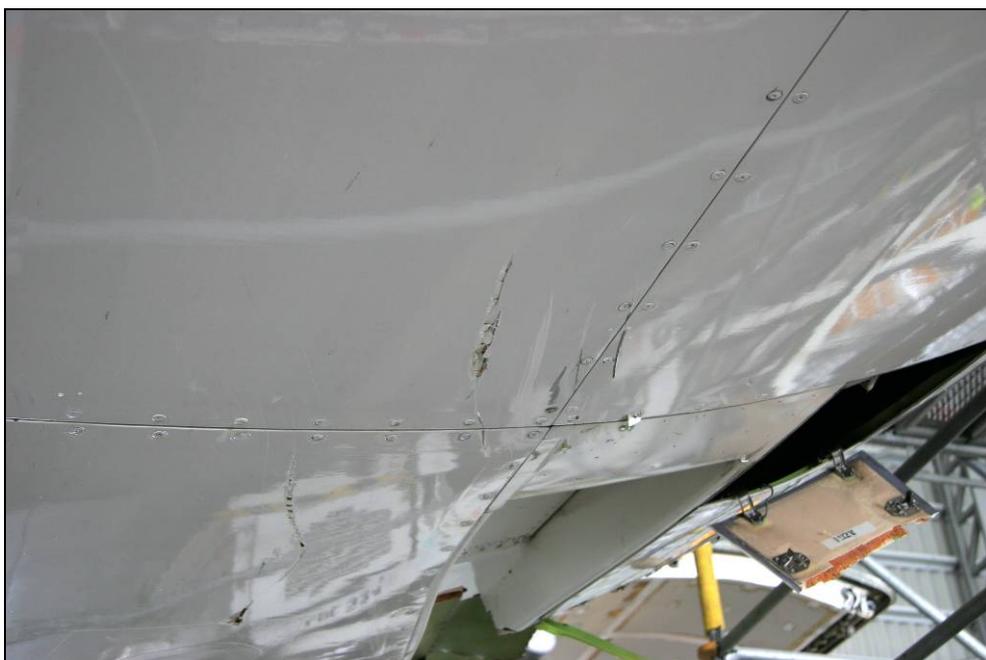
Rearward of the fuselage rupture, several localised areas of scuffing, puncture and scoring were evident along the underside of the aircraft, extending along a diagonal path from the ruptured area rearward toward the left body landing gear (Figure 4). Elongated score marks were also noted extending for several metres around the left side of the rear fuselage – typically around STA 1880 to STA 2000.

Figure 4. Panel damage to the rear of the rupture site

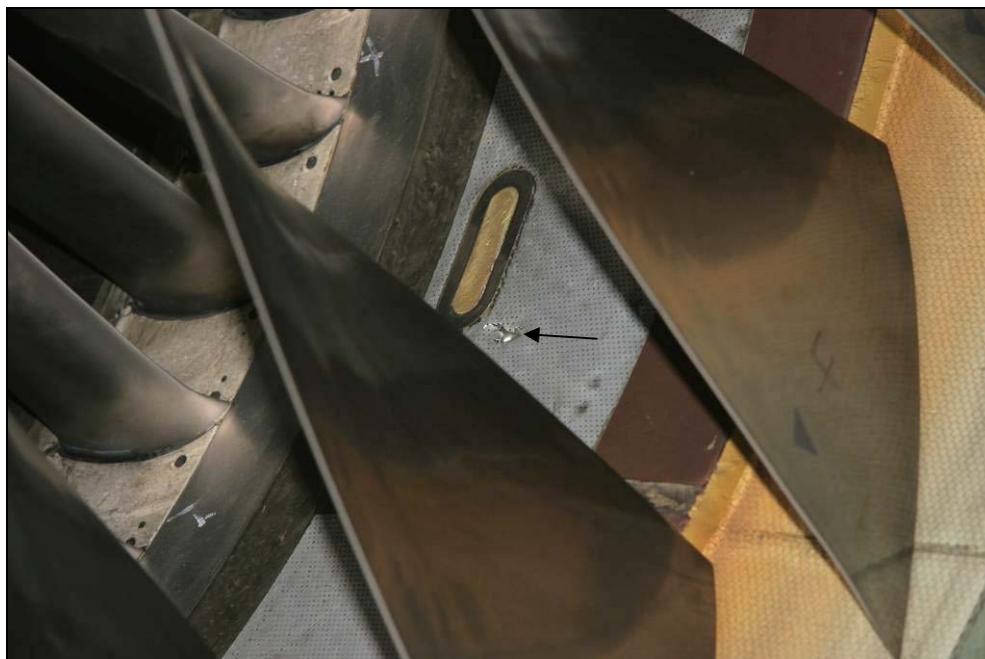
Several small pieces of structural honeycomb material of the type comprising the wing leading edge fairing were found trapped around the edges of panels within the left side of the number-3 engine pylon (side facing the rupture). A small indentation and cut was found within the number-3 engine intake acoustic panelling, located immediately inside the plane of rotation of the engine fan (Figure 5). There was no

evidence of damage to the fan blades themselves, nor was there any evidence of the ingestion of debris into the engine core.

Figure 5: Damage to acoustic lining (arrowed) behind the number-3 engine fan

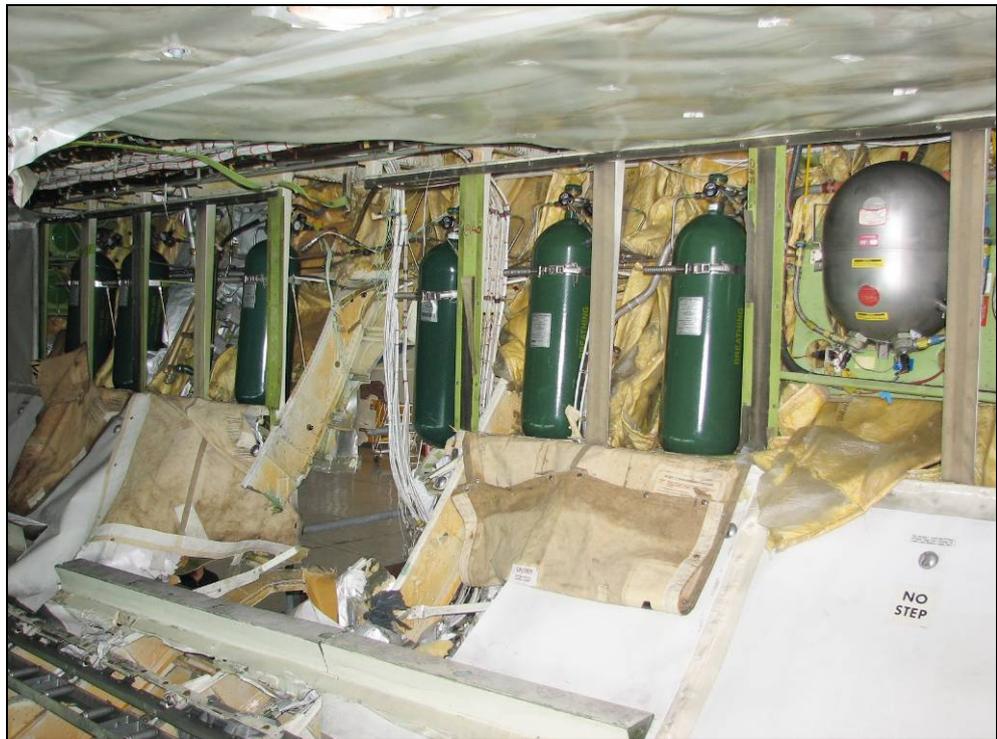
Following removal of all cargo materials and lowering of the hold right-side curtain panels, it was found that the fuselage rupture was aligned with the nominal position of the number-47 passenger emergency oxygen cylinder; one of seven such cylinders in a bank along the right side of the hold (Figure 6). A further six cylinders were located in a central location within the ceiling of the cargo hold. The number-4 cylinder was missing from the bank, with the upper support bracket bent downward and both the retaining strap and lower cradle not present (Figure 7). The adjacent number-5 cylinder lower support cradle had been pulled downward and away from the cylinder as a result of the fuselage rupture. However, the upper cylinder mount and strapping remained secure and the cylinder gas connections intact. Each of the passenger oxygen cylinders had three connected stainless steel lines – an overpressure relief vent line, a delivery line and a filling line. The filling and delivery lines were fed through a tee-piece from a common cylinder connection, with a pressure regulator and transducer integral to the assembly (Figure 8). All three lines to the missing number-4 cylinder had fractured, with remnants of the delivery regulator and filling connection fittings remaining attached to their respective lines. Close examination of all exposed connections, fittings and lines showed no evidence of heating, sooting or discolouration that might have suggested localised combustion had occurred within or in proximity to the cylinder and its connections. Similarly, all structural, panel and cargo surfaces that surrounded the fuselage rupture showed no evidence of heating or damage associated with combustion effects. The pressure gauges on all 12 remaining

Figure 6: Forward cargo hold wall with remaining six oxygen cylinders

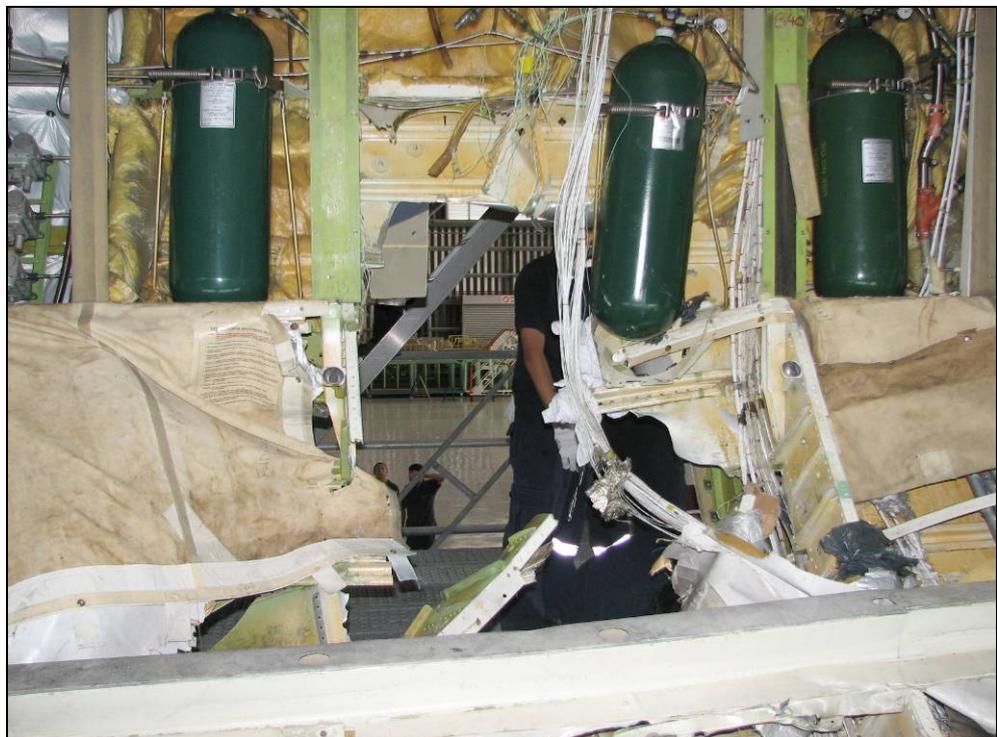
Figure 7: Fuselage rupture coincident with mounting position of the number-4 oxygen cylinder

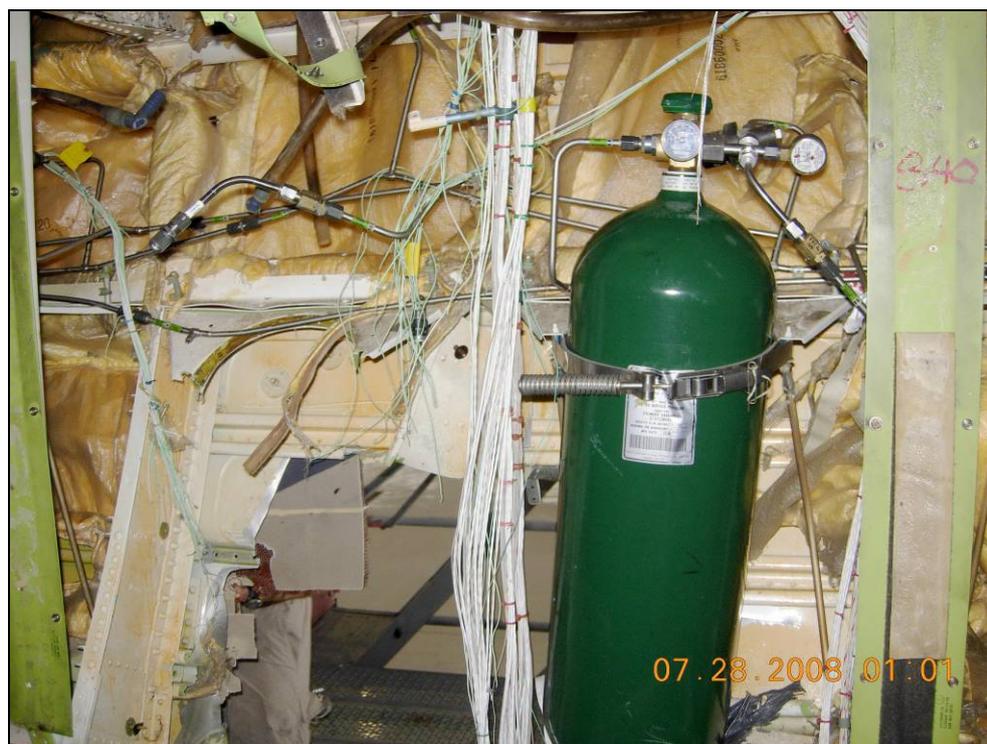
Figure 8: Number-5 oxygen cylinder adjacent to fractured fittings and lines from the number-4 cylinder

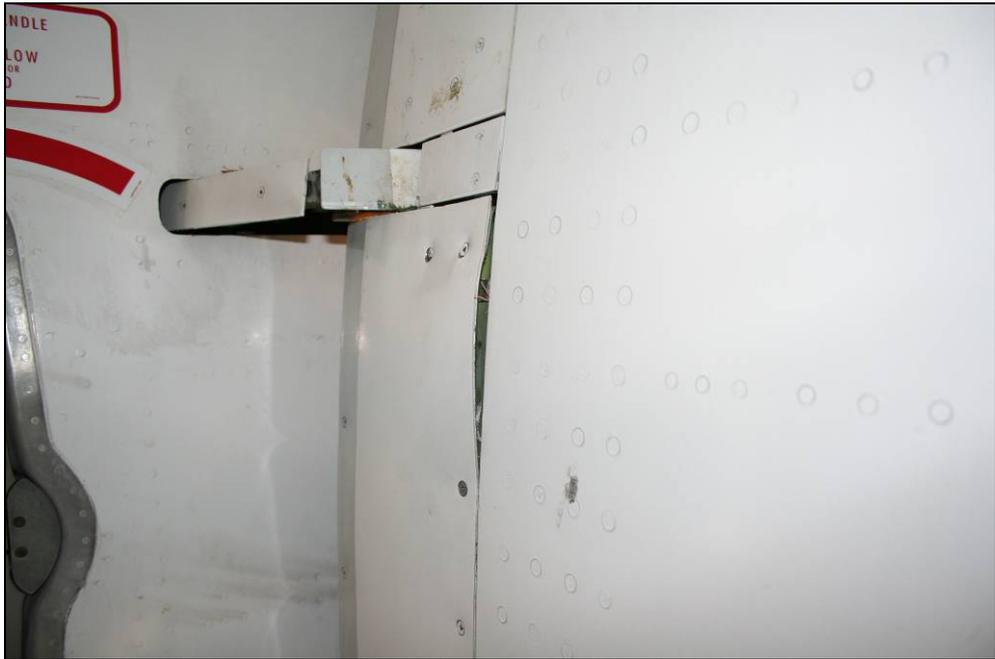
The R2⁸ door into the aircraft's main cabin was located directly above the fuselage rupture (at STA 830). An external panel located between the two door hinges showed localised outward bulging from a point immediately below the upper hinge, with the forward edge of the panel raised above the surrounding fuselage skin (Figure 9). The main external door handle was in the fully closed position, however the upper and lower door gates⁹ were partially retracted.

Figure 9: Cabin R2 door – damage to external panelling

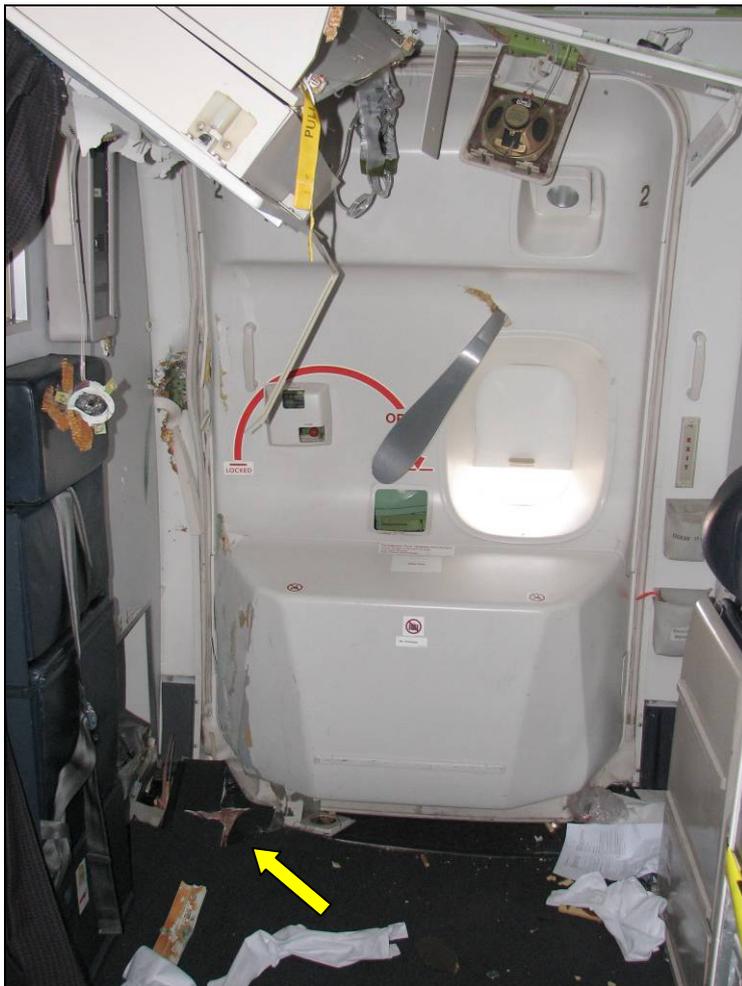
Within the aircraft, the cabin around the R2 door had sustained substantial damage and disruption (Figure 10). The cabin floor to the left and immediately inside the R2 door frame had sustained an impact that created a single circular perforation approximately 20 cm (8 inches) in diameter, located immediately above the number-4 oxygen cylinder position (Figure 11). Fragments of the cabin flooring and covering extended down into the hole. Above the hole, the forward partitioning panel between the door and the row 26J,K seats showed an elongated green coloured abrasion, leading upward to an area of impact damage at the mid-height position of the forward R2 door frame (Figure 12). The door escape slide shroud (bustle) also showed vertically-oriented scoring and green smear marks along the corner and forward facing surface. The portable walk-around oxygen cylinder normally located in an alcove just inside the R2 door was not present, and was not accounted for in a subsequent search of the aircraft.

Figure 10: Interior of R2 door and cabin – location of floor hole arrowed

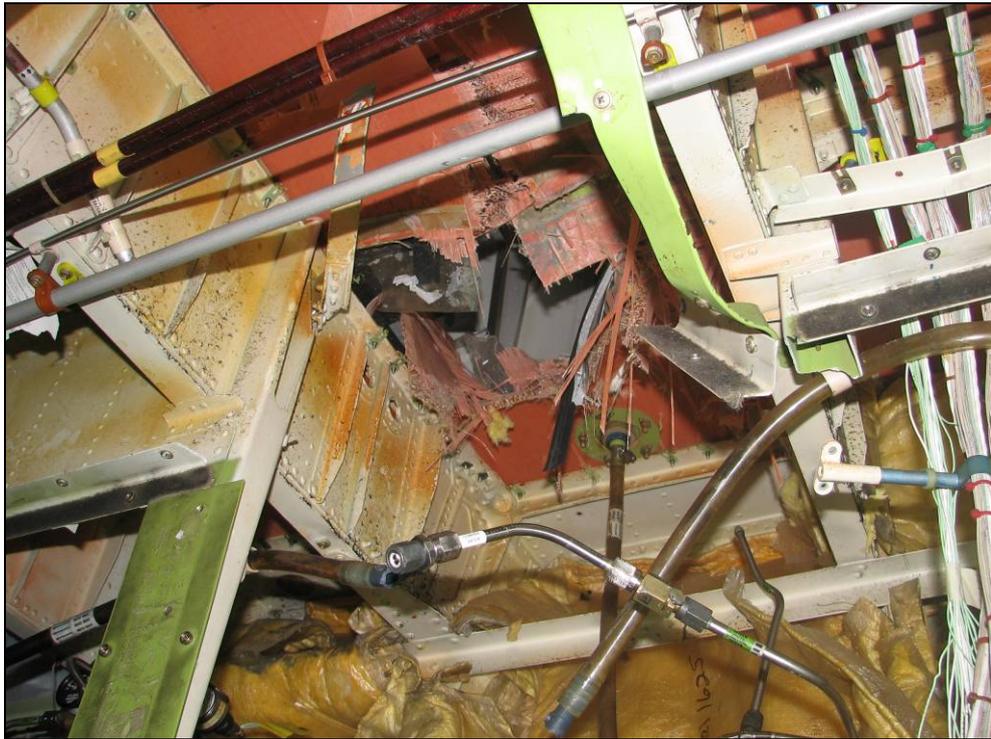
Figure 11: Hole in cabin floor – viewed from position of number-4 oxygen cylinder

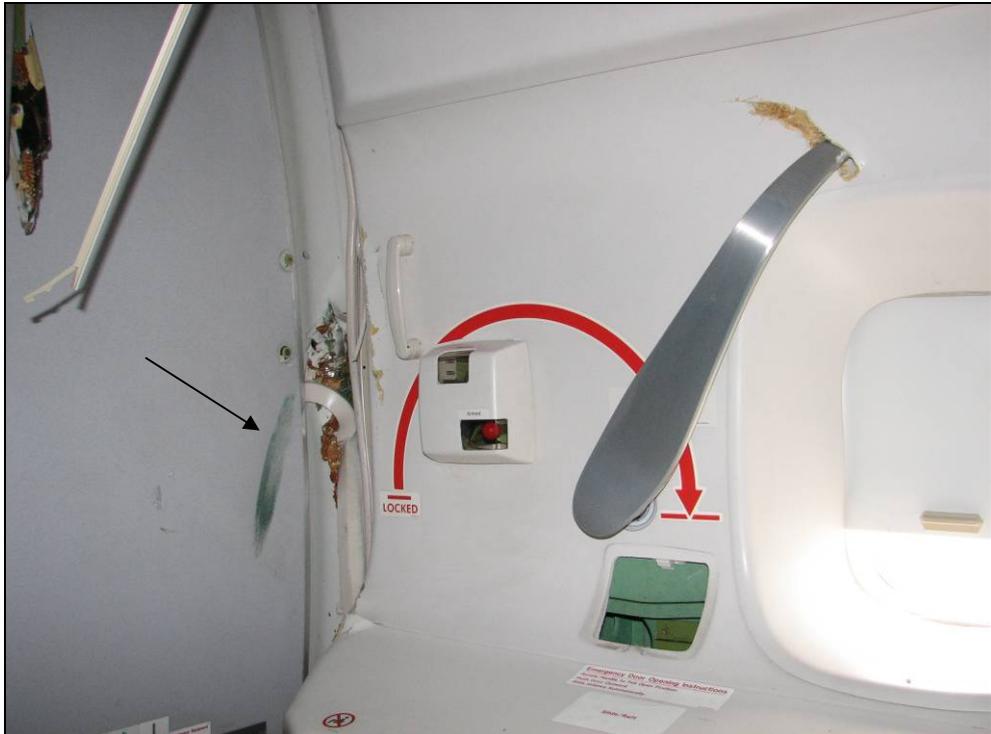
Figure 12: Door frame damage, green paint smear and rotated R2 door handle

The internal door handle was found in approximately the one-o'clock position (looking from inside), with the turned-in handle end embedded into the door lining material. That position was consistent with a movement through approximately 120 degrees from the fully-closed (locked) position. A 180 degree handle movement represented the fully open position. The downward facing surfaces of the handle end (when the door is in the locked position) showed damage and abrasion consistent with impact against another object. Inspection of the internal door systems showed the handle shaft had fractured and the actuating cam plate and retainer had pulled away from its associated mechanism (Figure 13), allowing the handle to rotate freely. As such, the handle position as observed inside the cabin was not indicative of the actual door security.

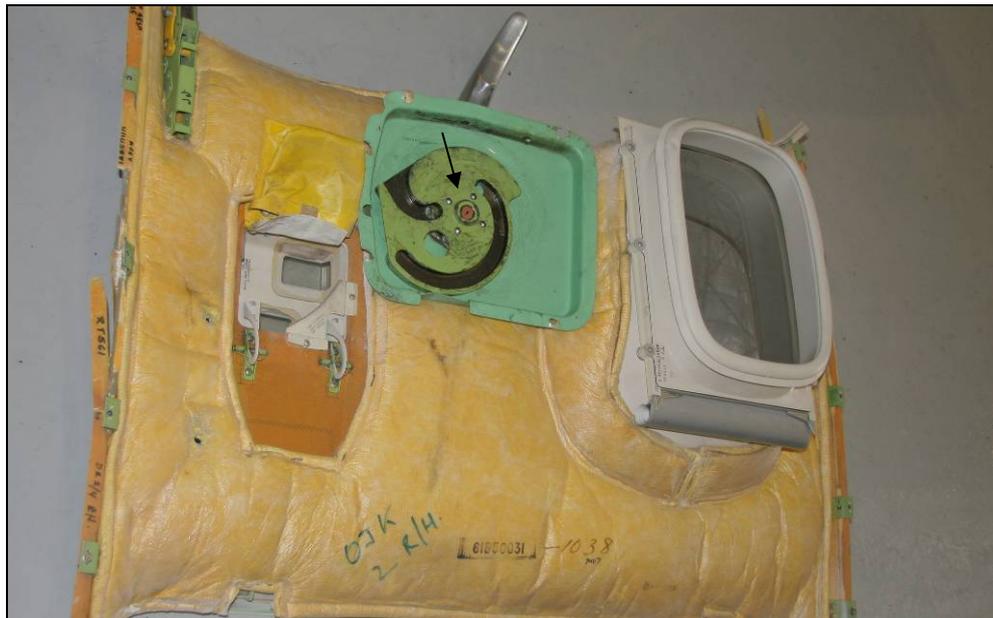
Figure 13: R2 door panel underside – fractured shaft and separated plate

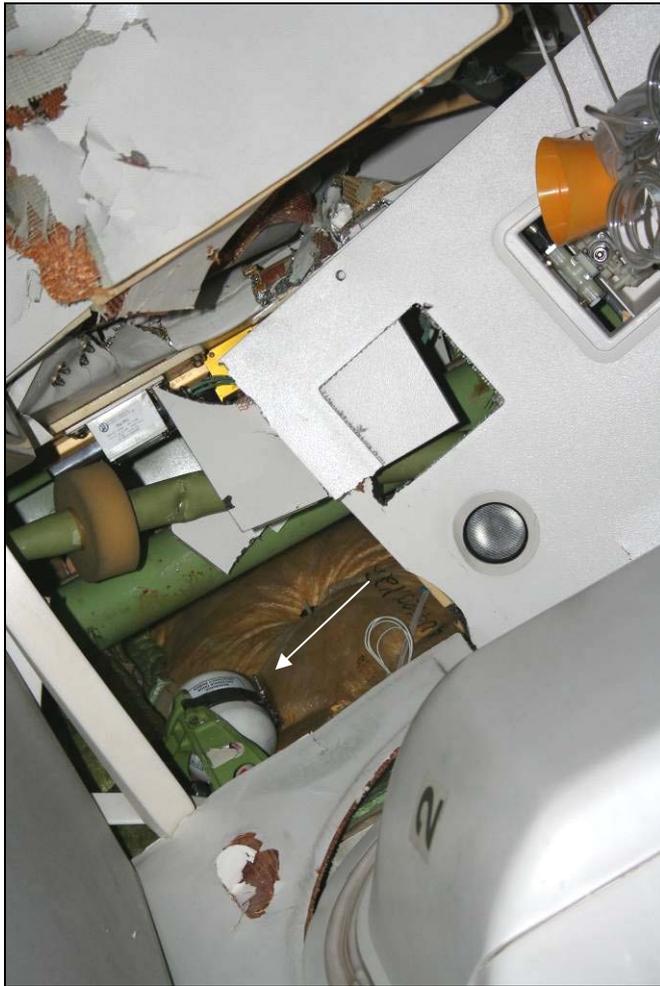
Above the R2 door within the cabin, the overhead panelling, fixtures and utility storage compartments had sustained extensive impact damage. The panels above the door frame had been pushed inward, exposing the overhead structure and pressure reservoir for the door emergency power assist opening system (EPAS, Figure 14). Amongst the impact damage, it was observed that an unusually uniform semi-circular section had been forcibly cut from the panelling and access door (Figure 15), with the cut-out section later recovered from above the damaged storage compartment casing. The diameter of the cut-out region closely matched that of the passenger oxygen cylinders (Figure 16). Adjacent to the cut-out opening was a semi-circular area of crushing damage to a partitioning panel (Figure 17); the damage being of a similar diameter to the cut-out section. A light fitting, normally present in the overhead panels had sustained upward crushing damage and presented clear green paint smears of a similar colouration to the marks on the partition panel and door bustle.

Figure 14: Damage above R2 door, exposing the EPAS cylinder (arrowed)

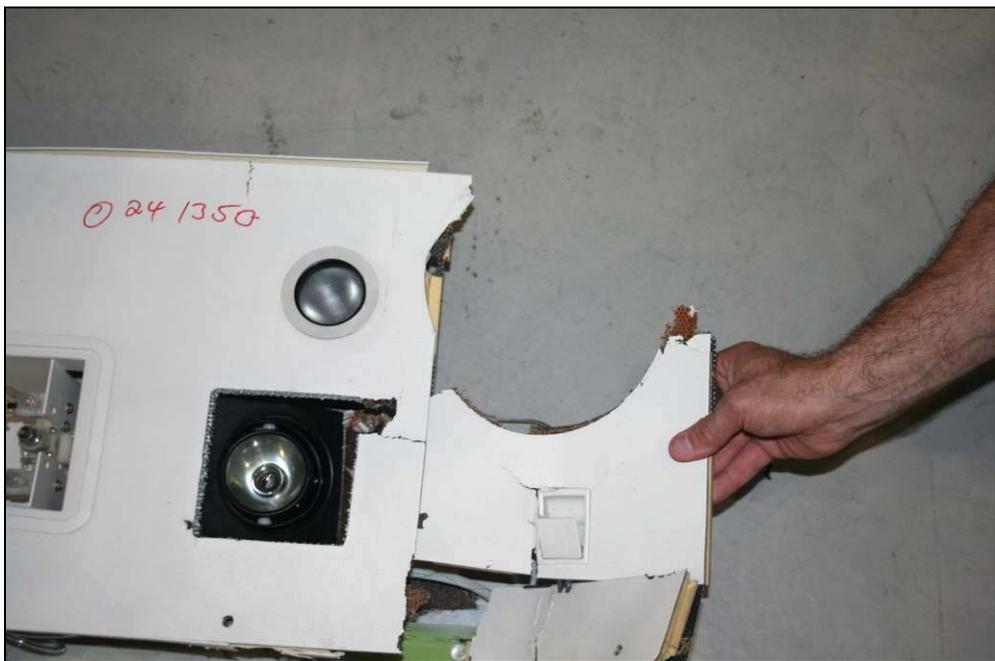
Figure 15: Cut-out section found in panels above the R2 door

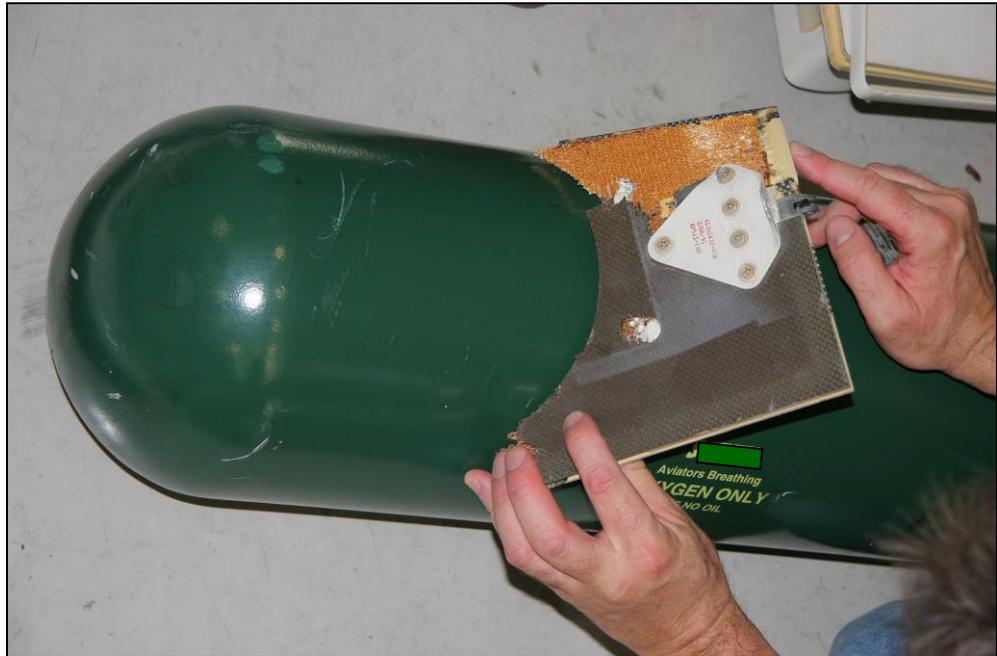
Figure 16: Panel with cut-out placed against another oxygen cylinder to illustrate the conformance in diameter

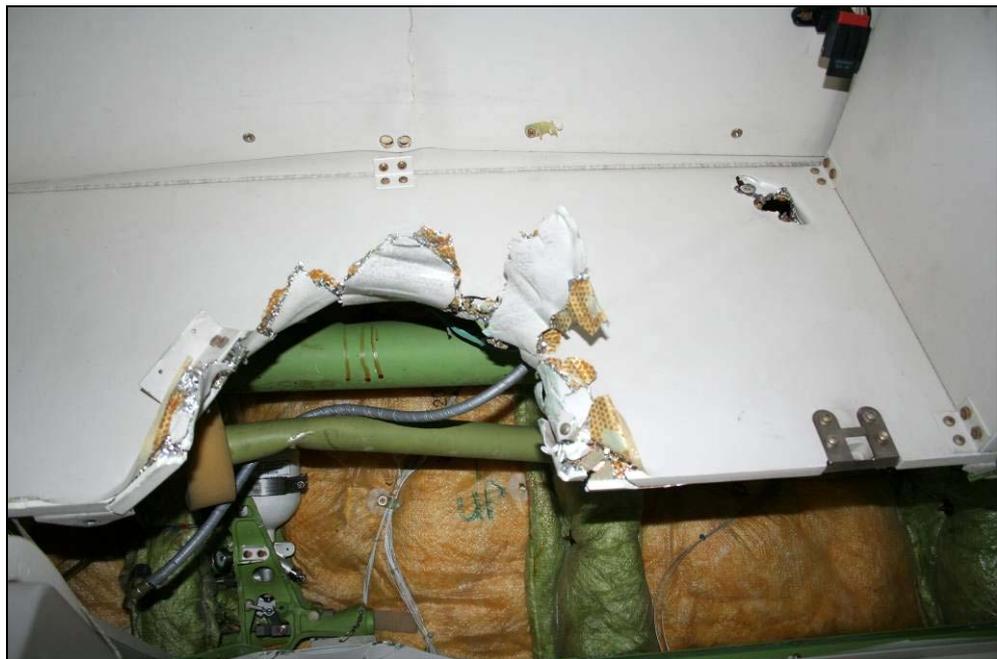
Figure 17: Semi-circular damage in partition of compartment above R2 door

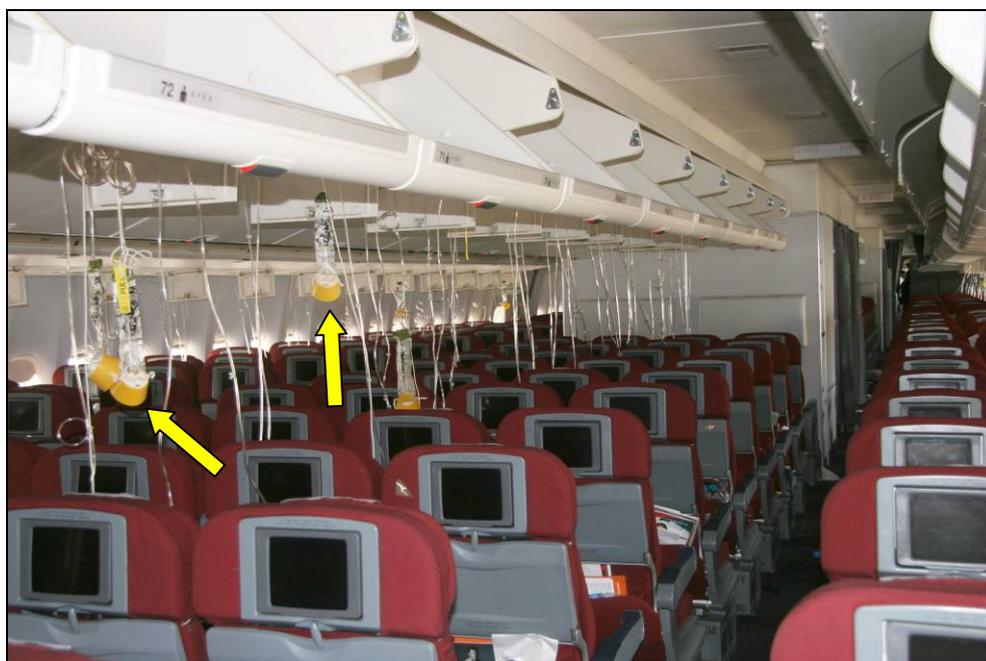
- there were 353 passenger seats in the aircraft
- 476 passenger oxygen masks had deployed from their overhead compartments
- 426 passenger oxygen masks were pulled down (i.e. activated for use)
- row 53 centre overhead passenger service unit was hanging down
- forward crew rest and customer support manager station masks had not deployed
- the covering on the rear surface of the partition in front of seats 40A,B,C was damaged
- floor pressure relief panels were open at seats 24A (2), 25A, 37K and 54A
- one mask hose was detached from the ceiling fitting at seat 4K (3 masks deployed).

Figure 18: Typical appearance of cabin. Note passenger masks dropped and activated, and those dropped and not activated (arrowed)

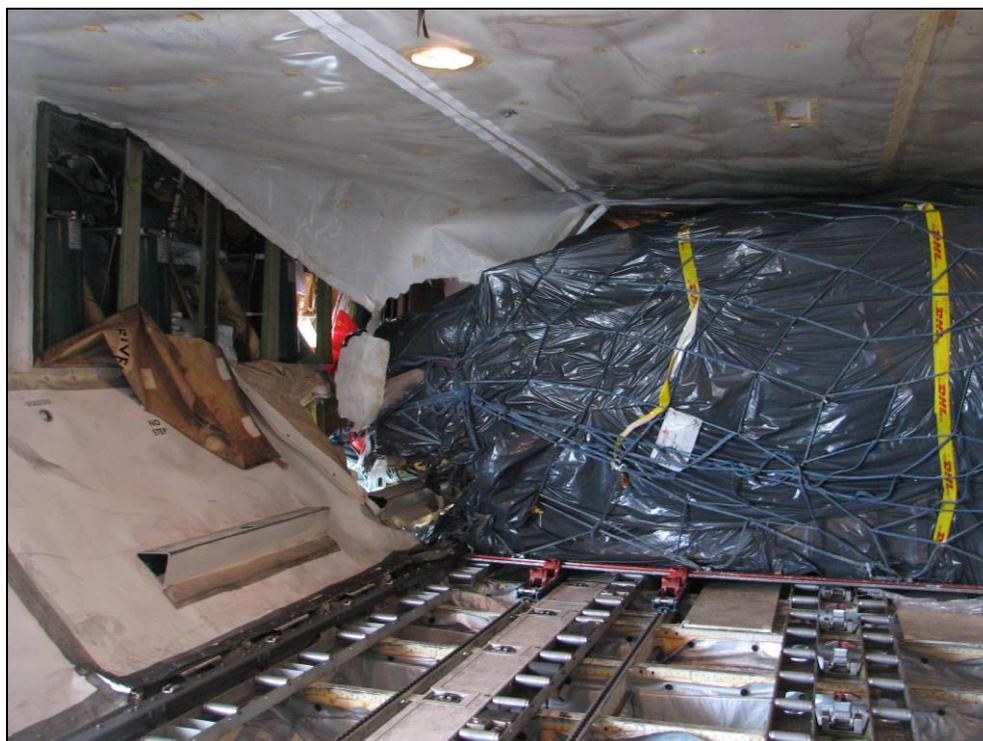
Figure 19: Cargo pallet adjacent to fuselage rupture (view looking to the rear)

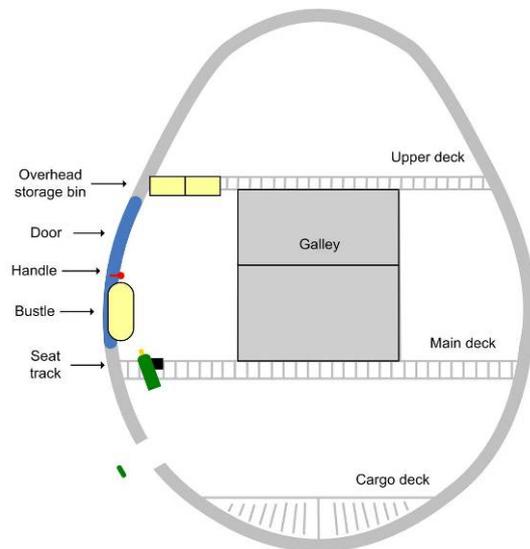
1. Normal arrangement (Oxygen cylinder and valve arrowed)

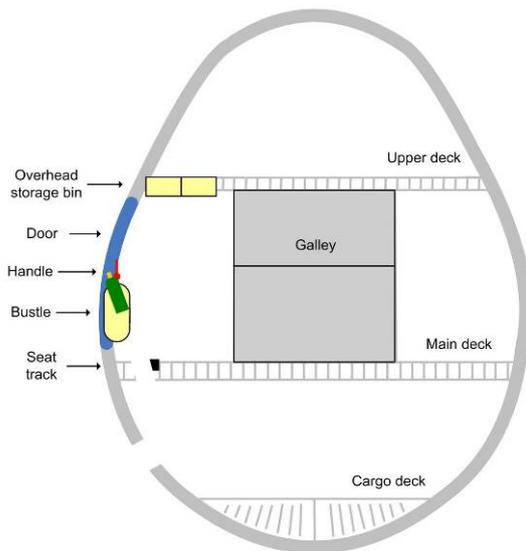
2. Cylinder failure produces fuselage rupture, with bulk of the cylinder length propelled upward through the cabin floor. See Figure 11.

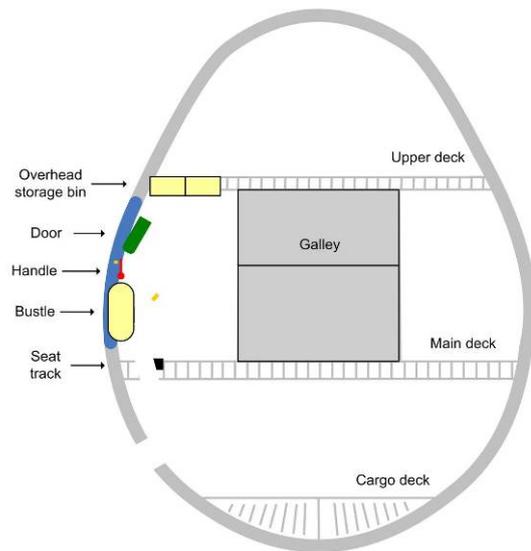
3. Cylinder impacts R2 door frame and internal door handle. See Figures 10 & 12.

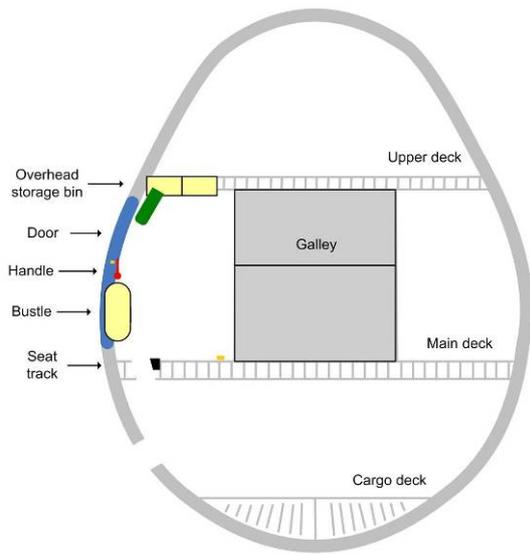
4. Door frame impact breaks off cylinder valve and causes cylinder to invert while continuing to travel upward.

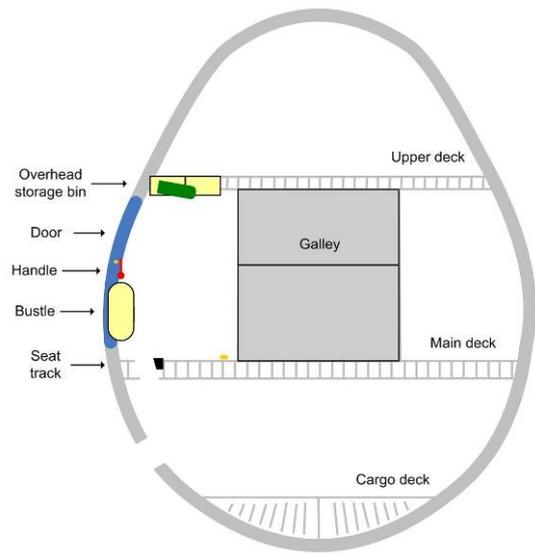
5. Cylinder impacts overhead panelling end-on, producing circular cut-out type damage. See Figures 14-16.

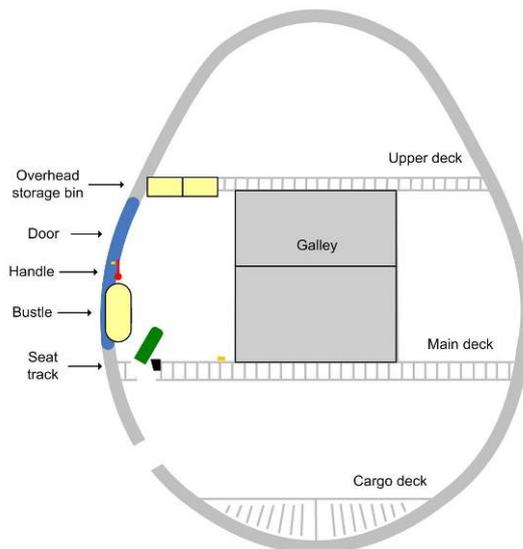
6. Still rotating cylinder impacts overhead storage bin, producing semi-circular crushing damage. See Figure 17.
