Wire Strike – Mataranka, NT – 23 August 2008

Abstract

On 23 August 2008, at about 1200 Central Standard Time, a Robinson Helicopter Company R22 Beta, registered VH-HPY, with a pilot and passenger on board, departed the sports ground at Mataranka, NT.

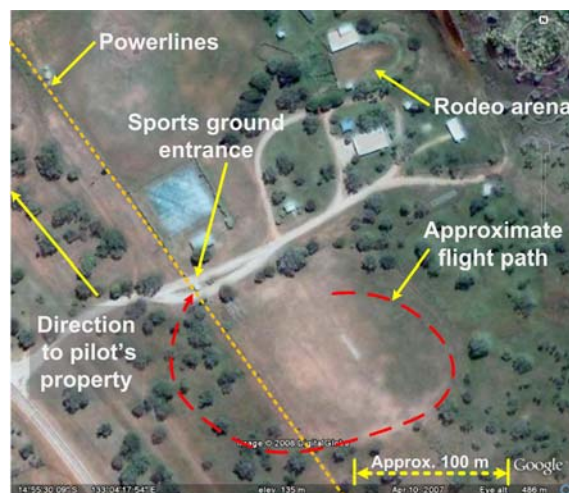
Figure 1: Aerial view of sports ground

landing, the pilot and passenger interacted with people at the sports ground who were preparing for a rodeo that afternoon at the nearby rodeo arena (Figure 1). A number of those people, who also reported knowing the pilot, commented that he appeared to them to be affected by the effects of alcohol.

The powerline consisted of three parallel aluminium alloy cables that were set at 10 m above the ground and spanned the roadway at the entrance to the sports ground, across the helicopter's direction of flight (Figures 1 and 2).

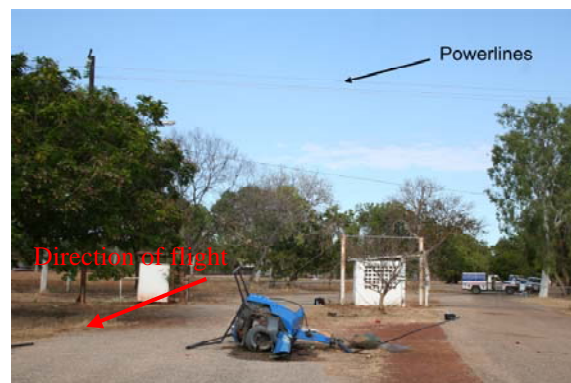
Figure 2: Main wreckage, looking opposite to the direction of flight.

The main wreckage came to rest on its right side facing the opposite direction to the flight, about 10 m from the powerlines (Figure 2). A number of the helicopter's structural components separated from the helicopter during the impact sequence.

There were powerline contact marks on the belly of the helicopter, on the upper surface of the right skid landing gear, and on the front face of the right forward skid landing gear crosstube. The right skid landing gear was fractured at the right forward crosstube attachment point, and was located a few metres from the main wreckage. The lack of powerline marks on the left skid landing gear indicated that the helicopter was in a right wing-low attitude at the time of impact with the powerlines.

- first cable was fractured in ductile overload
- middle cable showed evidence of bending
- last cable appeared to be undamaged.
