ATSB TRANSPORT SAFETY REPORT
Aviation Occurrence Investigation AO-2008-060
Final

Fuel system event

50 NM north-east Brisbane Airport, Qld

2 September 2008

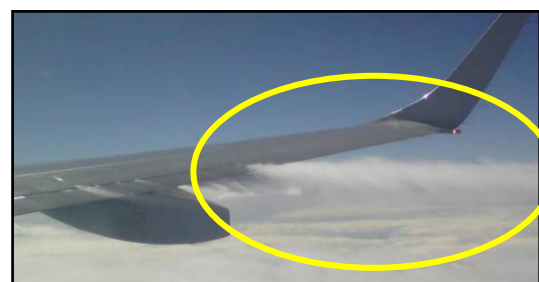
The flight crew later reported that, as they flew through moderate turbulence, they were notified by the cabin crew (the aircraft had two flight crew, three cabin crew and 40 passengers) that 'vapour' was streaming from both wing tanks. The pilot in command walked back to check and confirmed fuel streaming at a high rate from both wings (Figure 1).

Figure 1: Photograph taken by cabin crew of vapours from right wing during descent

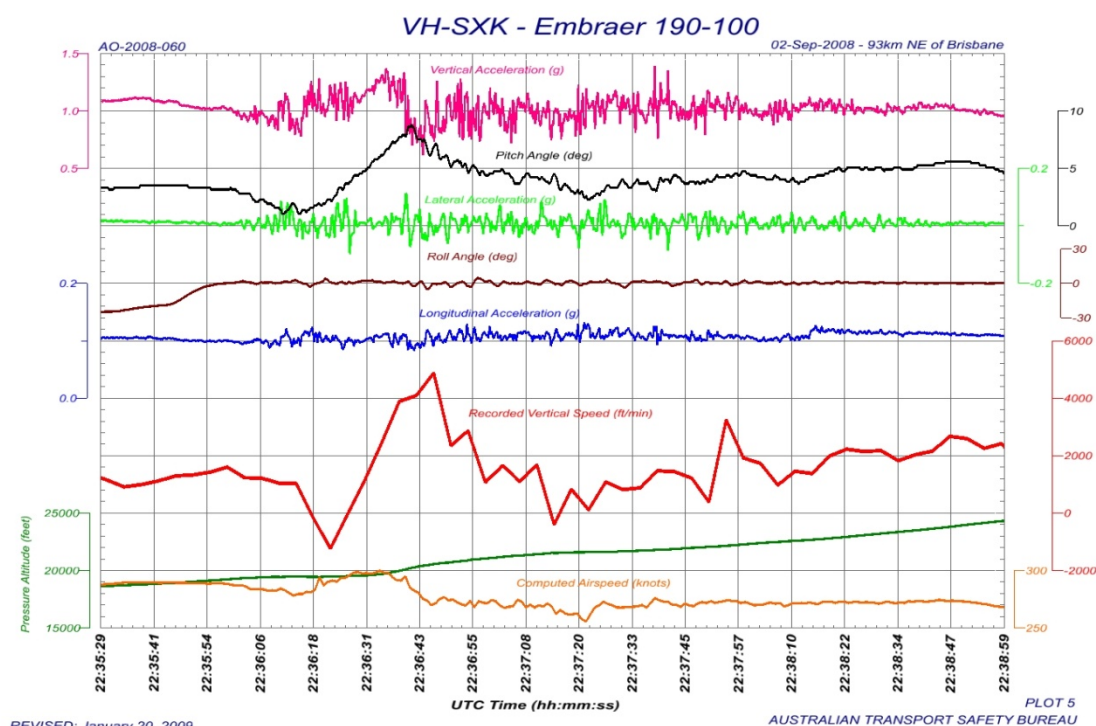
Figure 2: Plot of recorded data

The data recovered documented that just prior to the occurrence, the aircraft was passing through FL250 at 290 KIAS² when it encountered turbulence (Figure 2). The turbulence recorded values ranged from 0.6 to 1.4 positive absolute g³, a range of about 0.8 g, which lasted from about 0836:00 (22:36:00 UTC) until about 0838:30 (22:38:30 UTC).

The data also confirmed that the maximum computed airspeed was 299.75 KIAS at 0836:34 (22:36:34 UTC), momentarily decreasing to 270 KIAS before returning to 290 KIAS⁴, and that the vertical speed varied from -1,232 to 4,880 ft/min, with associated variations in pitch angle.

At 0839:30 hrs (22:39:30 UTC), the data confirmed the fuel disparity between fuel burn⁵ and fuel removed from the fuel tanks. According to the data, the difference was around 680 kg (1,500 lbs).

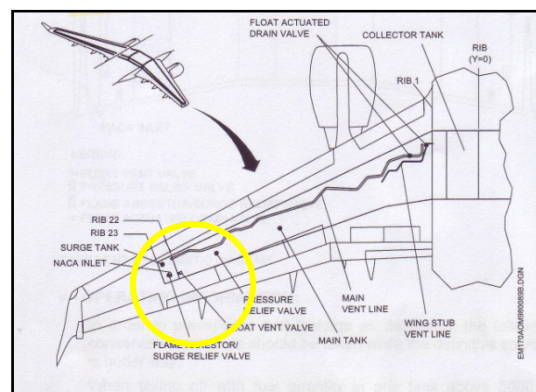
Figure 3: Operation bulletin fuel system⁷

- At high speeds, the NACA inlet air flow pattern may alter its performance in keeping positive pressure;
- The pressure inside the Surge Tank is suddenly reduced. This forces a high air flow from Wing Tank to the Surge Tank through the Float Vent Valve that jams it closed;
- Once the line between the Wing Tank and the Surge Tank is closed, the pressure inside the Wing Tank remains constant. As the airplane climbs, the outside pressure decreases generating a delta pressure between the Wing Tank and the atmosphere;
- In this condition, if the fuel level inside the Wing Tank is above the Main Vent Line end, located at the wing root, the fuel is boosted out of the wing tank to the surge tank and leaks to the atmosphere through the NACA inlet;
- The leak stops automatically after the Main Vent Line becomes uncovered.

The bulletin included a schematic of the fuel system with the area of the NACA inlet circled in yellow (Figure 3).

The bulletin recommended the following operating information to prevent fuel leakage:

When taking off with fuel quantity in any tank above 5000 kg (11000 lb), adopt the pre-set FMS [flight management system] climb schedule or maintain 290 KIAS maximum during climb until reaching cruise altitude (the recommendation also applies to step climb).
