ATSB TRANSPORT SAFETY REPORT
Aviation Occurrence Investigation A0-2008-073
Final

Airspace-related event - Mackay Airport, Qld

16 October 2008

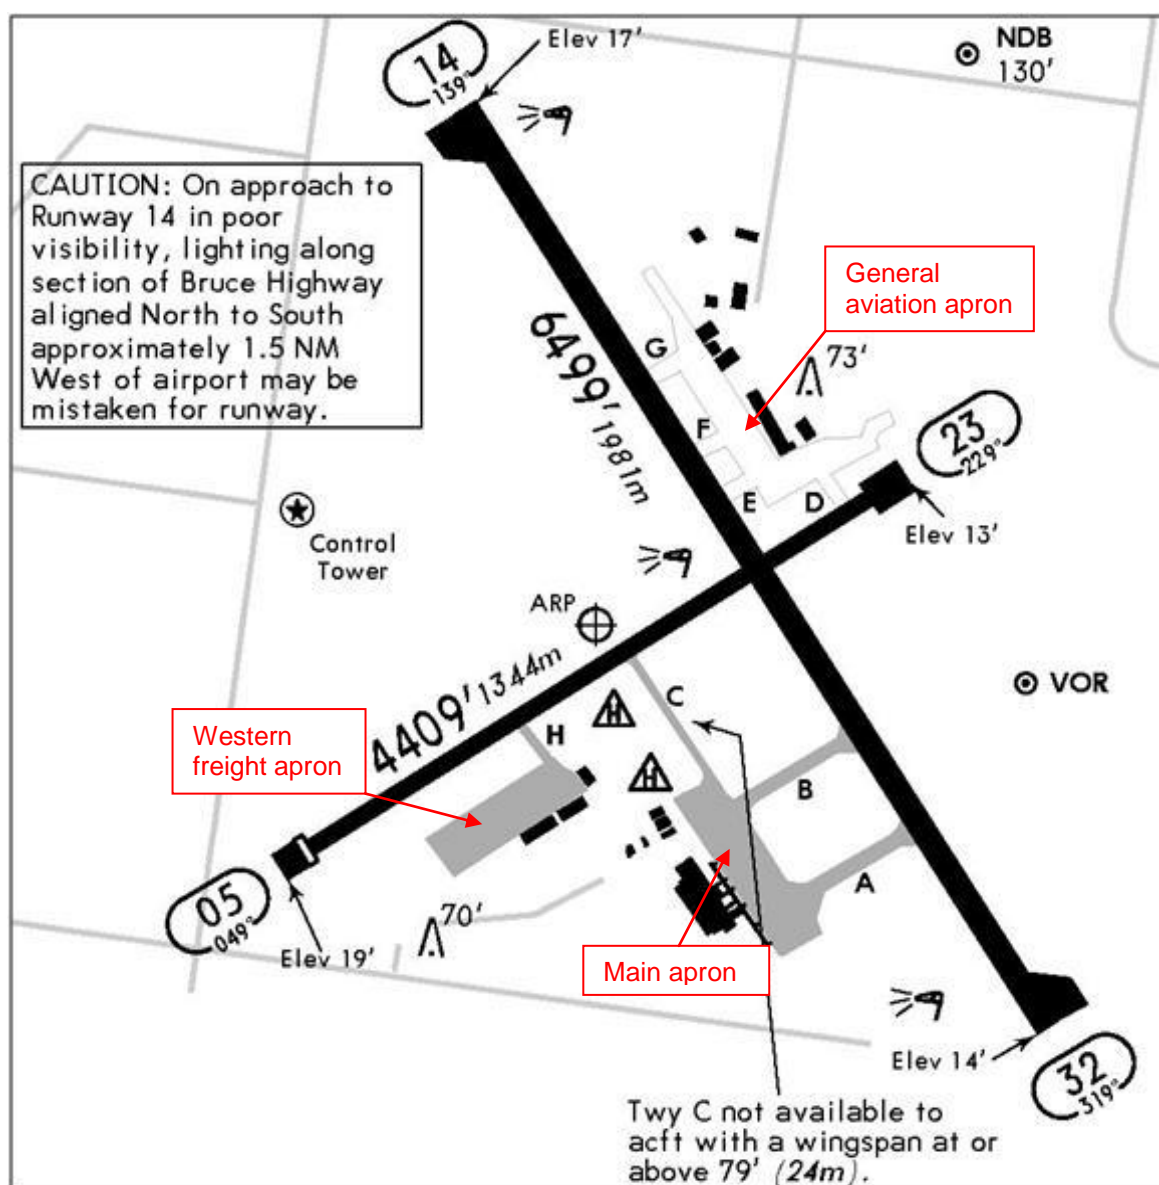
Figure 1: Mackay Aerodrome Chart⁵

During the landing roll, the aircraft passed the runway 05 intersection (Figure 1) and continued along the runway to the turning node that was located at the upwind end of the runway (runway 14 threshold). From that position, the flight crew commenced a backtrack², with the intention to vacate the runway via the crossing runway 05. The flight crew cancelled SARWATCH³ on area frequency 135.5 MHz (Brisbane Centre) and began the after landing checklist. Those checks were completed prior to taxiway Golf.

The pilot of UZA commenced the takeoff and, when passing a speed of about 70 kts, observed EEO backtracking to the runway 32/05 intersection. The pilot elected to continue the departure, and manoeuvred to the left of the runway centreline in order to avoid EEO.

The flight crew of EEO sighted UZA when they were at a position between taxiway Golf and taxiway Foxtrot, and moved to the left edge of the runway to avoid UZA.
