ATSB TRANSPORT SAFETY INVESTIGATION REPORT  
Marine Occurrence Investigation No. 255  
Final

Independent investigation into the grounding of the  
Greek registered bulk carrier

# Atlantic Eagle

at Maude Reef, off Albany, Western Australia  
15 July 2008

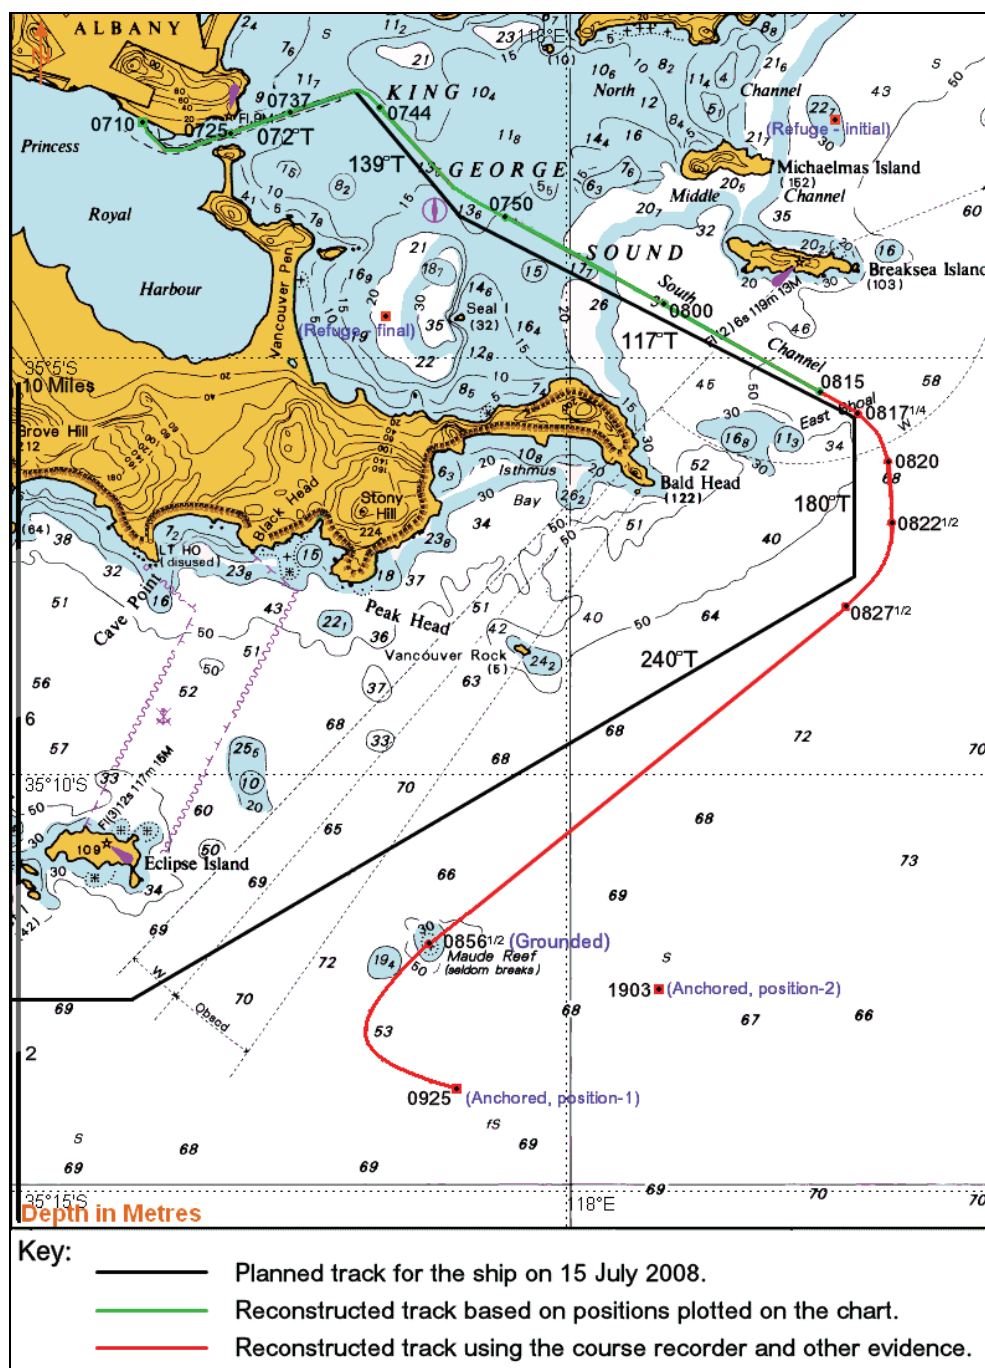
**Figure 3:** Section of navigational chart Aus 759 showing *Atlantic Eagle's* track

ships nearby but the coast and the islands could be seen. In the weather conditions at the time, Maude Reef, which seldom breaks, could not be seen. For the following 20 minutes or so, the second mate remained in that position and maintained the set heading of 235°.

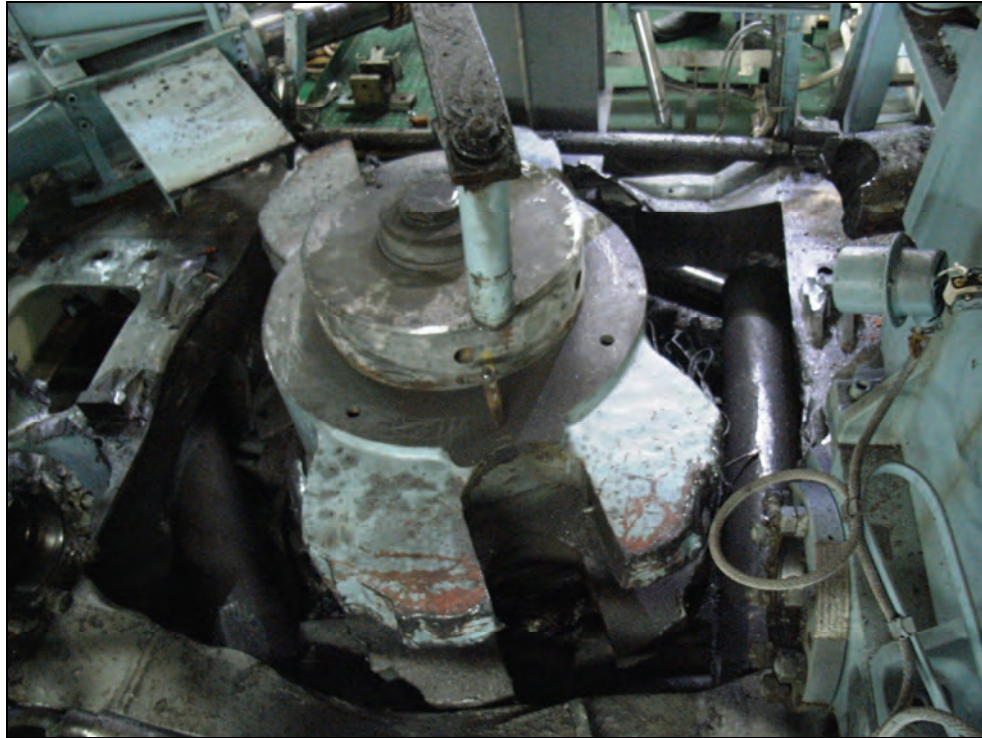
**Figure 4: Damaged steering gear with rudder stock and tiller in view**

At about 0900, the chief engineer reported from the steering gear room. All of the steering gear’s hydraulic rams and tiller arms were smashed and broken (Figure 4). The master called the chief mate to standby the anchors and told the second mate to call the necessary crew to go forward.

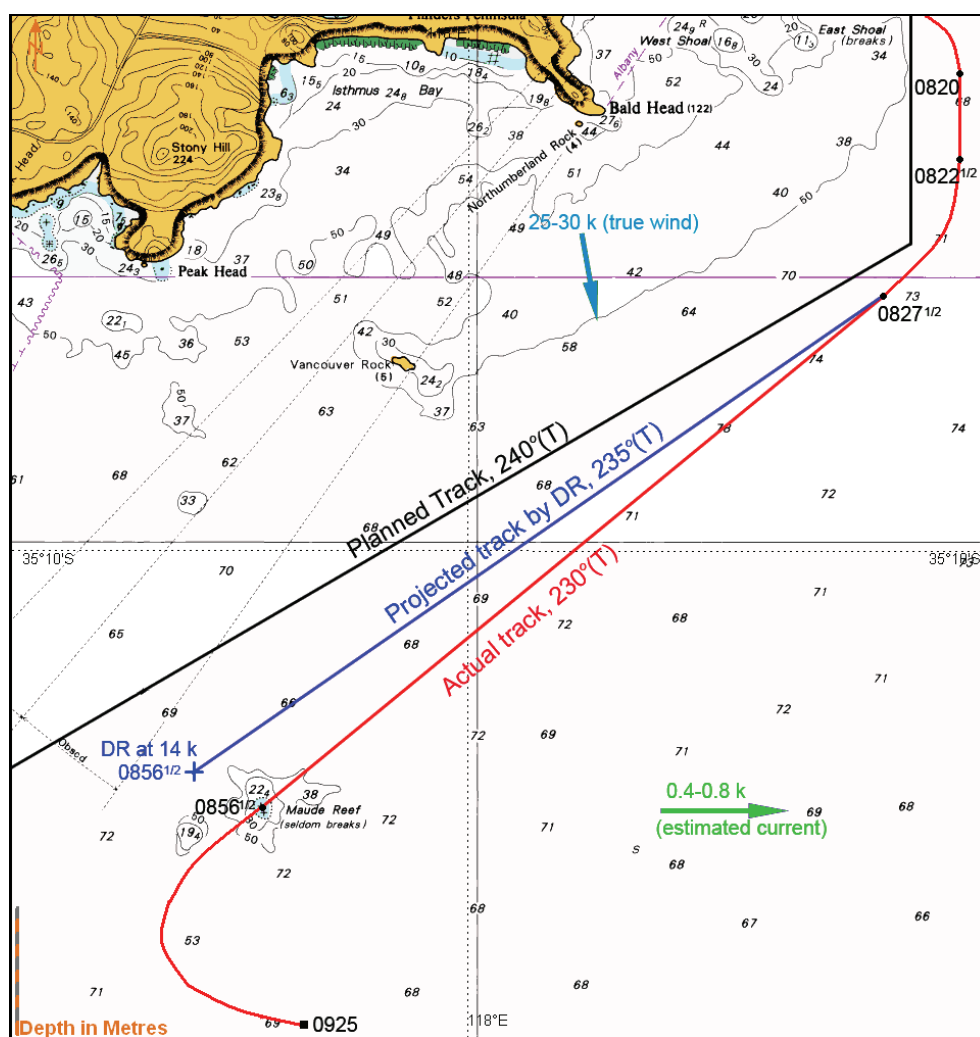
**Figure 6:** Section of chart Aus 118 with *Atlantic Eagle's* track superimposed

*Atlantic Eagle's* grounding was the direct result of the ship being put, and kept, on a heading of 235° that, in the prevailing current and weather conditions, took it directly over Maude Reef (Figure 6).

At 0827½ on 15 July, when *Atlantic Eagle's* heading was steadied on 235°, the ship was about 2.5 cables to port of its 240° (T) planned track. The ship's track by dead reckoning, with no allowance for wind and current, would have taken it 5.5 cables northwest of Maude Reef. However, on a heading of 235°, the ship experienced five degrees of combined set and leeway and made good a course of about 230° (T) over the following 29 minutes, until it struck the reef.

At the time, the direction of the wind was from 350° (T) at 25 to 30 knots and the current<sup>13</sup> is estimated to have been east-going at 0.4 to 0.8 knots. With the wind just abaft *Atlantic Eagle*'s starboard beam and the current on its starboard bow, the combined set and leeway the ship experienced at the time was not unusual. The ship could have been expected to be pushed to leeward, or to port of its heading, making an appropriate allowance to windward, or to starboard, necessary to follow the planned track. This allowance could have been relatively easily determined by the second mate had the ship's past track been adequately monitored. Instead, steering a heading of 235°, an allowance of five degrees to port, took the ship even further to port and directly over Maude Reef.
