Landing gear failure and runway excursion involving Cessna 441 VH-XBC

Coonawarra Airport, South Australia | 31 March 2013

ATSB Transport Safety Report
Aviation Occurrence Investigation
AO-2013-072
Final – 8 September 2014

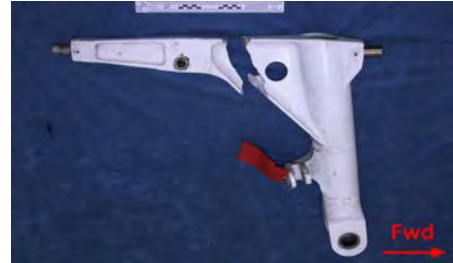
Failed main landing gear trunnion

The runway excursion resulted directly from the failure of the left main landing gear trunnion, which allowed the left main wheel to displace upward and contact the wing underside – producing an asymmetric and uncontrolled braking effect. Both the ATSB and component manufacturers' laboratory examinations attributed the trunnion failure to the development and growth of progressive fatigue cracking through the horizontal beam and central gusset section, with cracking propagating to the point where nominal landing loads produced the final overstress fracture and collapse of the assembly. Due to the extent of post-failure damage sustained by the fracture surfaces, neither laboratory examination was able to specifically identify the factors behind the initial development of the fatigue cracking.

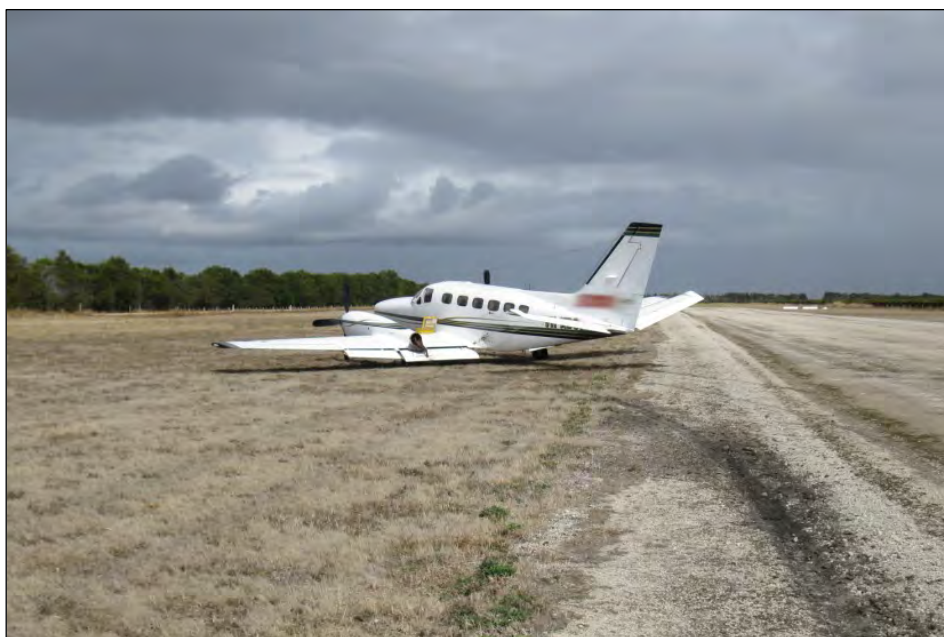
Figure 1: VH-XBC following the landing event at Coonawarra, SA

Visual inspection of the aircraft in preparation for its removal from the runway area found that the left main landing gear had partially collapsed after the fracture of the main trunnion section (Figures 2 and 3). The trunnion failure had allowed the uncontrolled upward movement of the strut and swing arm, bringing the left main wheel into contact with the wing and producing a strong asymmetric braking effect that resulted in the aircraft veering to the left and departing the runway surface. The aircraft operator reported only minor damage to other components and parts.

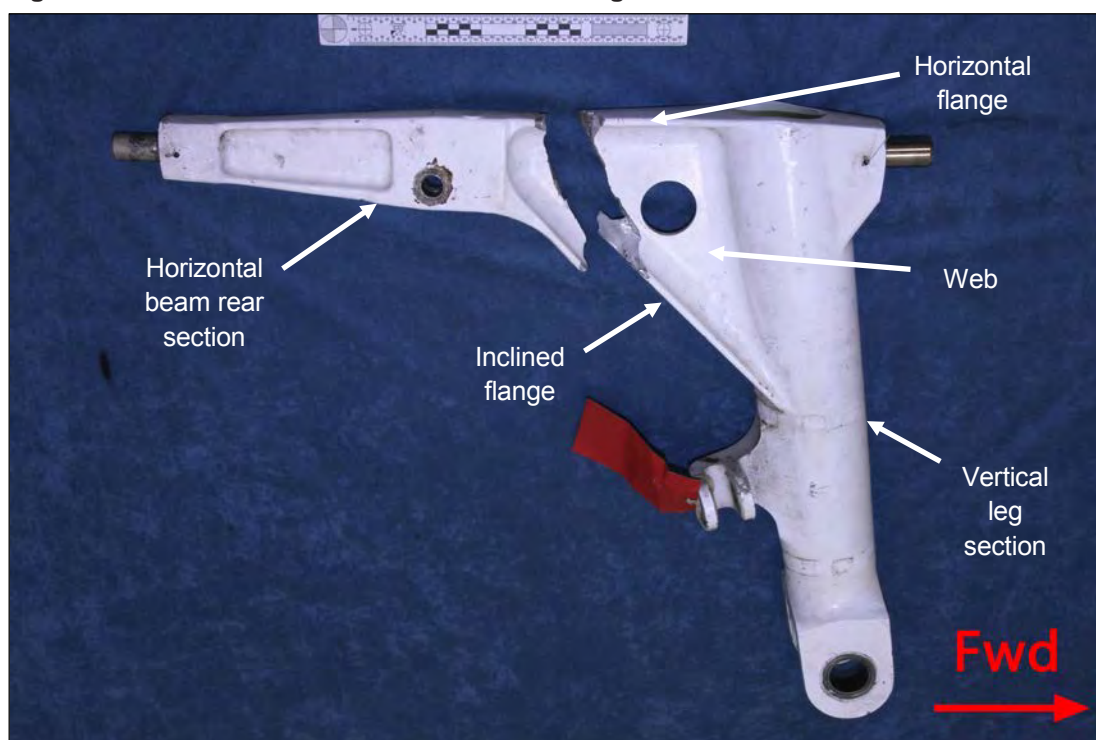
Figure A1: Trunnion removed from XBC showing fracture location

As depicted in Figure A1, the trunnion had fractured through the web between the strut attachment point and the vertical leg – following a plane roughly parallel to the leg axis.

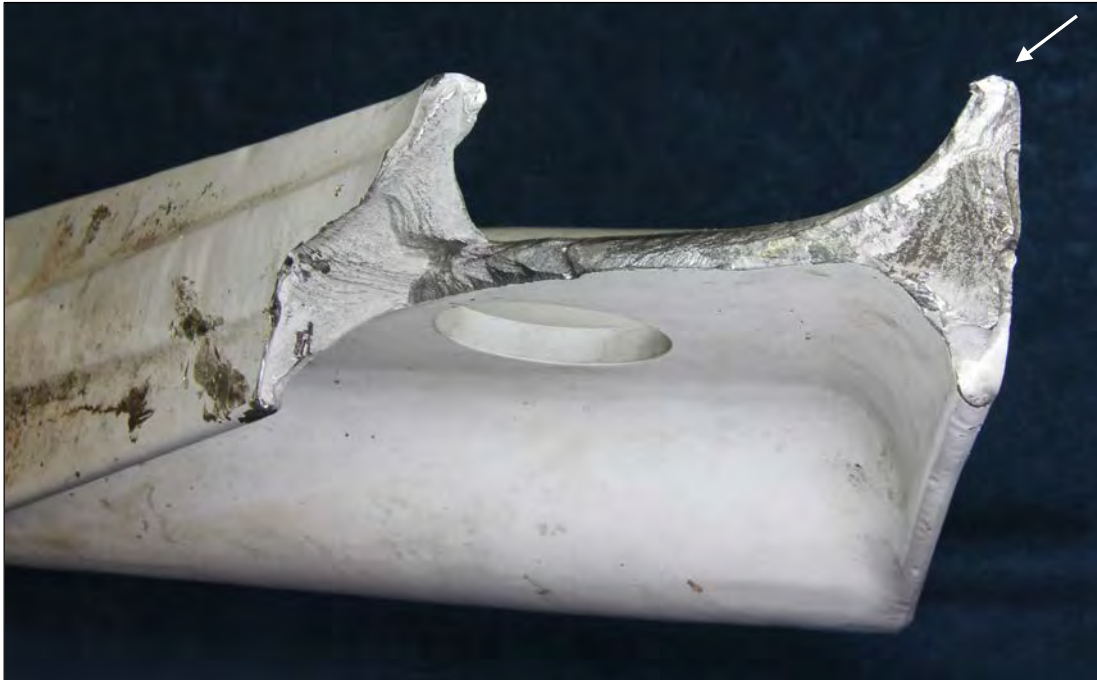
The fracture surfaces through the horizontal and vertical flange sections presented areas of heavy mechanical deformation and contamination that were consistent with post-failure mechanical contact and damage (Figure A2). Between these areas, the general surface morphology was consistent with overstress fracture in higher strength aluminium alloys.

Figure A2: Fracture surface from vertical leg section – possible fatigue crack origin at damaged upper flange corner (arrowed)

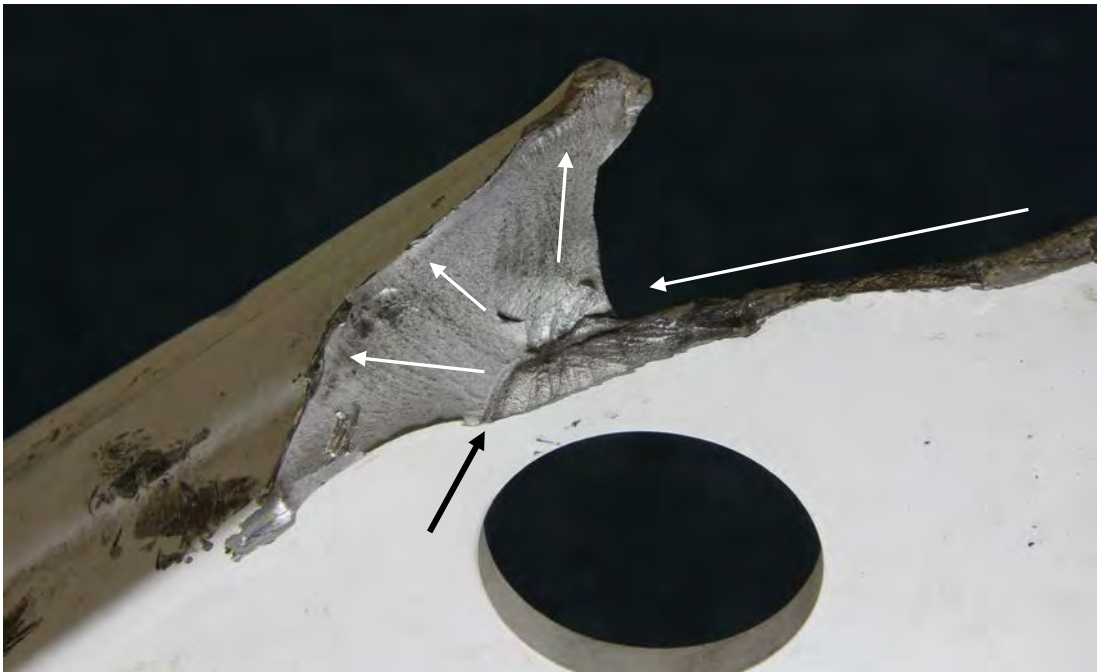
Within the central webbing section toward the area of transition to the inclined flange (Figure A3), the fracture presented a notable transition to a region of brighter, lustrous surface with patterned characteristics suggestive of a progressive crack growth mechanism. Closer study of this region revealed an unusual area of internal separation aligned along the web centreline (Figure A4). In areas, the internal surfaces of this region showed a quasi-crystallographic appearance of broad facets aligned along a single plane. Targeted mechanical sectioning allowed removal of a section of the web transition and the exposure of a larger area of the internal planar feature (Figure A5). Under stereomicroscopic examination, the intersection of the planar separation and transverse progressive crack pathways could be clearly discerned (Figure A6).

Figure A3: Fatigue / overstress fracture transition adjacent to the inclined flange (black arrow), and fracture pathways / direction (white arrows)

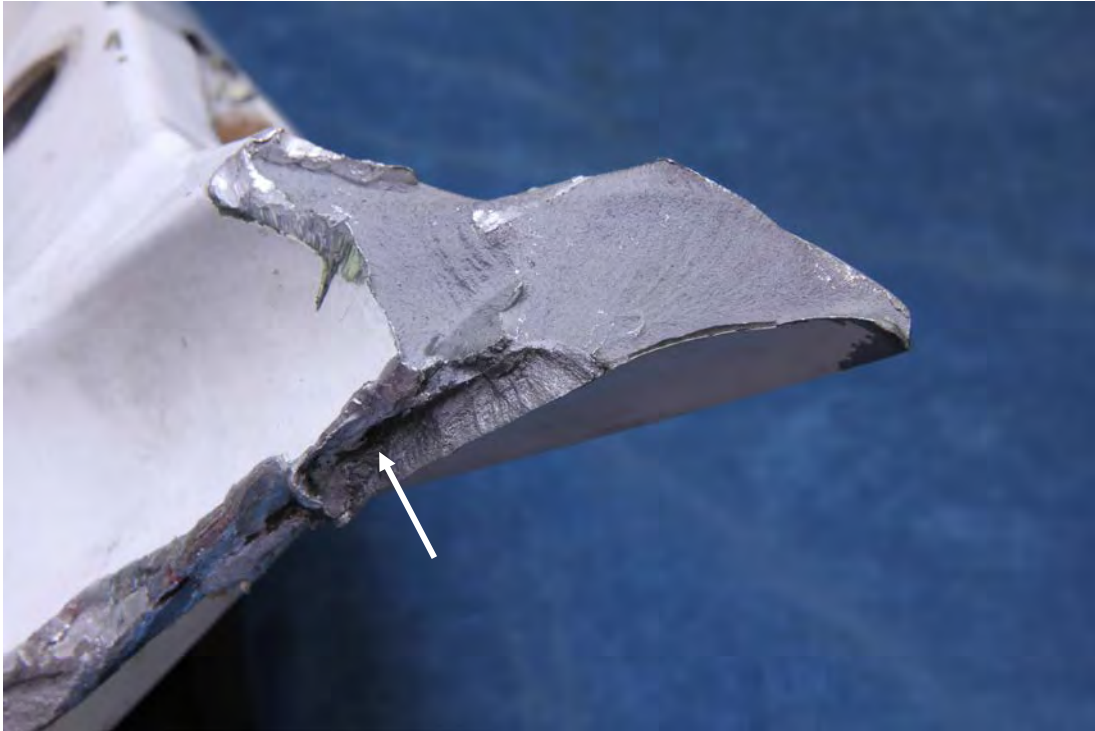
Figure A4: Inclined flange transition region of fracture (horizontal beam rear section) showing internal separation of the web (arrowed)

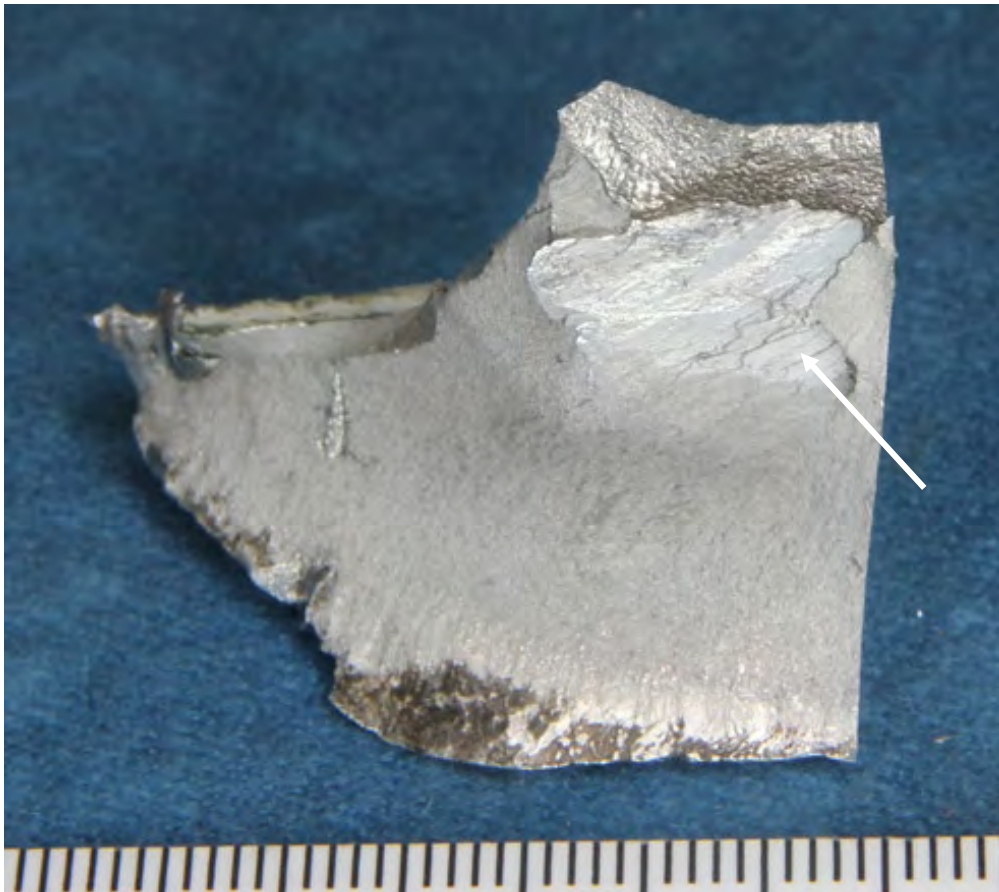
Figure A5: Removed section of the trunnion fracture showing part of central planar separation (arrowed)

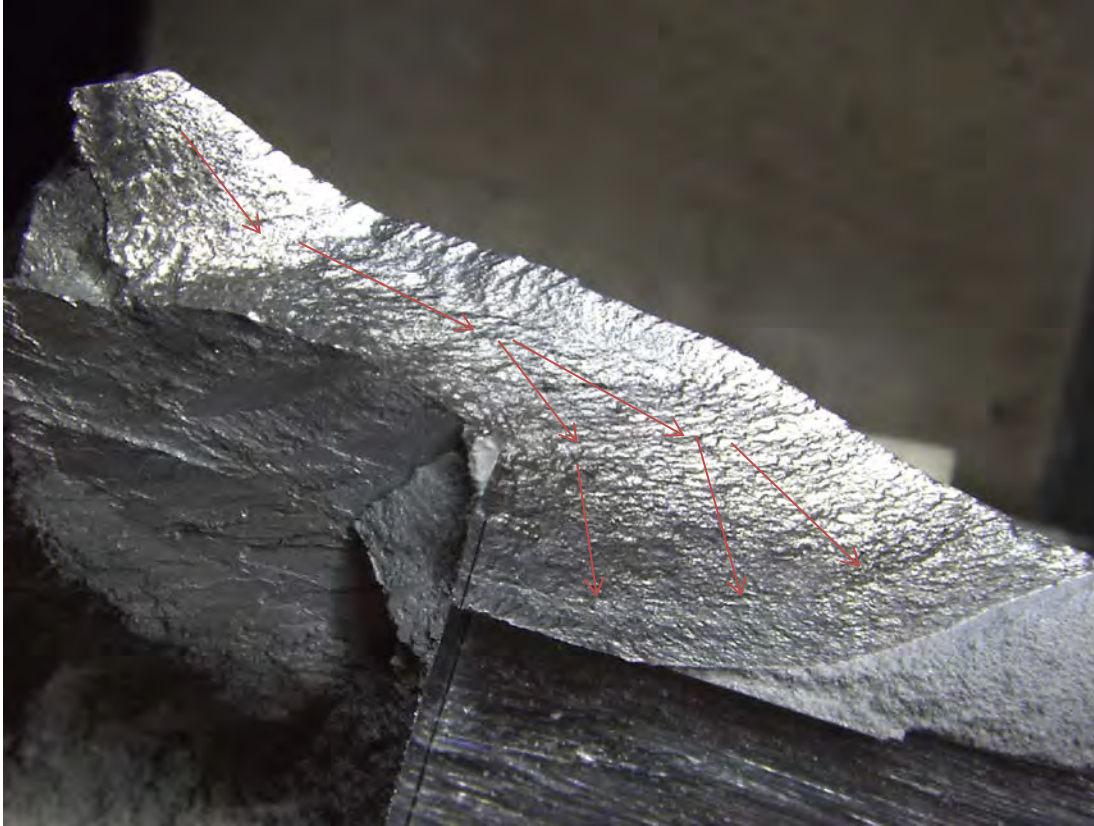
Figure A6: Intersection of central planar separation feature (piece shown in figure A5) with transverse progressive cracking (after sectioning). Arrows show direction of fatigue propagation

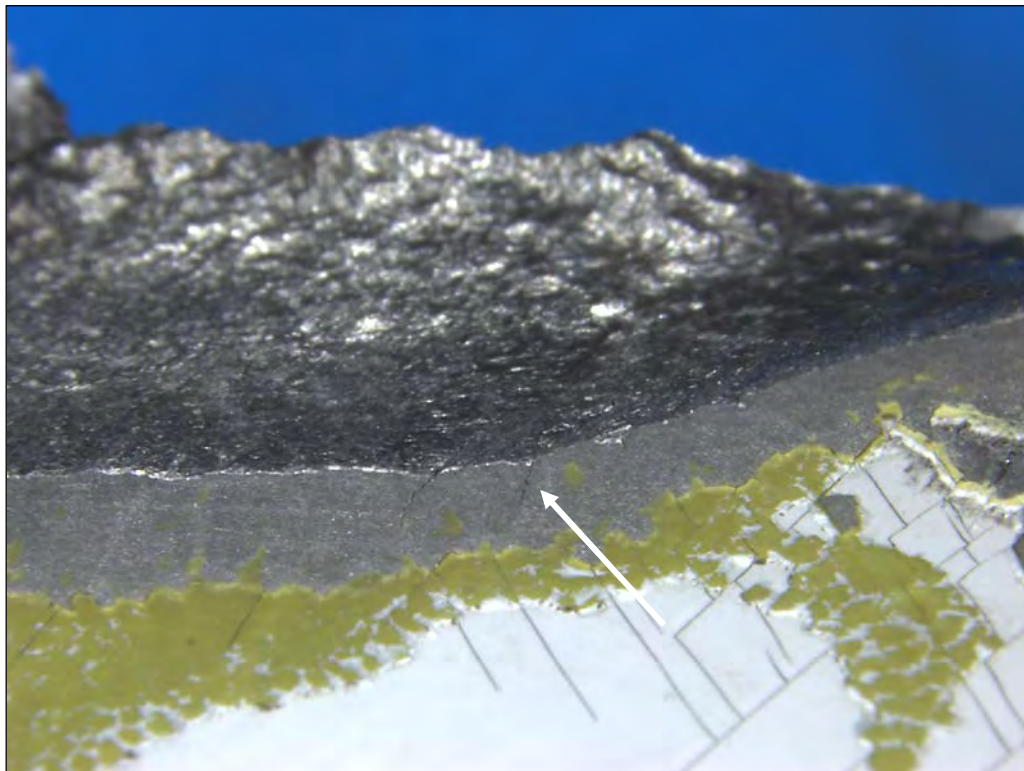
In areas along the progressive cracking, fine secondary cracks were apparent beneath the external paint coating (Figure A7).

Figure A7: Secondary cracking (arrowed) extending from the primary progressive region.

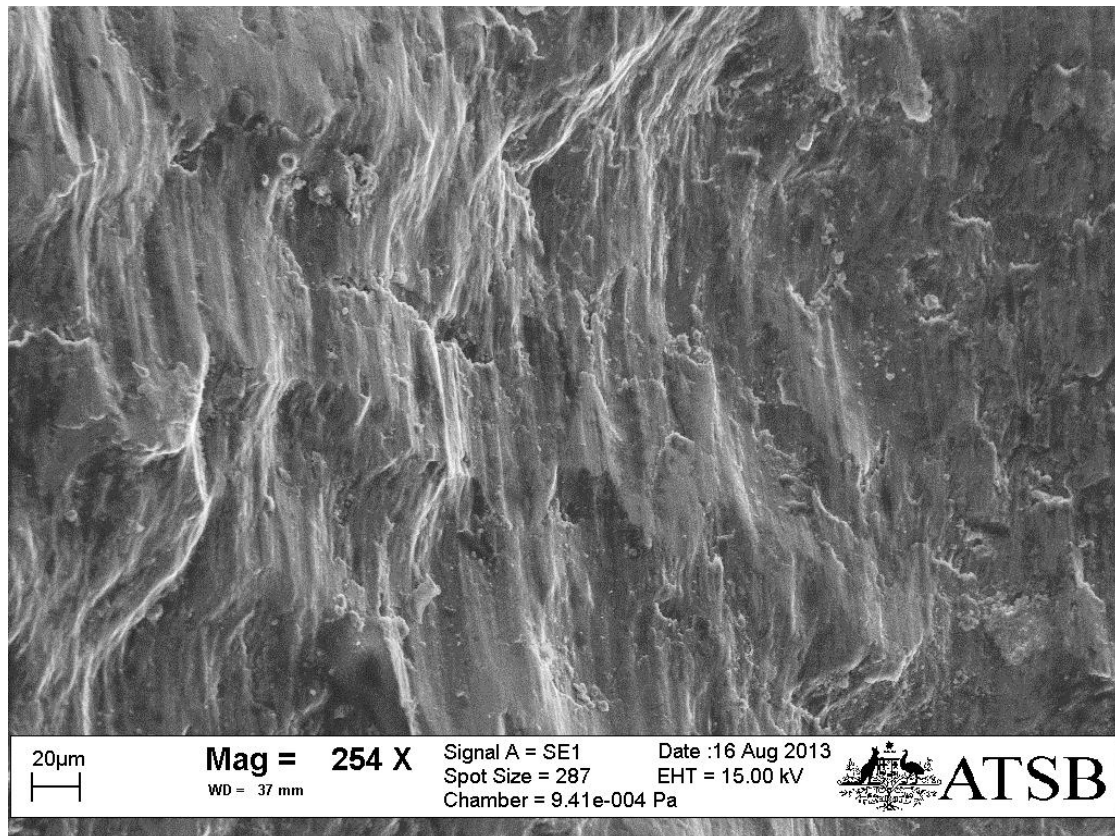
While the areas of progressive cracking were somewhat burnished and flowed from suspected inter-surface contact, the SEM examination highlighted the presence of regular and repeating surface patterns that were suggestive of a fatigue cracking mechanism (Figure A8). Outside of the fatigue regions, the surfaces transitioned to an irregular, undulating morphology that was consistent with a ductile overstress failure (Figure A9).

Figure A8: Fatigue area – some surface flow and deformation

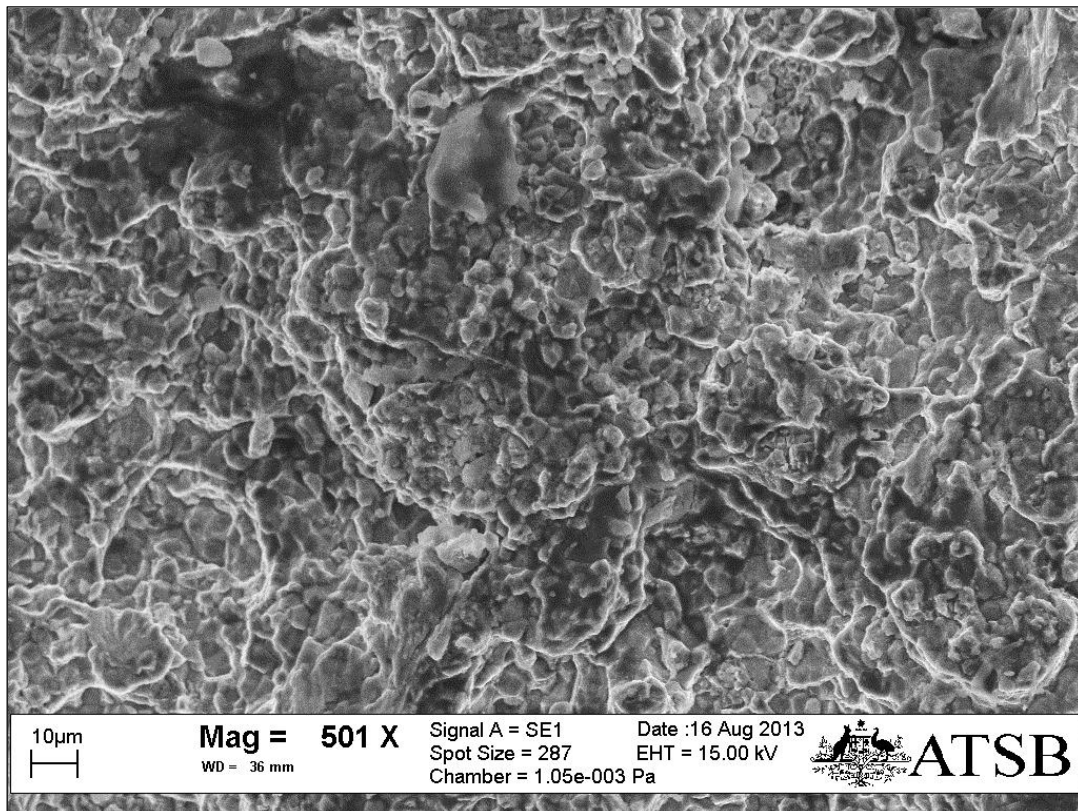
Figure A9: Overstress area of fracture surface – dimpled rupture

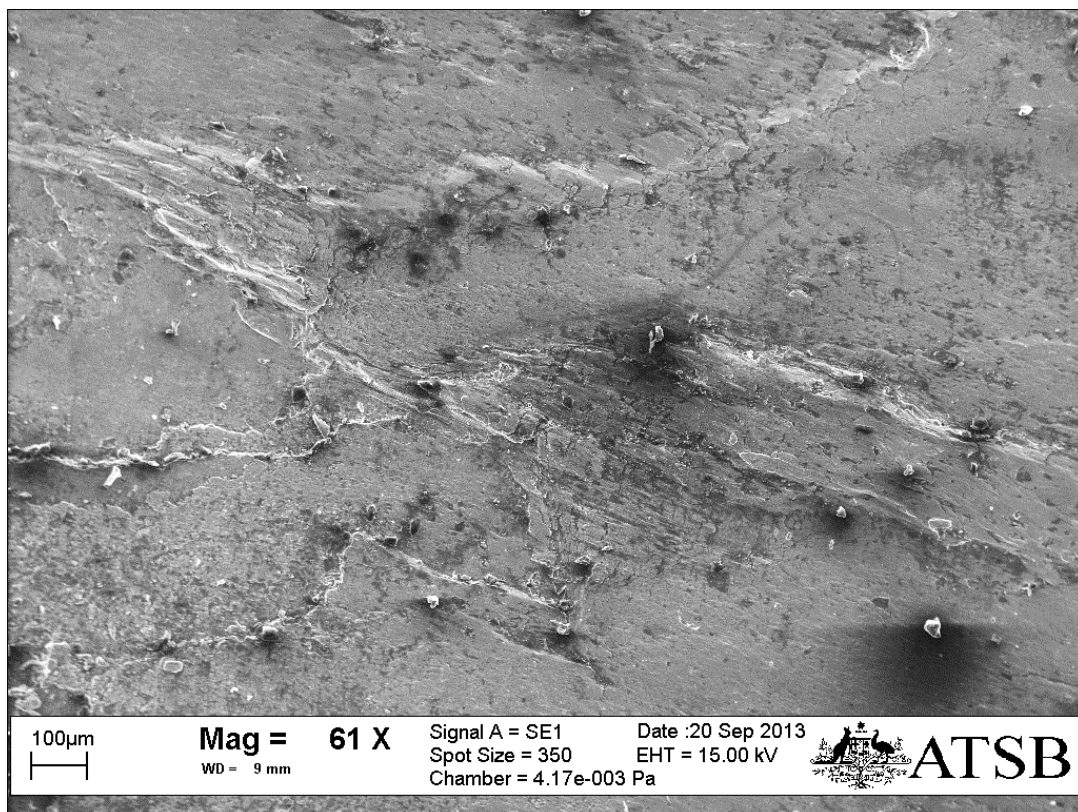
The central area with a distinct crystallographic/faceted appearance was smooth and relatively featureless, with localised regions of mechanical smearing and flow (A10). There were no identifiable fracture characteristics and no suggestion of directionality or progressive crack growth.

Figure A10: Internal planar area of fracture surface – generally featureless

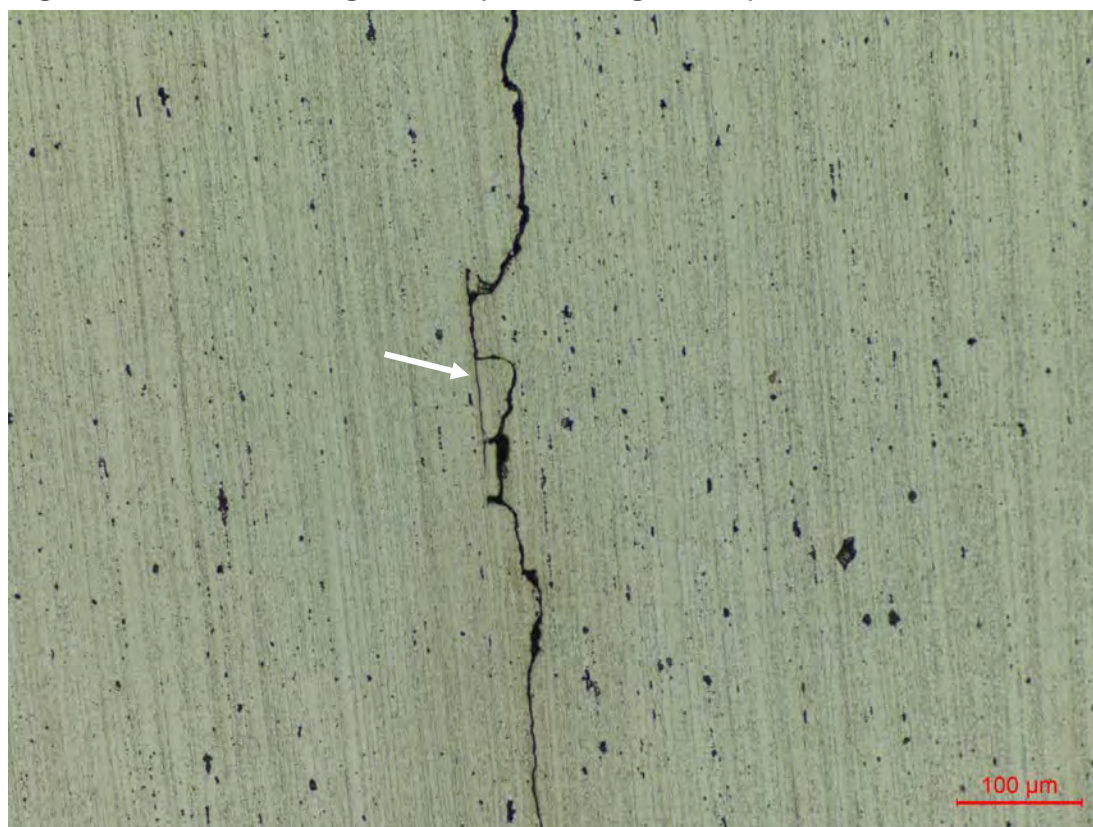
Of the sections examined as part of this study, several showed the coincidence of two unique fracture modes. Figure A11 shows a small linear defect aligned tightly with the orientation of the principal grain flow; from this extended several transgranular cracks with a curving propagation path. Other adjacent regions presented a stepped propagation path that was aligned with the directional grain flow (Figure A12).

Figure A11: Transgranular cracking extending from a fine linear separation (arrowed) aligned with the dominant grain flow (Keller's reagent etch)

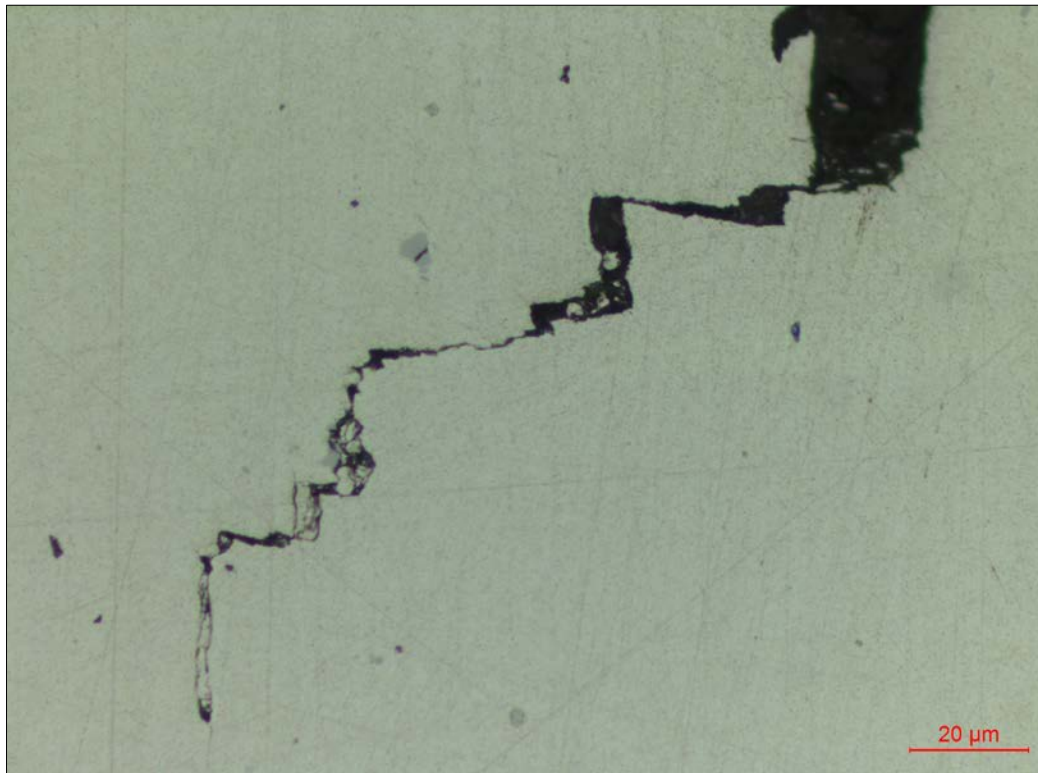
Figure A12: Step-wise crack extending from primary fracture surface (unetched).

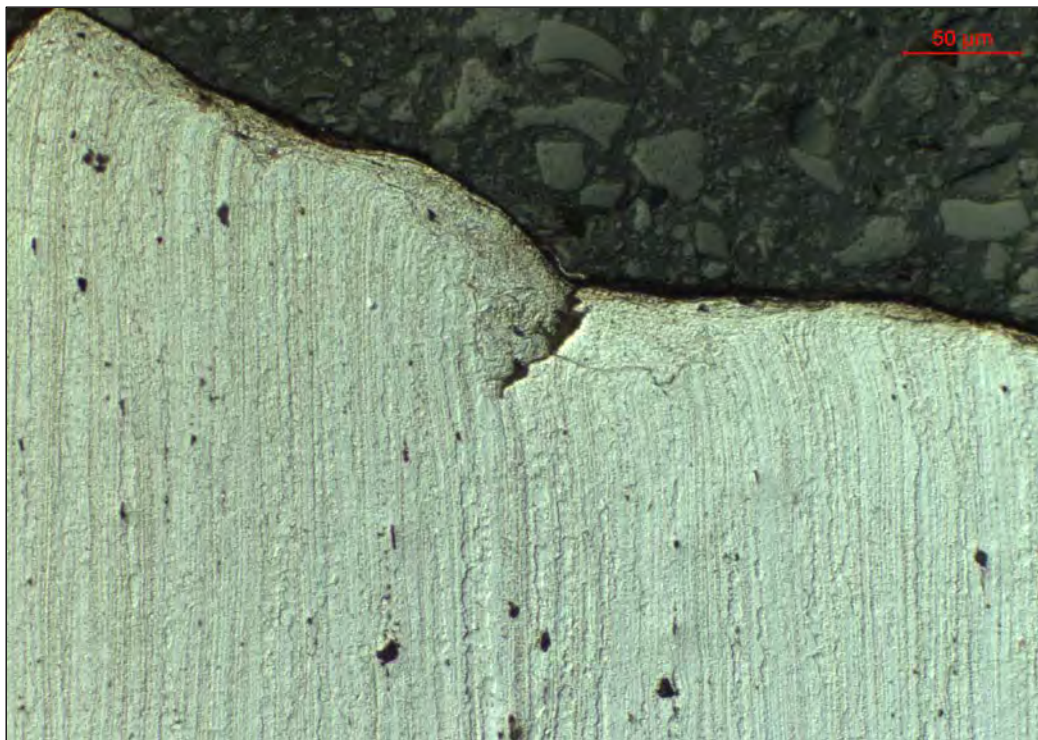
Shallow grain deformation/flow and minor cracks were observed across the surfaces of most of the progressive fracture (Figure A13) – consistent with the effects of repeated inter-surface contact prior to final trunnion fracture.

Figure A13: Grain deformation and cracking observed on exposed crack surface
