Wheels-up landing involving Fairchild SA227-AT Metro III, VH-UZA

Brisbane Airport, Queensland | 15 February 2012

ATSB Transport Safety Report
Aviation Occurrence Investigation
AO-2012-024
Final – 29 September 2014

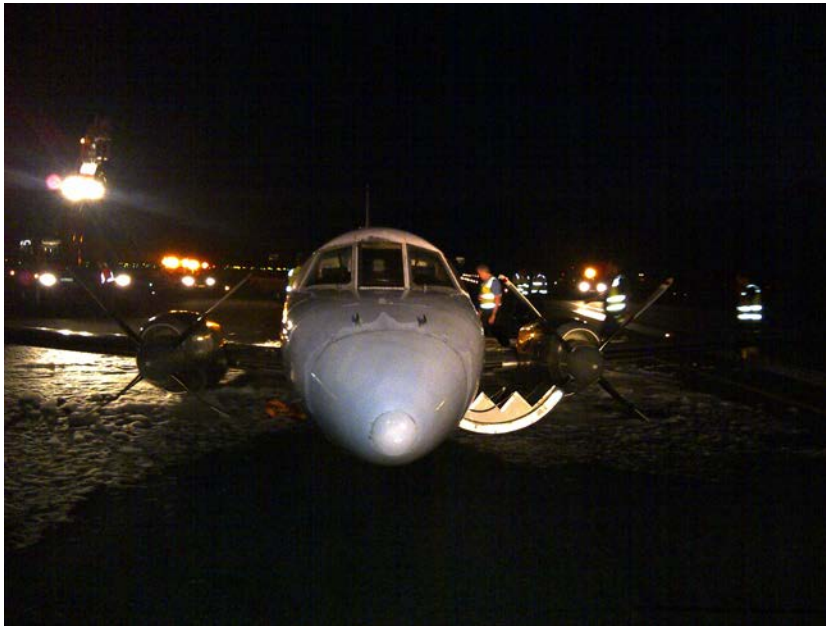
Figure 1: VH-UZA on runway 19 following the wheels-up landing

The local aviation rescue and firefighting (ARFF) service were deployed prior to the aircraft landing. This pre-positioning allowed ARFF to promptly apply foam to the runway and under the aircraft as soon as it came to rest (Figure 1).

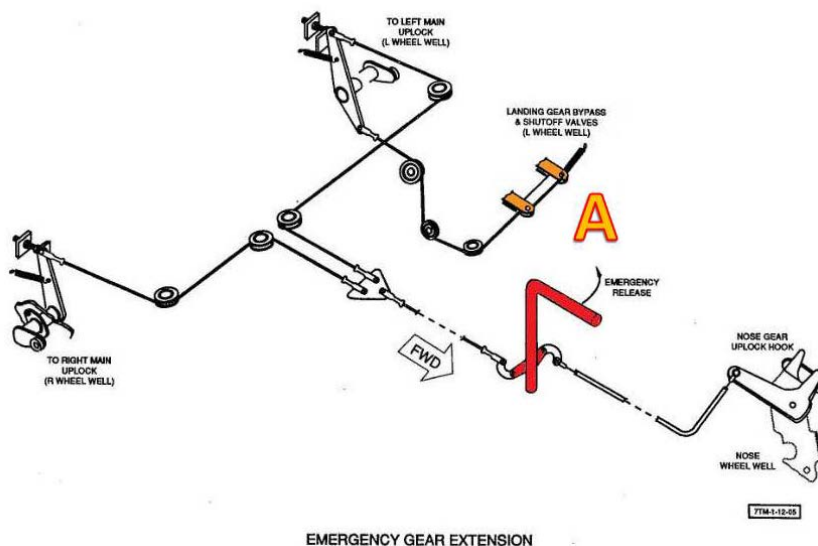
Figure 3: Landing gear emergency extension

Rotation of the emergency release lever mechanically released the landing gear up-locks and positioned the shut-off and bypass valves (item 'A' Figures 2 and 3). This isolated the normal selector valve and allowed hydraulic fluid within the retract side of the system to return to the reservoir (Figure 3). Completion of that action should allow the landing gear to gravity freefall. The emergency gear selector, when rotated to the 'emergency gear' position, directed reservoir fluid to the emergency hand pump, which could then be used to increase pressure on the extend side of the landing gear actuators to assist in moving the gear to the fully locked down condition.

As a result of that failure, a rigging check of the landing gear and emergency extension system was carried out. This revealed an out of limits low tension on the cable between the left up-lock release bell crank and the power pack. The low cable tension did not allow full actuation of the shut-off and by-pass valves, preventing the landing gear actuators up lines from completely depressurising. Therefore, system pressure was still able to be applied to the retract side of landing gear actuators when in the emergency extension mode with the landing gear handle in the 'up' position.

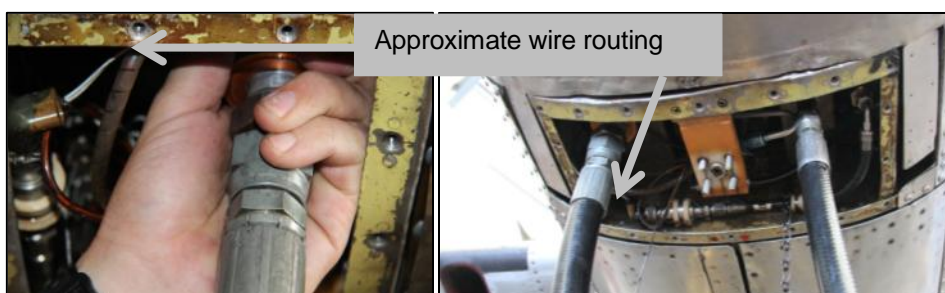
Figure 4: Hydraulic rig connection

The wiring loom that contained the separated wire was located in the vicinity of the external hydraulic connectors in the left engine nacelle below the hydraulic power pack. On examination, it was confirmed that normal connection and disconnection of the external hydraulic rig would have brought the hand of the engineer performing the task in contact with the wiring loom (Figure 4).

Microscopic examination of the broken wire indicated that its strands contained a combination of low-cycle fatigue and ductile overstress. The low cycle fatigue was consistent with forward and rearward cyclic movement of the wire over time leading to fracturing of the outer strands. The ductile overstress present on the inner core strands was consistent with them having undergone tensile loading such as being wrenched or pulled.

The low-cycle fatigue and ductile overstress failure of the landing gear selector valve electrical wire was consistent with its forward and aft movement and tensile loading. The proximity of the external hydraulic power connector to this wire, and periodic connection/disconnection of the external hydraulic unit within a confined space provided a mechanism for such movement. Once initiated, in-service vibration and flexing could have exacerbated the weakening of the wire, contributing to the eventual failure. This scenario is supported by the November 2008 'up' solenoid wire failure, with that wire in similar proximity to the hydraulic connector points.

The operator has since significantly reduced the likelihood of further damage to the landing gear selector valve's electrical harness wires in its Metro aircraft by re-routing the harness to provide greater clearance from the external hydraulic connectors. The aircraft manufacturer also provided guidance to all Metro operators on re-routing the landing gear selector valve electrical harness.

As a result of this occurrence, Toll Aviation Pty Ltd re-routed the landing gear selector valve electrical wiring loom within the left nacelle of its Metro III/23 aircraft to minimise the risk of damage to the wires during routine maintenance.
