# Derailment of train ST24

near North Melbourne, Victoria | 11 July 2014

## ATSB Transport Safety Report

RO-2014-013

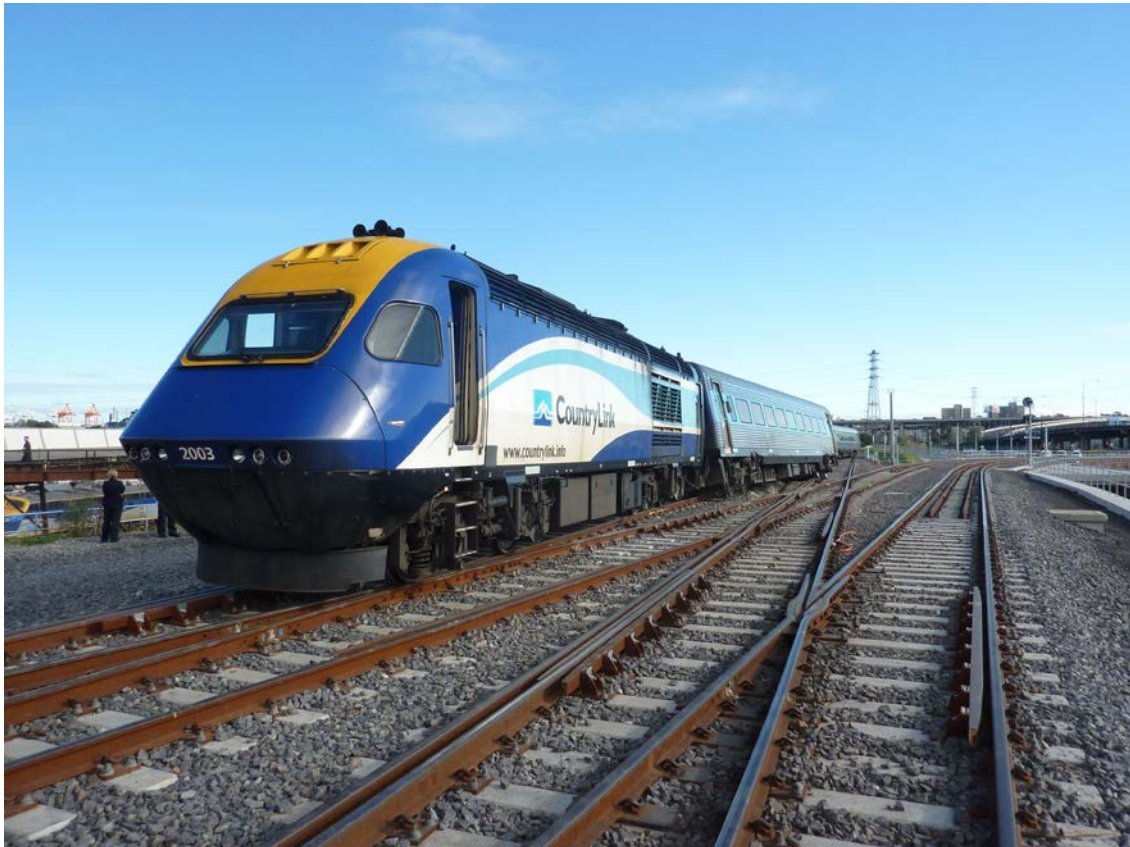
**Figure 2: Train ST24 trailing power car 2003 and derailed carriage 2176**

observed a *clear medium speed* with 'S' indication. To the driver, this meant that the route was correctly set and that the train could traverse MYD887 (dual gauge 'down' turnout) at up to 25 km/h. As the train traversed the turnout at about 20 km/h, the driver and pilot felt several large jolts, followed by a series of fault indications on the driver's display screen as the train came to a standstill. The pilot then rang the train controller and advised that train ST24 had derailed on the fly over (Figure 2). When the site was secured, the driver walked back to inspect the extent of the damage. Recovery personnel arrived shortly thereafter and commenced disembarking passengers.

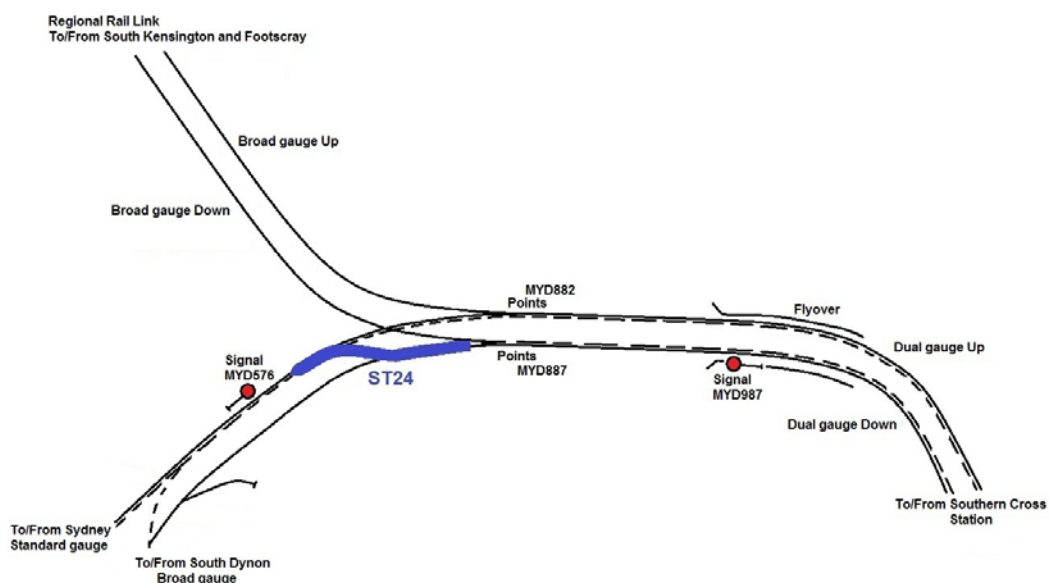
**Figure 3: Location of turnouts MYD882 and MYD887**

The derailment occurred at turnout MYD887, located on a section of track that had been recently constructed as part of the Regional Rail Link project (RRL). Turnout MYD882, where the driver and pilot experienced the heavy bounce when travelling towards Southern Cross station, was located adjacent to MYD887 (Figure 3). The RRL project included extensive track reconfiguration and upgrades to the North Melbourne rail-over-rail fly over for accessing platforms 1 to 8 at Southern Cross station. V/Line provided both the infrastructure management and train control functions for this section of track, under a lease arrangement with VicTrack.

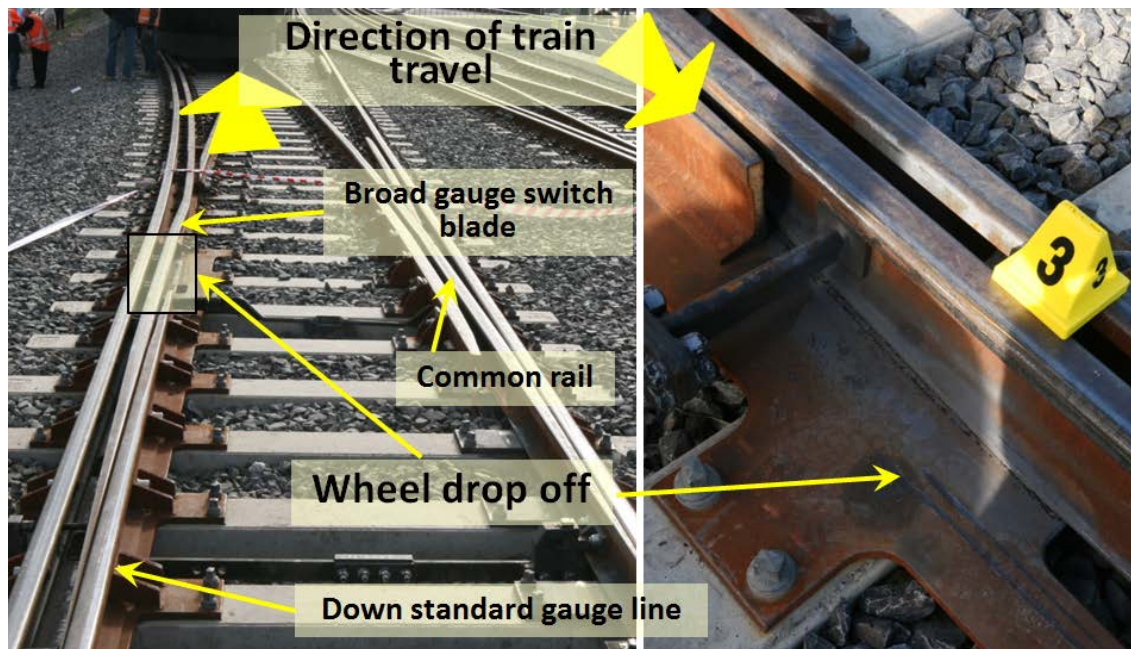
Figure 4: Turnout MYD887 point of wheel drop and flange marks on turnout base plate

An examination of the track across the area of the derailment found that as the left wheel of a carriage from the XPT train had transitioned from the down standard gauge line onto the broad gauge switch blade<sup>3</sup>, the wheel had dropped into the four foot<sup>4</sup>. This is evidenced at Figure 4 (right side image) which shows bruising on the gauge face corner of the broad gauge switch blade, and flange marks on the base plate at the bottom of the turnout. At that point however, there was no evidence of corresponding wheel flange marks on the opposite side – suggesting that the right wheel had not derailed at that point. It was not until about 1.3 m further along the track that there was evidence (wheel flange marks) produced by the right wheel climbing over the head of the right rail.

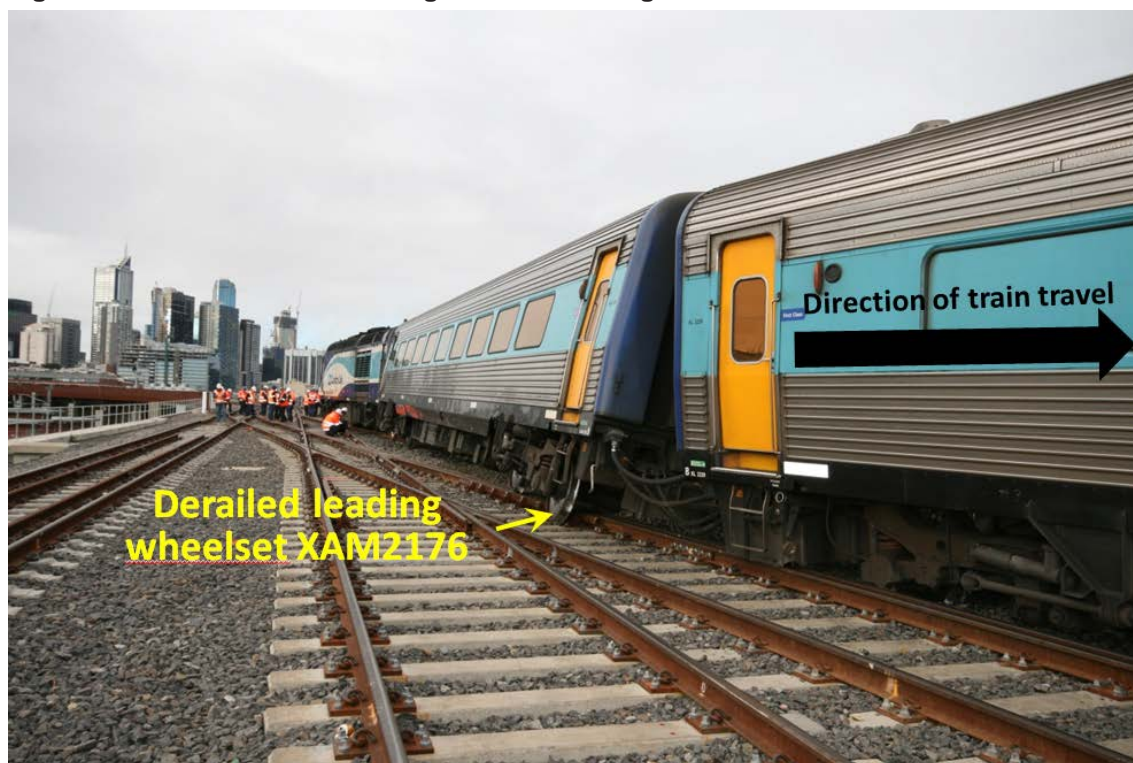
**Figure 5: Photo – Derailed leading wheelset carriage XAM2176**

An examination of the rolling stock determined that all wheels under passenger carriages XL2229 and XAM2176 were derailed. It was noted that the lead bogie of carriage XL2229 had derailed to the left in the direction of travel, while all others had derailed to the right. Considering that evidence markings on the rail indicated that the initial derailment was to the right, it is likely that the lead bogie of carriage XL2229 had derailed to the left as a consequence of the carriage twisting when its rear bogie derailed to the right. Examination of the derailed carriages therefore focused on the wheelsets of XL2229 (trailing bogie) and XAM2176 (Figure 5 - lead bogie).

Observations established that one (or more) left wheels had dropped off at the broad gauge switch rail, while the opposite right wheel(s), on the same axle, had initially remained on the common rail. An initial review of this evidence suggests a possible mismatch between the wheelset dimensions and the track gauge through the transfer area of the dual gauge turnout.

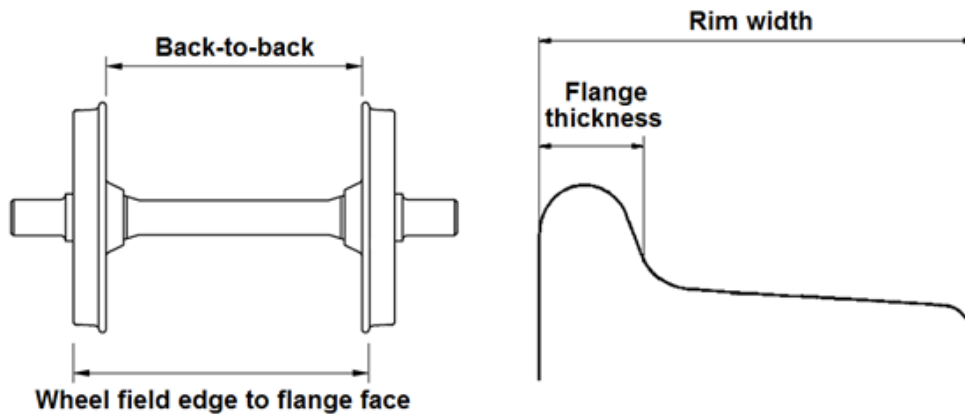
Figure 6: Wheelset dimensions

For rolling stock, the wheelset dimensions that are critical to ensure compatibility with track gauge, are rim width, flange thickness and wheelset back-to-back distance (Figure 6). For a wheel to drop in between a track, the *wheel field edge to flange face* distance theoretically must be less than track gauge.

AS7517.3-2009 prescribes back-to-back dimensions of between 1357 mm and 1360 mm for standard gauge rolling stock. In this occurrence, the measured back-to-back dimensions for all derailed wheelsets were 1358 mm or 1359 mm and therefore within tolerance.

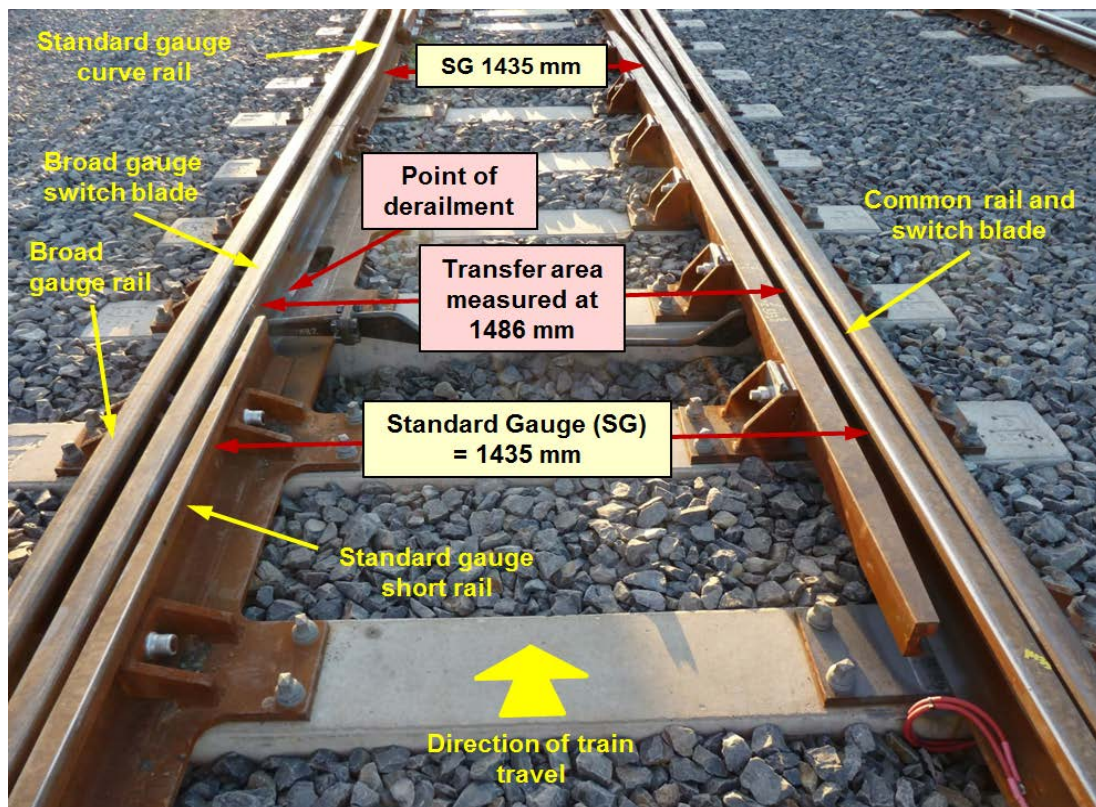
Figure 7: On site track measurements

For standard gauge trains, as the left wheels transfer from the standard gauge short rail (Figure 7) onto the broad gauge switch blade (before entering the standard gauge curve rail), the gauge by necessity is wider. This is to allow both broad and standard gauge wheelsets to pass through the transfer area. For a standard gauge train, this results in reduced rim contact on the rail head through the transfer area, and it was at this area that train ST24 derailed.

After the derailment, the measurement through the transfer area was 1,486 mm; 6 mm greater than the design width of 1,480 mm. It is likely however, that there was some level of permanent bending of the switch rail as a result of the derailment.

Examination of the lead wheelset/lead bogie of carriage XAM2176 (wheelset with narrowest field edge to flange face distance) confirmed that there was limited rim contact on the rail head through the transfer area. With the left wheel of XAM2176 running on the right edge of the broad gauge switch rail (in the direction of train travel), this would likely have applied high outward torsional loading on the switch blade. In circumstances where the broad gauge switch blade is insufficiently restrained through the transfer area, the switch blade can both roll and flex outward, increasing the likelihood of one or more wheels dropping in between the track and causing the train to derail.

V/Line is currently actively managing the redesign, alteration and validation of the type 37 turnout to support restoration of standard gauge, 127 mm rim width, services.
