# Runway incursion involving a Bombardier DHC-8, VH-QOP

Gladstone Airport, Queensland, 17 April 2014

**ATSB Transport Safety Report**  
Aviation Occurrence Investigation  
AO-2014-073  
Final – 15 October 2014

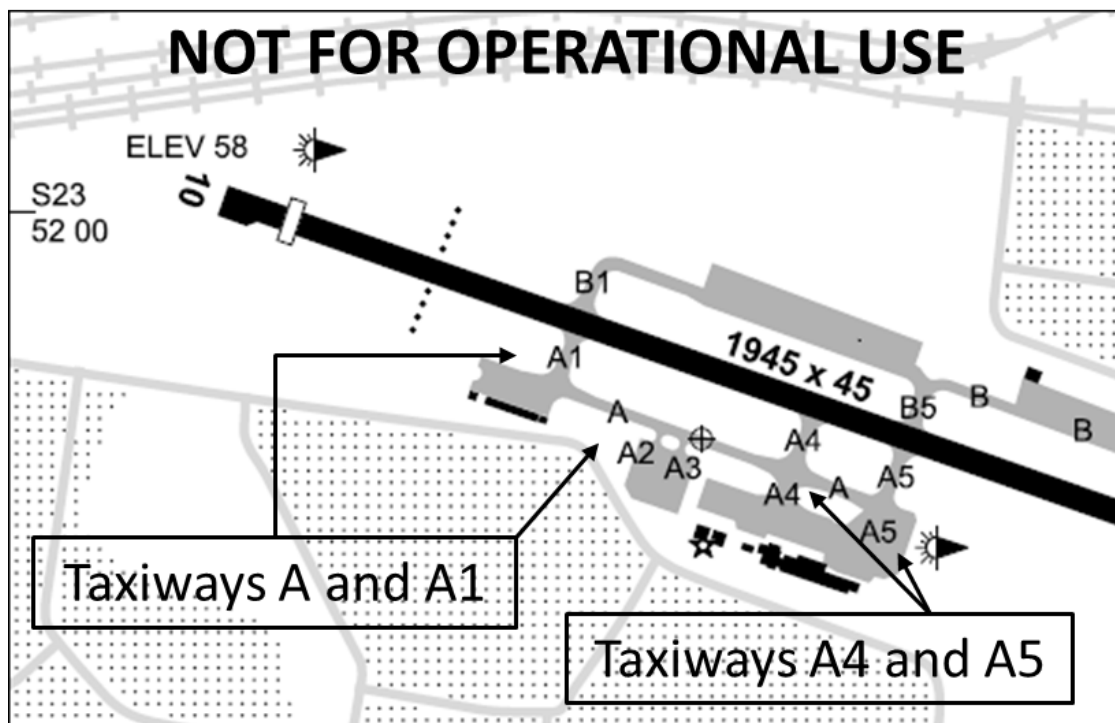
Figure 1: Excerpt from Gladstone aerodrome chart

Noting the position of the ATR-72, the crew of VH-QOP elected to taxi in a westerly direction along taxiway A, planning to enter the runway via taxiway A1 after the ATR-72 had landed. The crew commented they would probably have used taxiway A4 or A5 to enter the runway had it not been for the inbound ATR-72. Although they were not all that familiar with Gladstone Airport, the crew of VH-QOP were aware that runway entry via taxiway A4 or A5 was more common, if the air traffic situation allowed (Figure 1).

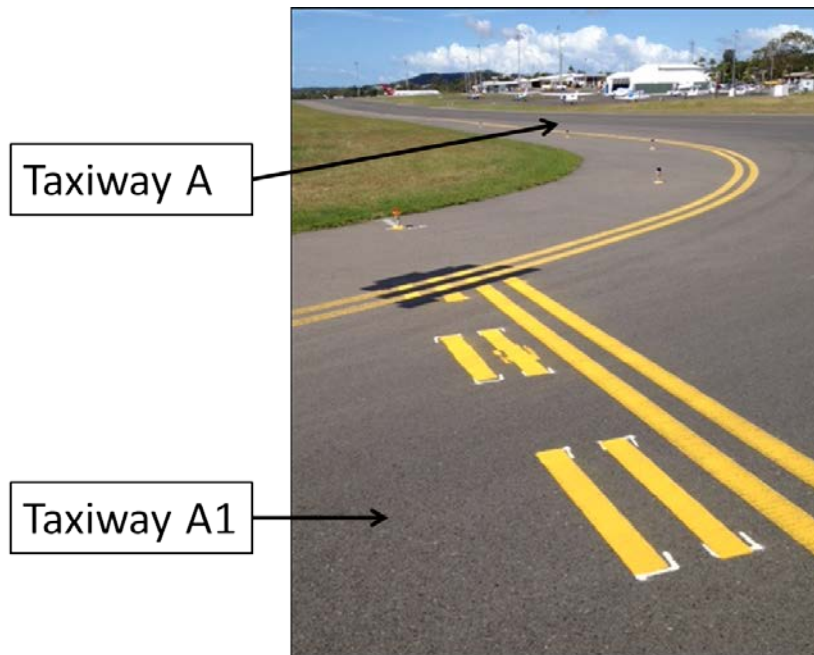
The crew of VH-QOP made a right turn from taxiway A onto taxiway A1 as the ATR-72 was on late final approach, but did not notice the holding point line near the commencement of taxiway A1 (Figure 2). The crew inadvertently continued over the holding point line before coming to a stop on taxiway A1, as the ATR-72 continued its approach and landed.<sup>2</sup>

**Figure 2: Holding point line on taxiway A1 (looking in a south-easterly direction)**

A ground-based observer noticed VH-QOP continue over the holding point line, and was concerned that the aircraft may be about enter the runway in front of the ATR-72 on late final approach. The observer monitored the progress of VH-QOP until it came to a stop, noting that the main wheels of the aircraft were just beyond the holding point line as the ATR-72 landed. The observer also commented that a shower of rain was passing over the airport at about the time that VH-QOP entered taxiway A1.

- The crew were busy as they taxied, assessing how weather in the area might affect their departure, and assessing the suitability of runway 28 for departure (including a review of relevant performance data).
- The tarmac surface was wet following heavy showers. As such, the holding point line may have been less prominent than might normally be the case, particularly noting the time of day (late afternoon) and possibly the position of the sun in relation to their taxi direction.
- The crew were not particularly familiar with Gladstone Airport, and even less familiar with taxiways A and A1. They were not aware of the position of the holding point line on taxiway A1.

This incident highlights the importance of careful attention to airfield markings during ground manoeuvring, especially when crew workload is elevated, and when a crew is unfamiliar with the airport layout. This message applies equally to all airside vehicle operators.

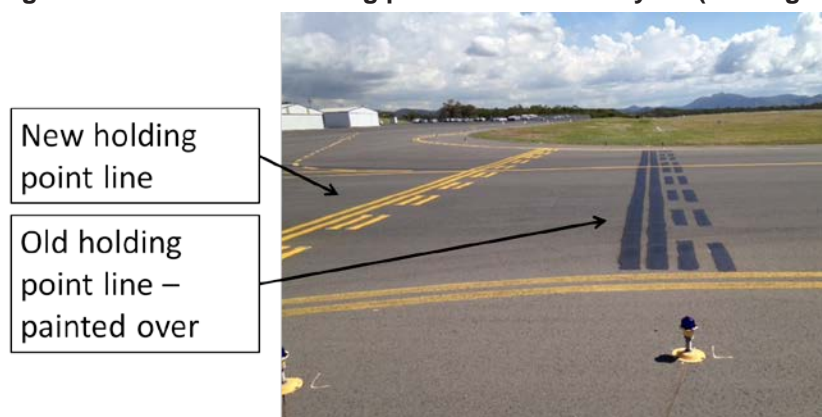
While it does not appear to have been a factor in this incident, it is noteworthy that the holding point on taxiway A1 had been moved back from the runway a small distance about a week prior to this incident (associated with airport infrastructure improvements). A new holding point line was painted, and the old line painted over with dark grey paint.

**Figure 3: New and old holding point line on taxiway A1 (looking in a westerly direction)**
