Fuel exhaustion involving a Piper PA-25, VH-SSO

Near Bacchus Marsh (ALA), Victoria, 18 May 2014

ATSB Transport Safety Report
Aviation Occurrence Investigation
AO -2014-094
Final – 15 October 2014

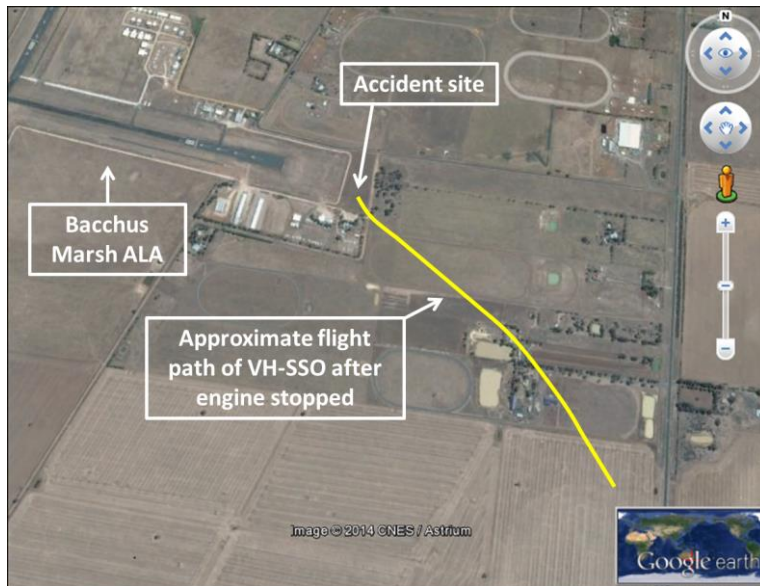
Figure 1: Approximate flight path of VH-SSO after the engine stopped

As the aircraft descended through about 300 ft AGL, the pilot noticed a substantially increased rate of descent and was concerned he may not be able to reach the ALA. He identified a cleared area short of the ALA in which to land, and transmitted another MAYDAY call. As he neared the selected area however, the pilot grew concerned about a possible collision with trees. He was able to clear the trees, but immediately beyond the trees the aircraft aerodynamically stalled² and landed heavily in a cleared area adjacent to the ALA (Figure 1).

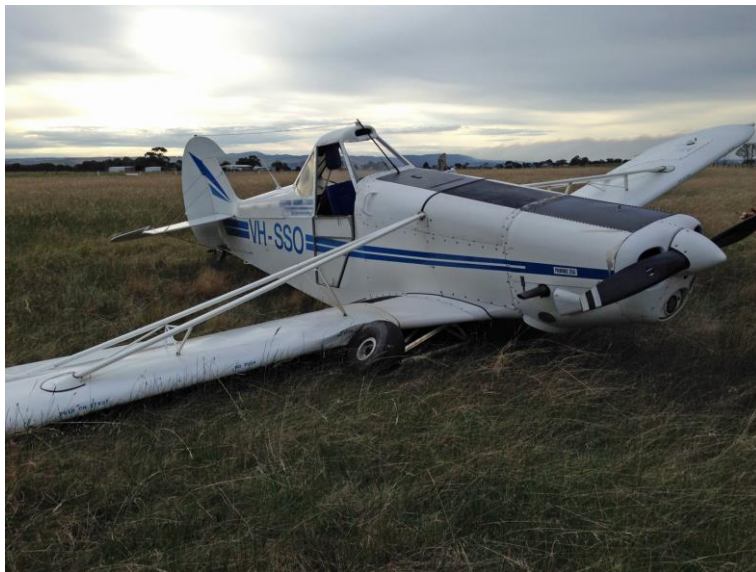
Figure 2: Damage to VH-SSO

As the aircraft impacted the ground, the right main landing gear collapsed and the aircraft slewed to the right, coming to rest facing towards the east-south-east. As the right landing gear collapsed it impacted the right wing, damaging the leading edge (Figure 2). One of the propeller blades was also damaged when it struck the ground during the accident. After the aircraft came to a stop, the pilot turned off the electrical system and exited the aircraft uninjured. Subsequent inspection found that the aircraft fuel supply was exhausted.

As a result of this occurrence, the GFA indicated that they intended to remind all glider towing pilots of the importance of fuel management and fatigue awareness.
