Wirestrike involving a Robinson R66, VH-JRX

near Giru, Queensland, 20 August 2014

ATSB Transport Safety Report Aviation Occurrence Investigation AO-2014-142 Final – 15 October 2014 Released in accordance with section 25 of the Transport Safety Investigation Act 2003

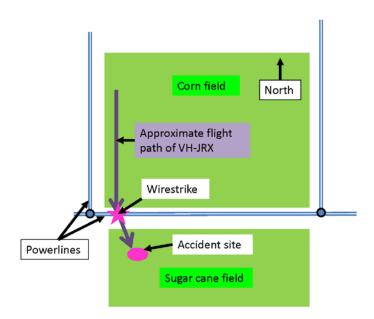
Figure 1: Approximate flight path of VH-JRX

At about 1645, after completing 14 loads of spraying, the pilot commenced the final clean-up run. The helicopter was operating from north to south along the western boundary of the paddock, parallel to the powerlines (Figure 1). The pilot was aware of those powerlines, however when about 5 m from the southern boundary, he sighted the powerlines running perpendicular to the direction of flight. The pilot assessed that it was too late to climb over the powerlines and elected to fly underneath them. The crop was about 6 ft tall and the pilot wanted to ensure the helicopter remained above the crop.

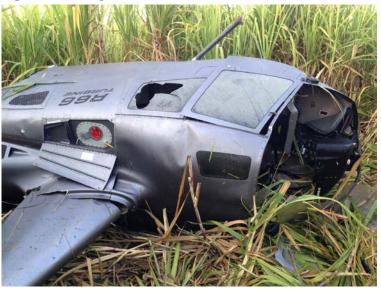
Figure 2: Damage to VH-JRX

The main rotor blade hub struck the powerlines and the helicopter collided with the ground. The helicopter was substantially damaged (Figure 2) and the pilot sustained minor injuries.

- He had sprayed parallel to the wire which JRX struck and his attention was on the other powerlines that he had to climb over on each run.
- Normally he would do an extra check of the paddock prior to commencing the clean-up run, but he omitted it on this day.

Research conducted by the ATSB identified 180 wirestrike accidents between 2001 and 2010. Of these, 100 occurred during agricultural operations. The research report cautioned pilots to conduct an aerial reconnaissance to confirm wire locations and other hazards. Having a plan and a procedure to minimise the risk of wirestrike is a valuable mitigation strategy. The ATSB report *Wirestrikes involving known wires: A manageable aerial agriculture hazard* is available at www.atsb.gov.au/publications/2011/avoidable-2-ar-2011-028.aspx.
