# Locomotive fire

Awaba, New South Wales | 5 June 2014

RO-2014-010

Final – 31 October 2014

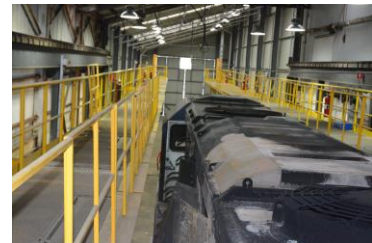
## 8221 Fire damage pattern

At 2245 on 5 June 2014, the crew on Pacific National (PN) coal service ER64 reported that flames were emanating from the top of the fourth locomotive, 8221, on their train. At the time, ER64 was near Awaba in New South Wales enroute to unload at the Eraring power station. The crew stopped the train and assessed the extent of the fire while also calling for fire brigade assistance. The fire was declared extinguished at 0139 on 6 June 2014. It caused substantial damage to the locomotive.

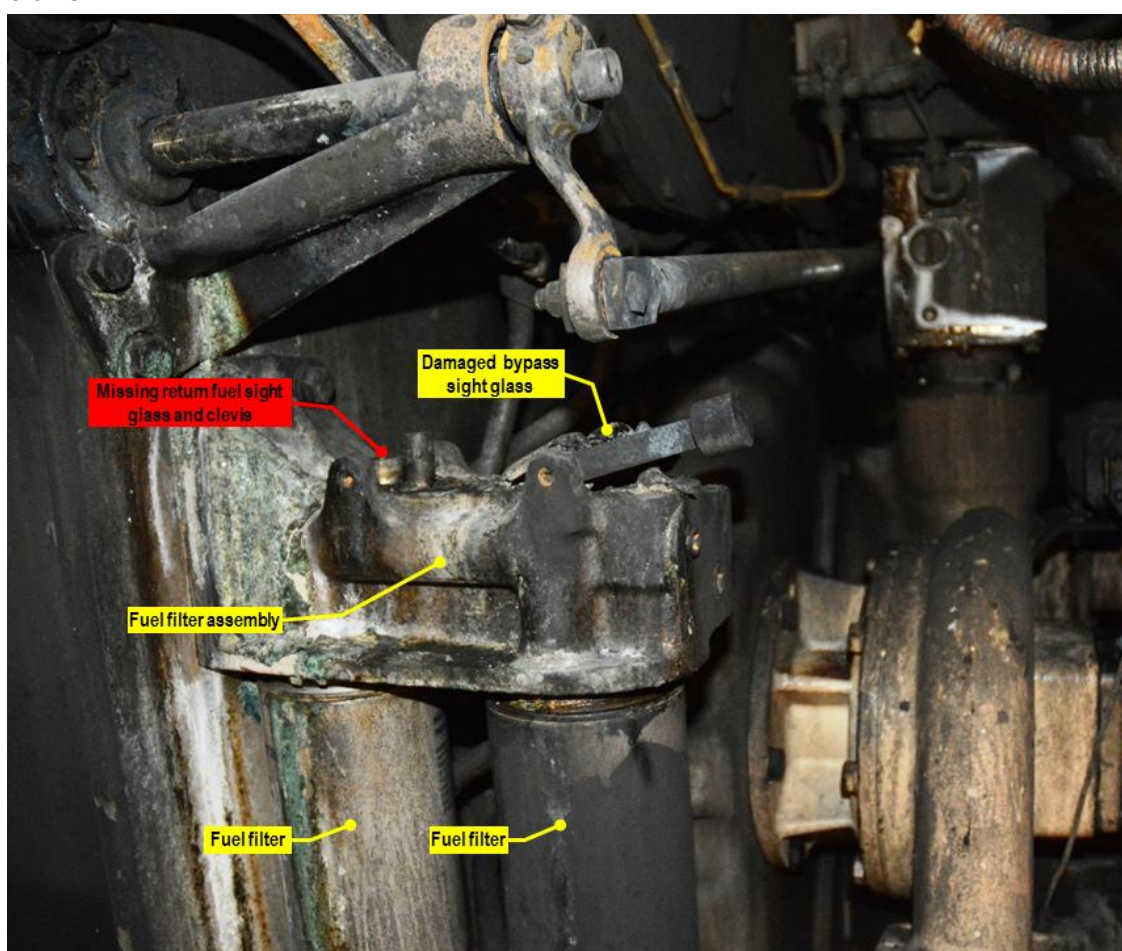
**Figure 3: Damaged fuel filter assembly including missing return fuel sight glass and clevis**

The inspection further determined that the fire had most likely originated at the return fuel sight glass which was missing from the top of the fuel filter assembly (Figure 3). Remnants of the return fuel sight glass, a sight glass seal and the sight glass clevis, which clamps the sight glass onto the filter assembly, were recovered from the sump floor unaffected by the fire (Figure 4). The clevis and remnants of the second (bypass) sight glass were observed still in position albeit fire affected.

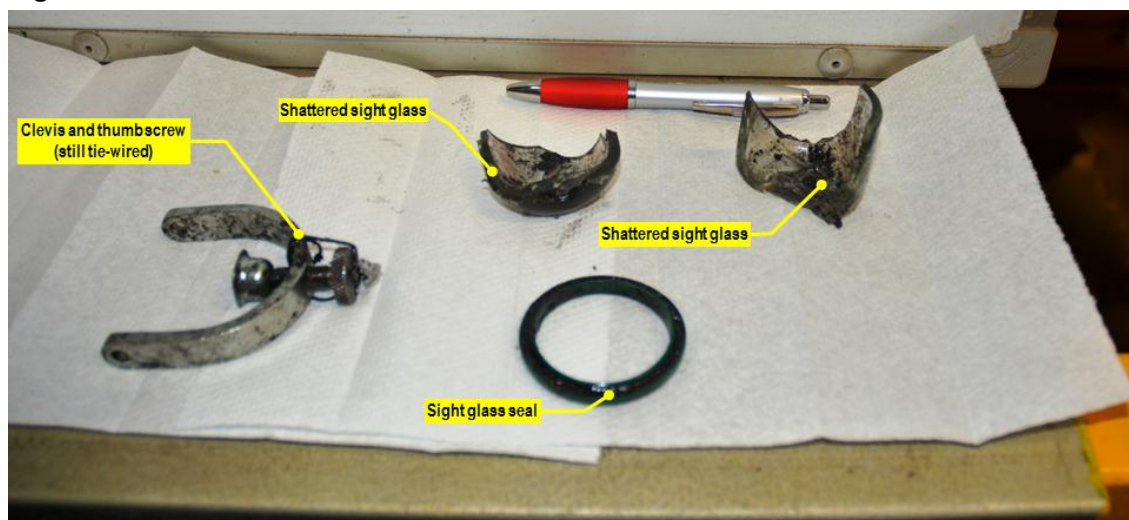
**Figure 4: Recovered items**

The absence of fire damage on the recovered items indicated that they had disengaged and fallen from the filter assembly prior to the fire igniting. This disengagement would have caused diesel fuel under pressure to leak and eventually spray throughout the engine bay starving the engine of fuel and causing it to lose power. The crew reported that the train had experienced a power loss as it passed through Newstan Colliery.

- The clevis thumb screw was still tie-wired in position complete with clamp seat intact but not in accordance with current maintenance procedures. However, the second (bypass) sight glass was a Durox® ratcheting type which is currently being removed from service as its thumb screw cannot be tie-wired in accordance with these procedures

- The overall width of the clevis had compressed and bent inwards from 170 mm to 164.5 mm. This caused an excessive total gap of 5.5 mm when the clevis was fitted into position in the mating (170 mm) aperture on the fuel filter assembly

- The protrusion of the two clevis bolts, which measured 6 mm and 2.5 mm respectively, was not set correctly in the fuel filter aperture
- The thumb screw hole was not centrally located width-wise in the clevis

- The thread on the thumb screw exhibited considerable wear
- There were no part number or equipment manufacturer details marked on the clevis.

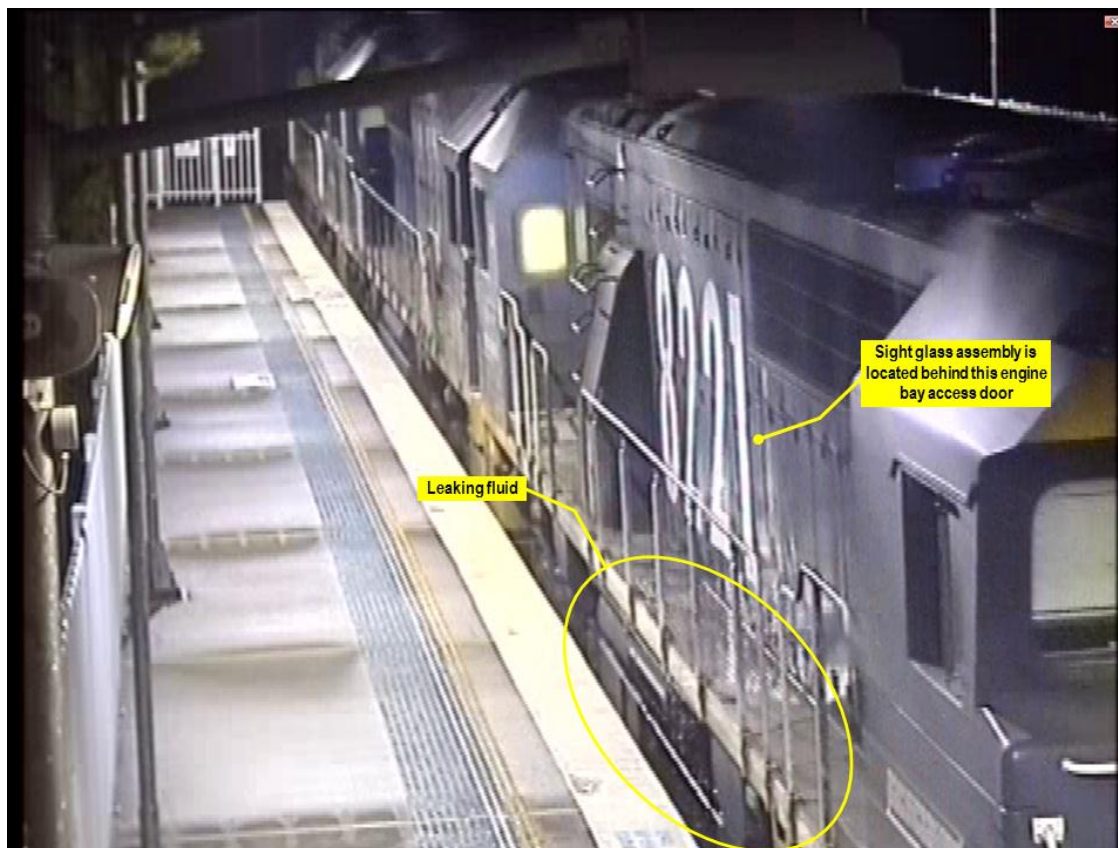
**Figure 5: 8221 passing through Fassifern Station**

Locomotive fuel management system logs from 8221 indicated that, at 2216, the same time the train was standing stationary in the colliery awaiting a path back onto the Up Main line, its fuel return flow rate suddenly reduced from 1454 litres per hour to approximately 4 litres per hour. The change in the return rate and the loss of power indicated that a major fuel leak had developed on the locomotive. An increasingly large fluid trail, indicative of such a leak, was evident in CCTV footage taken from Fassifern station when 8221 passed through at 2237, approximately five minutes before the fire (Figure 5).

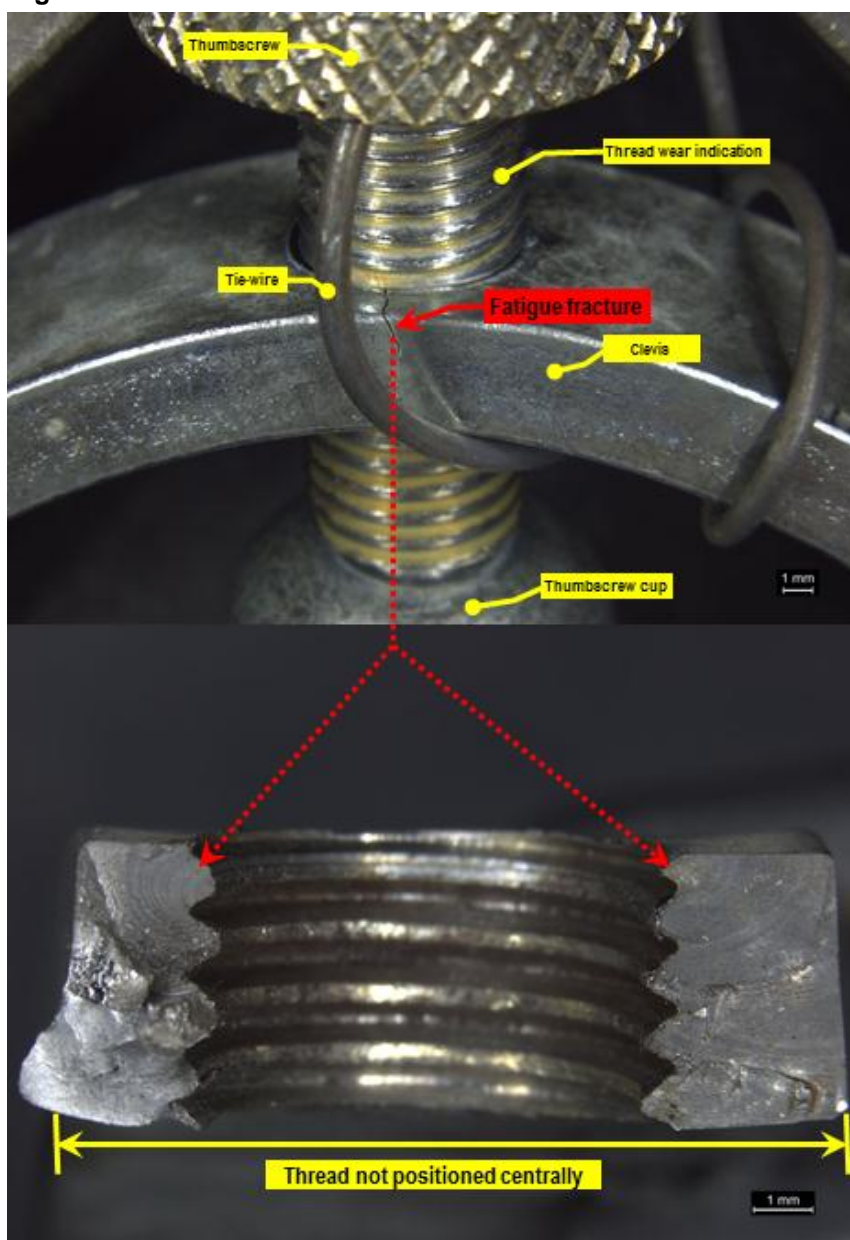
**Figure 6: Fatigue fracture**

- The presence of a fatigue fracture that had progressed through 75% of the cross sectional area at the thumb screw hole of the clevis (Figure 6)
- There were gas inclusions (bubbles) within the sight glass material
- The seal recovered was not made of the current specified material.

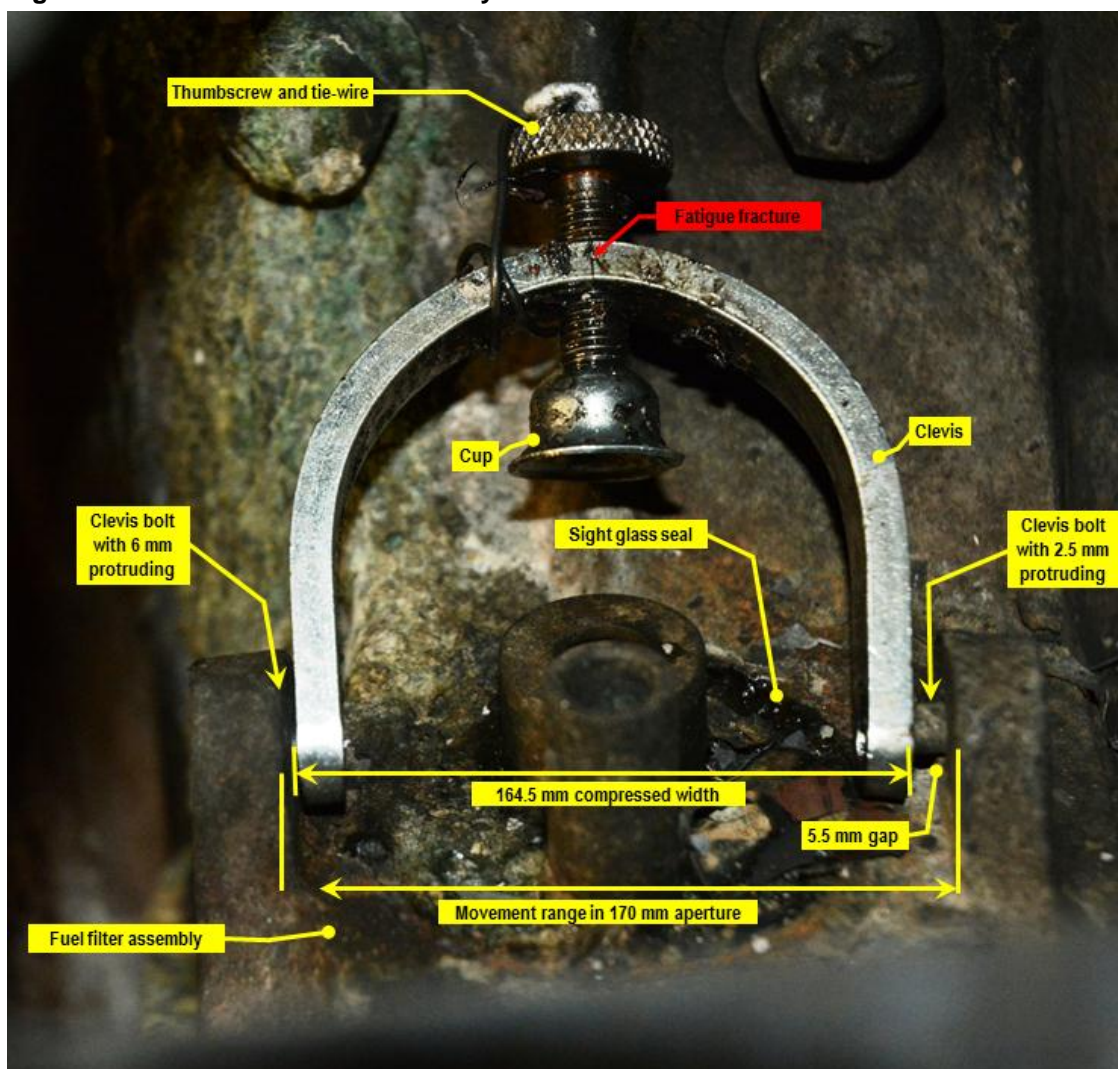
**Figure 7: Clevis on fuel filter assembly**

- The overall width of the clevis had compressed from a nominal width of 170 mm to 164.5 mm. This created a total gap of 5.5 mm for lateral movement between the clevis and the faces of the aperture in the fuel filter assembly (Figure 7)
- One of the clevis bolts protruded only 2.5 mm into the aperture. With the 5.5 mm gap in the aperture, the clevis only had to move laterally the length of the protruding pin (2.5 mm) before one side disengaged. Once disengaged, all clamping on the sight glass was released allowing fuel under pressure to escape into the engine bay.

In addition, subsequent dismantling of the fuel filter assembly by PN, in conjunction with Downer EDI Rail (DEDIR), identified that the short protruding clevis bolt was a non-OEM part with a differing thread which had misaligned upwards during replacement of the clevis on 27 April 2014.

The compressing of the clevis was most likely the result of continual over-tightening. The continual over-tightening was evidenced by the wear on the upper surface of the thumb screw thread and the fatigue fracture which initiated at a stress point relative to the thread in the clevis.

The subsequent movement of the clevis was most likely caused by engine vibration under normal operating conditions.

- An immediate inspection of all locomotives fitted with the sight glass arrangement to ensure clevis assemblies conform with OEM specifications and requirements
- A best practice review and various amendments to the current maintenance procedures which have increased the inspection requirements for the clevis and clevis bolts. Included are additional requirements to inspect for the following:
  - Bending in at the base of the sight glass clevis
  - Worn clevis bolts
  - Elongation of clevis bolt locating holes
  - Fracture of sight glass clevis
  - Worn thread on the sight glass thumb screw
  - Correct alignment of the clevis bolts in the aperture of the fuel filter assembly
- An audit of its current stock of clevis bolts to ensure conformance to OEM specifications
- Improved sight glass clevis tightening procedures
