Collision with terrain involving Cessna 172, VH-WLF

10 km west of Wentworth Airport, NSW | 28 May 2012

ATSB Transport Safety Report

AO-2012-072

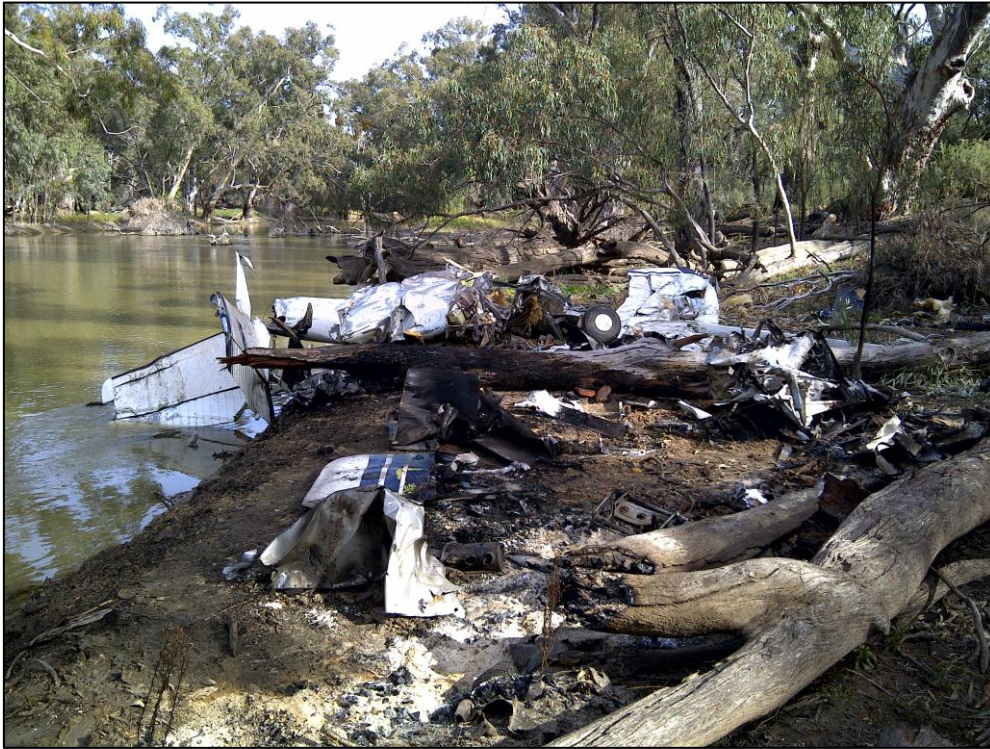
Figure 3: Accident site

The accident site was located on the timbered riverbank of a waterway associated with the Murray River (Figure 3). Examination of the site and aircraft wreckage identified that the aircraft collided steeply with the terrain at high speed. Analysis of tree contact marks and the main impact point suggested a descent angle of about 60°. Sections of the aircraft were affected by a post-impact fire that self-extinguished prior to location of the accident site by the crew of the search and rescue helicopter. The accident was not survivable.

The majority of the wreckage came to rest on the riverbank with the engine partially submerged in the water. All major parts of the aircraft, with the exception of the pilot's (left) door, were identified on site. The witness who observed the aircraft depart Wentworth Airport stated that the pilot's door was fitted at that time. There was no evidence that the door had contacted the airframe structure or control surfaces in-flight and the aircraft manufacturer advised that there was no adverse effect on the aircraft when operating with the pilot's door off. In addition, the cabin doors were not considered during the manufacturer's structural analysis of the airframe. A damaged, GPS-capable⁸ 406 MHz portable locator beacon was also identified among the aircraft wreckage (see the section titled *Emergency locator transmitters*).

The degree of impact and fire damage prevented a complete assessment of the integrity of the aircraft's flight control system. However, all control cables were terminated correctly at their respective control surface attachments and all of the damaged control cables that were identified had failed during the accident sequence as a result of overstress. There was no evidence of any in-flight failure of the airframe structure or control surfaces.

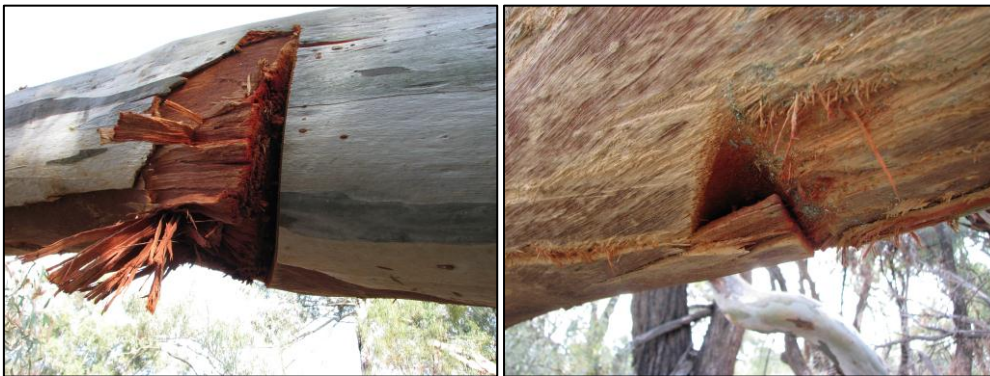
Figure 4: Propeller contact marks

The engine was severely disrupted during the impact sequence. The level of damage to the engine and propeller, as well as two propeller contact marks identified 1 m apart in a large tree branch that was felled by the aircraft (Figure 4), indicated that the engine was producing a significant level of power at the time of the accident.

Examination of the engine tachometer that was recovered from the accident site showed that the engine and propeller were rotating at about 2,700 RPM at the time of the accident. The aircraft manufacturer advised that this rotational speed was reasonable in a dive. Consideration of the propeller RPM and the distance between the observed propeller slash marks, indicated that the aircraft contacted the tree at about 320 km/h (173 kt).
