Runway excursion involving a Cirrus SR22, VH-SRI

Great Lakes Airfield, Victoria, 30 March 2014

AO-2014-060

Final - 3 December 2014

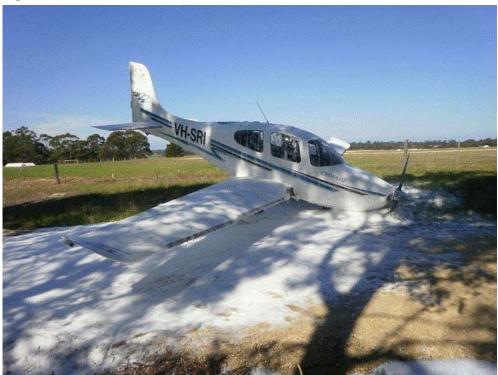
Figure 2: Accident site

The pilot reported that the approach and landing was normal. The aircraft touched down on the runway at the first white gable marker (Figure 1) at about 1320 Eastern Daylight-saving Time. As the aircraft passed the intersection with runway 26/08, the pilot realised that the aircraft was not slowing quick enough to stop in the remaining runway available and so applied the brakes harder. The aircraft departed the end of the runway, went through the airport boundary fence and came to rest on a road. The pilot turned off the fuel and all switches and exited the aircraft with the passenger. The pilot and passenger were uninjured and the aircraft was substantially damaged (Figure 2).
