# Hard landing, involving a PA28RT, Piper Arrow, VH-ADU

Mangalore Airport, Victoria, 17 June 2014

**ATSB Transport Safety Report**  
Aviation Occurrence Investigation  
AO-2014-112  
Final – 3 December 2014

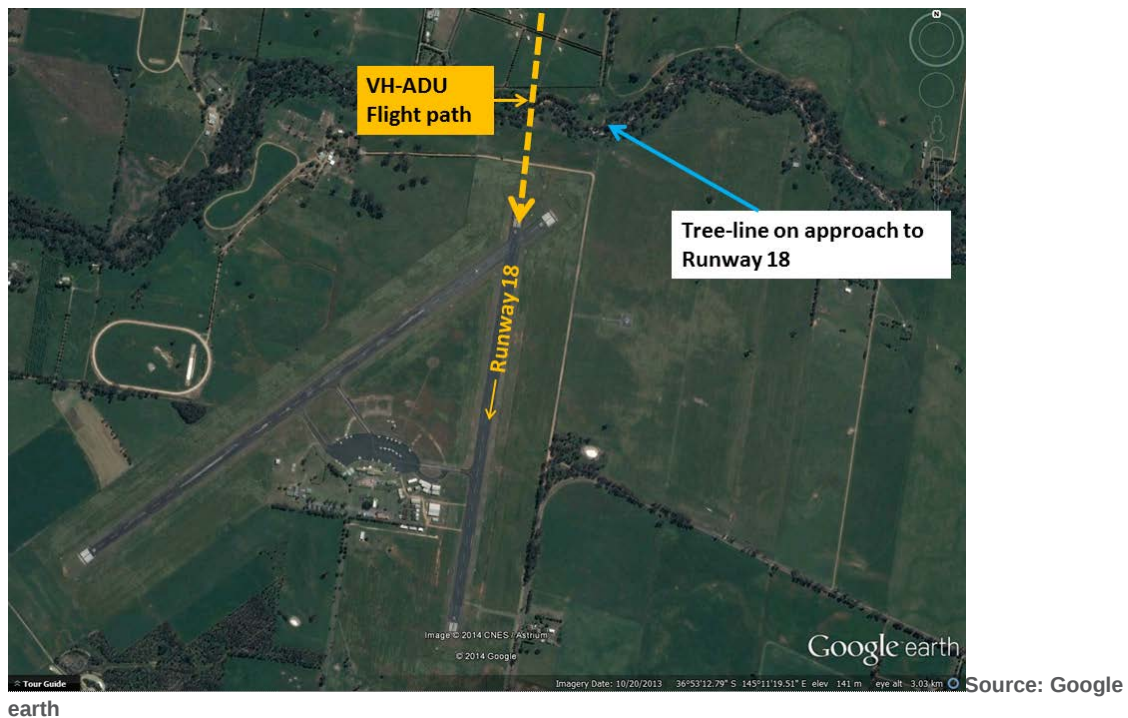
**Figure 1: Mangalore Airport Runway 18**

Some mechanical turbulence from a line of trees under the approach (Figure 1) caused the wings to roll, however the student was satisfied that the approach was still on profile.
