# Separation issue involving a Bell 206, VH-XJA, and an Airbus A320, VH-VGJ

Sunshine Coast Airport, Queensland, 3 July 2014

**ATSB Transport Safety Report**  
Aviation Occurrence Investigation  
AO-2014-125  
Final – 3 December 2014

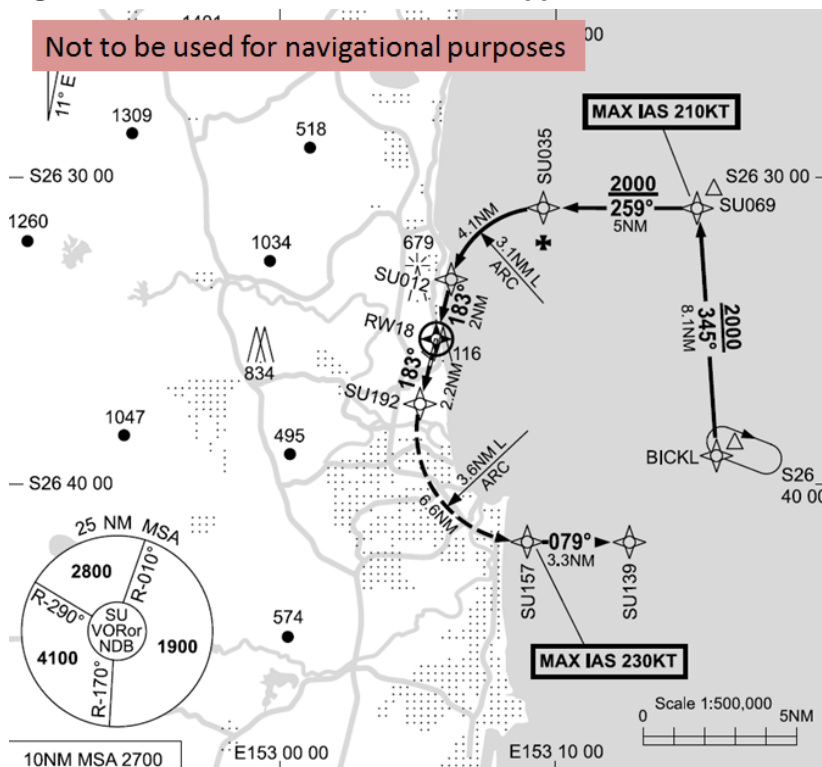
**Figure 1: Extract from RNAV-X RWY 18 approach, Sunshine Coast**

A Jetstar Airbus A320 aircraft, registered VH-VGJ (VGJ), was inbound from Melbourne, Victoria to Sunshine Coast Airport via the area navigation (RNAV) required navigation performance approach to runway 18 (Figure 1). When about 30 NM from the Sunshine Coast, the first officer, as pilot monitoring (PM),<sup>2</sup> broadcast on the common traffic advisory frequency (CTAF), that they were inbound with an estimated arrival time of 2002 EST. The first officer did not receive any response to the broadcast, and reported that the CTAF was quite busy with a lot of radio broadcasts from other aircraft in the vicinity.

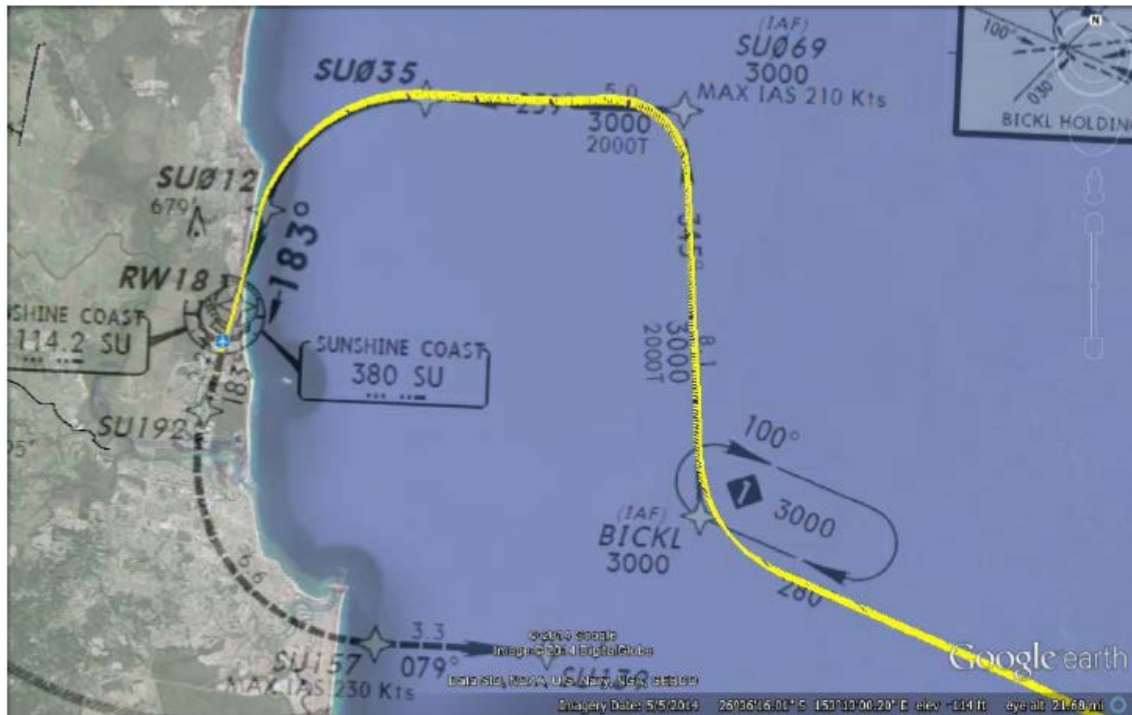
**Figure 2: VH-VGJ track via the RNAV-X RWY 18 approach**

When approaching waypoint BICKL (Figure 2) and passing about 4,500 ft on descent, VGJ was cleared by Brisbane Centre ATC to leave controlled airspace and advised that there was no relevant instrument flight rules (IFR) traffic. The crew observed some visual flight rules (VFR) aircraft on the traffic collision avoidance system (TCAS)<sup>3</sup>. Another Jetstar A320 aircraft then broadcast on the Brisbane Centre frequency that they were taxiing at Sunshine Coast Airport and ATC confirmed that the first officer of VGJ had copied that call.

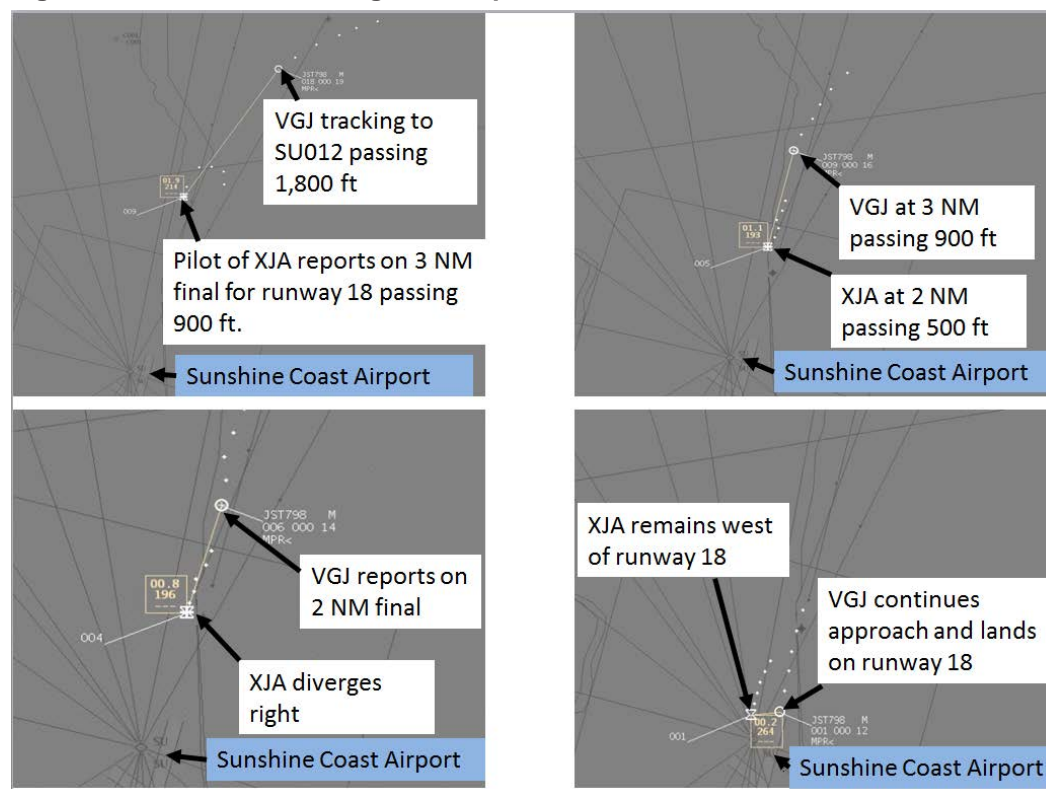
**Figure 3: Radar data showing relative positions of VH-VGJ and VH-XJA**

Radar data provided to the ATSB by Airservices Australia indicated that the two aircraft passed at an altitude of about 200-300 ft with a lateral separation of about 370 m (Figure 3).

<sup>6</sup> TCAS RAs were inhibited below 900 ft AGL, all aural alerts were inhibited below 400 ft and when VGJ was below 1,700 ft, all 'intruders' below 380 ft were inhibited.

A 'red' flight standing order (RED FSO)<sup>7</sup> was issued to remind all flight crew of the importance of vigilance when operating at non-controlled aerodromes. The FSO advised flight crew to review the standard procedures and maintain a high level of awareness of other traffic using all possible means. Pilots were reminded to be aware of the inhibition logic of TCAS during approach to land.
