Collision with terrain during a go-around, involving a Cessna 206, VH-TND

Rawnsley Park ALA, South Australia, 2 August 2014

ATSB Transport Safety Report
Aviation Occurrence Investigation
AO-2014-135
Final – 3 December 2014

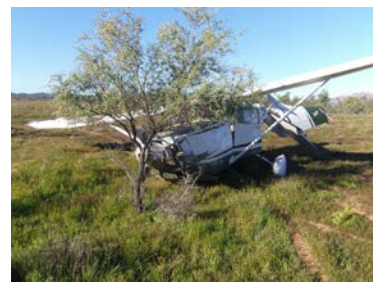
VH-TND accident site

As TND passed over the windsock, the pilot heard a 'clunk' and the aircraft 'wobbled'. Moments later, the aircraft spun rapidly to the left and collided with the ground (Figure 4). It came to rest about 18 m from the windsock (Figure 5). The pilot shut down the aircraft, and assisted the male passenger from the front left pilot door, then the female passenger from the rear door.

The male passenger sustained serious injuries, and the female passenger minor injuries. The pilot was not injured; however the aircraft was substantially damaged.

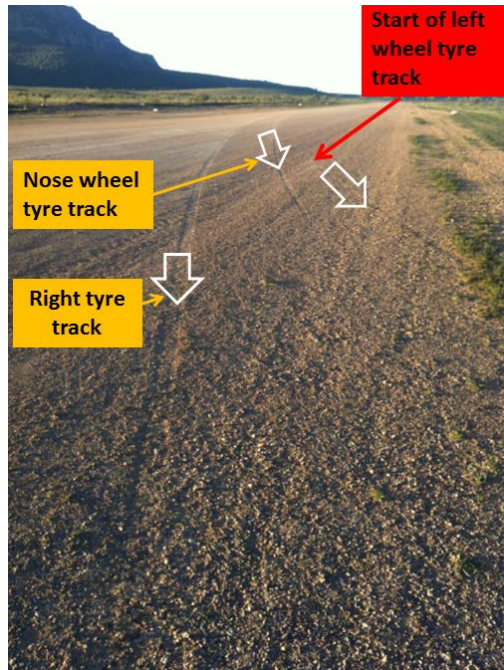
Figure 1: VH-TND tyre tracks runway 21

With about 50 knots of airspeed remaining, the aircraft began to veer to the left (Figure 1). In an attempt to re-align the aircraft with the runway, the pilot applied right rudder, but soon realised he was unable to correct the situation. He applied full power and initiated a go-around.

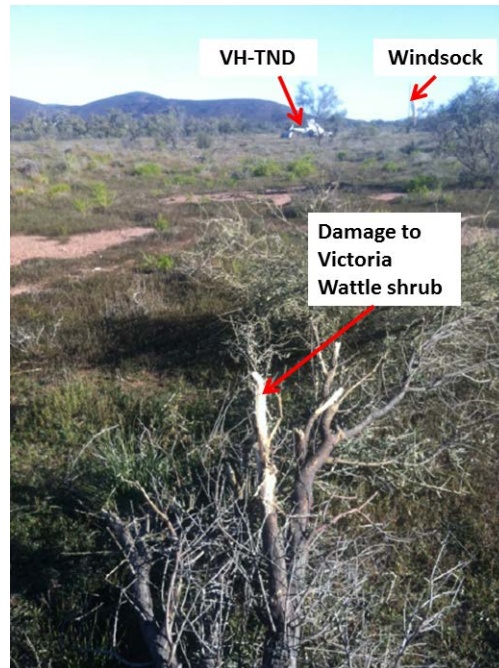
Figure 2: Shrub, aircraft and windsock

The aircraft continued toward a 45 cm high levee bank running parallel to the runway. The main wheels struck the levee bank, and the aircraft became airborne in a nose high, tail low attitude. In an attempt to clear a shrub (Figure 2), the pilot raised the nose of the aircraft. The aircraft horizontal stabiliser (Figure 3) struck the main trunk of the shrub about 45 cm above the ground, uprooting it.
