Collision with terrain involving a Bell 206, VH-FHX

94 km ENE of Jabiru, Northern Territory on 14 September 2014

ATSB Transport Safety Report
Aviation Occurrence Investigation
AO-2014-151
Final – 3 December 2014

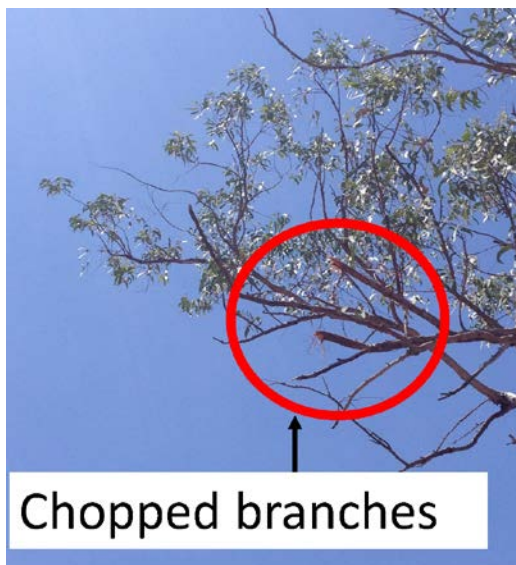
At about 1218 Central Standard Time, the pilot conducted an approach and, when at about tree-top height, completed a final appraisal of the site and elected to continue the approach to land. The pilot then conducted a vertical descent into the selected landing site. When at about 1 ft AGL, the passenger seated in the left front seat alerted the pilot to the tree stump on the left, observing that he thought it may be tall enough to strike the main rotor. Due to the sense of urgency in the passenger's voice, the pilot immediately manoeuvred the helicopter up and to the right. During this manoeuvre, the pilot heard the helicopter strike a tall tree (Figure 1).

Figure 1: Tree damage following helicopter strike

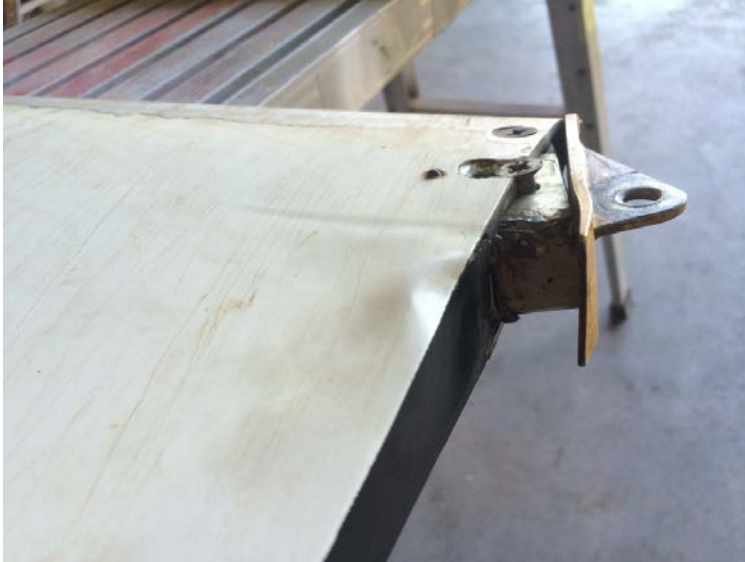
About 20 minutes later, after landing at Jabiru, the pilot inspected the helicopter and found the damage to the main rotor blade had worsened significantly (Figure 2). The pilot then assessed the

helicopter as unserviceable and contacted the senior base engineer. The engineer subsequently determined that the main rotor blade and tail rotor blade had sustained substantial damage and required replacement.

Figure 2: Damage to main rotor blade tip
