# Rotor drive v-belt failure involving Robinson R22 helicopter, VH-HRX

100 km SW of Borroloola, Northern Territory | 27 March 2014

**ATSB Transport Safety Report**  
Aviation Occurrence Investigation  
AO-2014-058  
Final – 17 December 2014

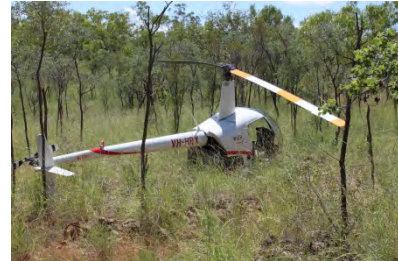
Accident site

Soon after, the station owner found the helicopter complete and upright in a relatively clear area. The pilot of VH-HRX, who was laying a few metres from the helicopter, had sustained a serious head injury. The station owner tended the casualty and alerted emergency services at Borroloola of the accident, as well as personnel at the station homestead. Station personnel accessed the accident site over the rough terrain and started to transport the injured pilot on the back of a utility vehicle. The casualty was later transferred to a Bell 206 Jetranger helicopter for transfer to Macarthur River Mine. An aeromedical service then transported the injured pilot to Darwin where he was hospitalised for a number of weeks.

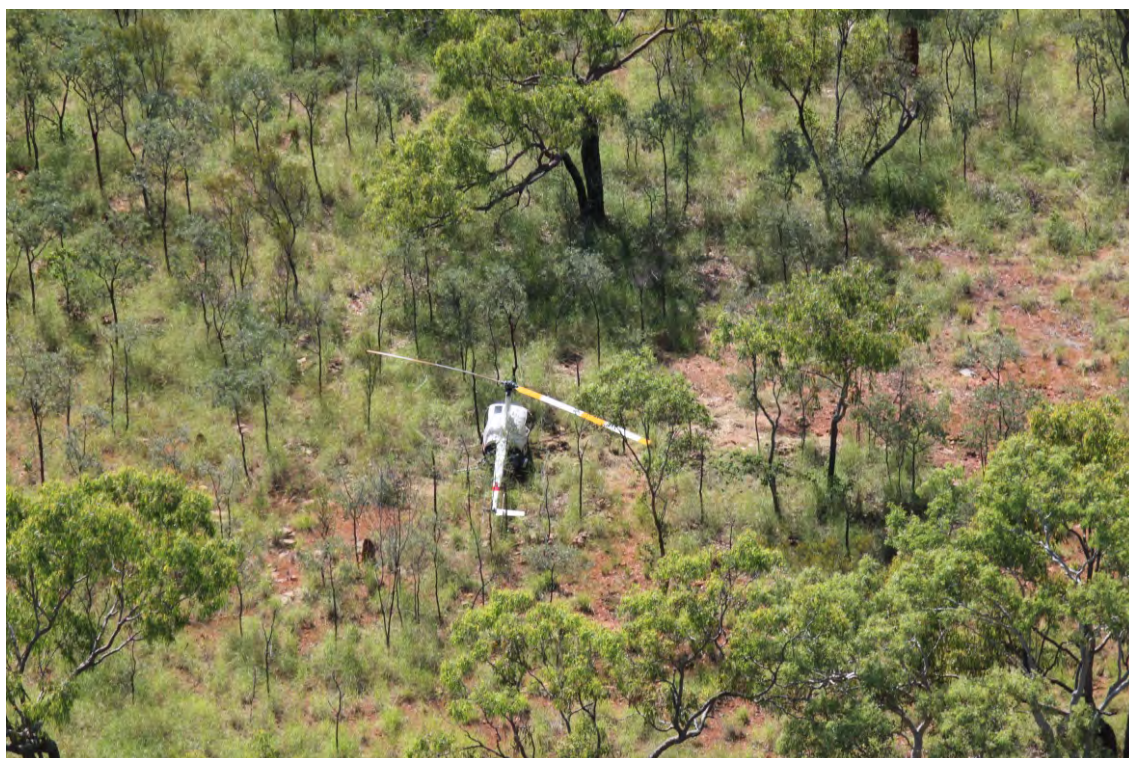
**Figure 2: Accident site from the air showing VH-HRX**

The station owner flew to where the helicopter had descended out of sight and landed near to where the pilot had landed (Figure 2). The station owner found the pilot lying on the ground about 5 m from the helicopter, which was already shut down. The pilot, who was not wearing a helmet during the flight, had sustained neck/head injuries and was disoriented and distressed. The station owner attended to the injured pilot and used his satellite phone to call the station homestead and the Borroloola health clinic for help. The clinic dispatched an ambulance with two clinic nurses towards the site and advised local police who mobilised a rescue team from the nearby Macarthur River Mine, as well as dispatching police towards the site.

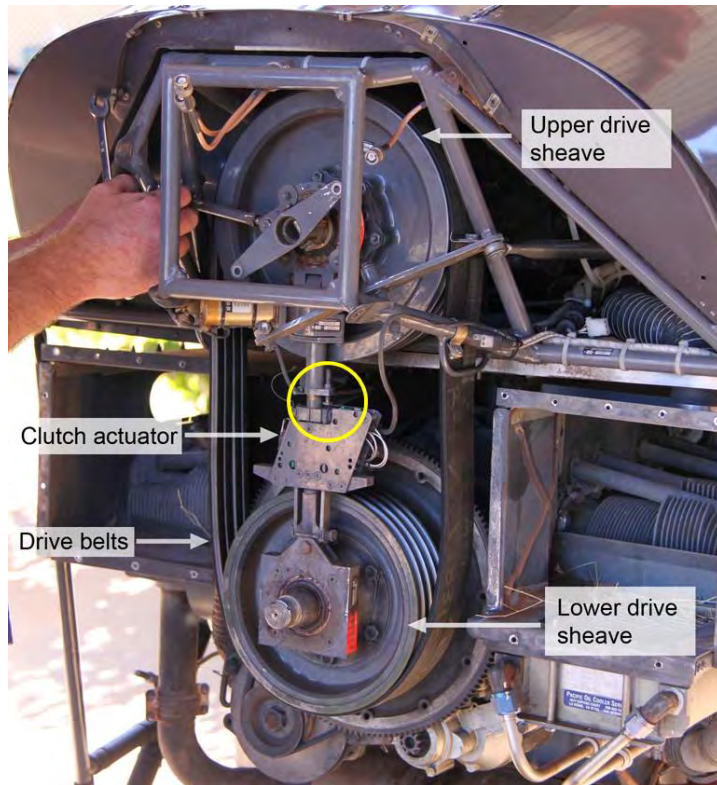
**Figure 4: Typical mechanical arrangement of the R22 drive system (viewed from the rear with tailcone and cooling fan assembly removed) with the down limit stop circled**

down limit stop (circled in Figure 4) from the clutch actuator should be adjusted to ensure the correct drive belt deflection.

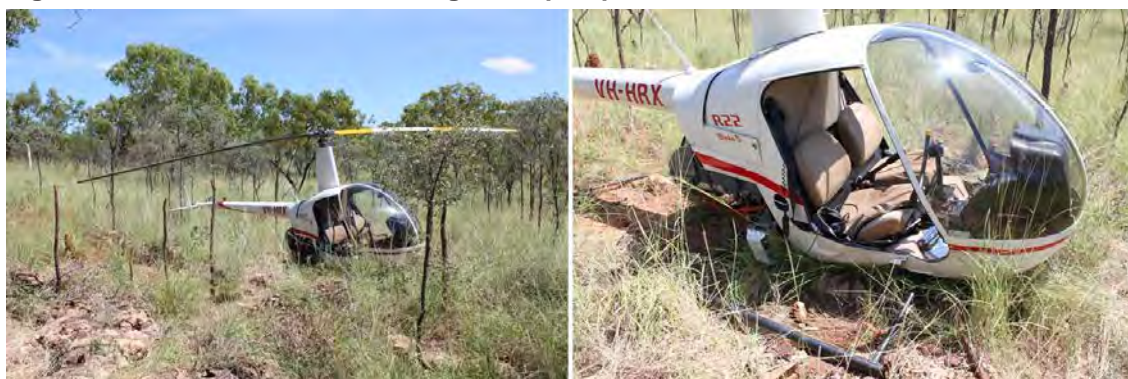
**Figure 5: Accident site from an on-ground perspective**

ATSB investigators travelled to the accident site and examined the helicopter (Figure 5). This examination found that the helicopter was relatively intact and the damage observed to the fuselage and skid-type landing gear was consistent with a hard landing with some forward-right drift. The main rotor blades had dents and scratches from contact with saplings in the rotor arc but were otherwise undamaged. The tail boom was bent from contact with a tree during the landing but the tail rotor was undamaged. The two fuel tanks held a substantial amount of fuel and the engine contained sufficient oil.

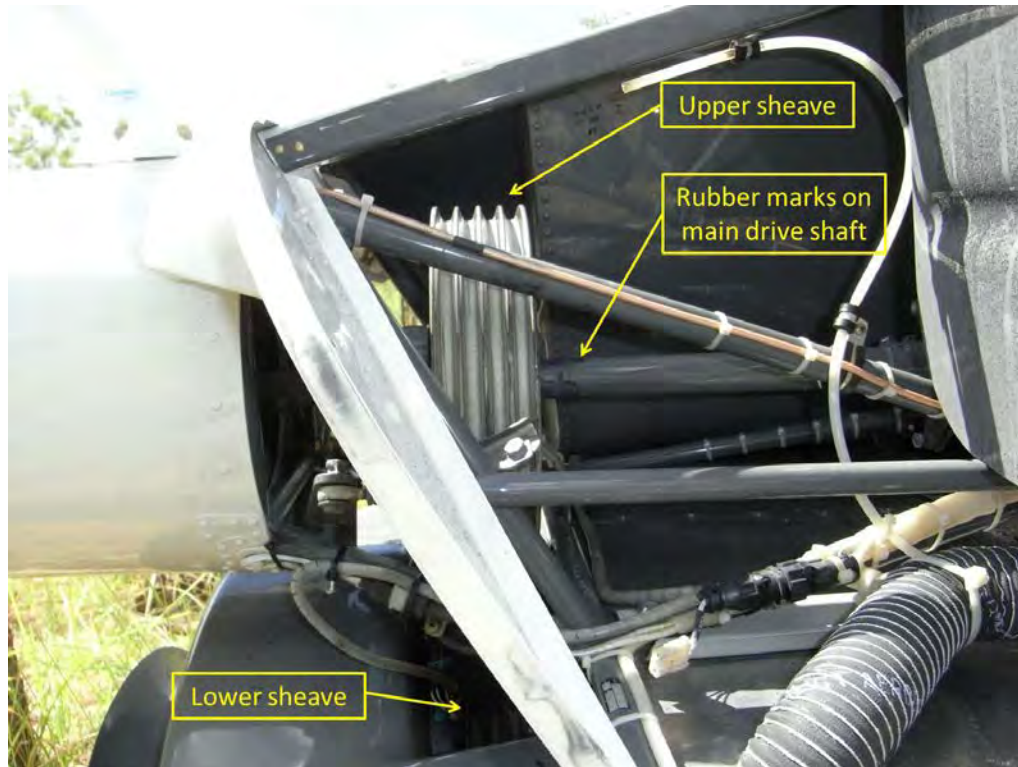
**Figure 6: View of the upper sheave and main rotor drive shaft as found onsite (cowls removed)**

The rotor drive system from the upper drive sheave rearward to the tail rotor and forward to the main gearbox demonstrated continuity but the v-belts were not present on the sheaves (Figure 6). There were rubber-transfer marks forward of both sheaves, and small belt fragments and rubber dust scattered around the upper sheave. Some larger belt fragments were found on the ground in the vicinity of the lower sheave.

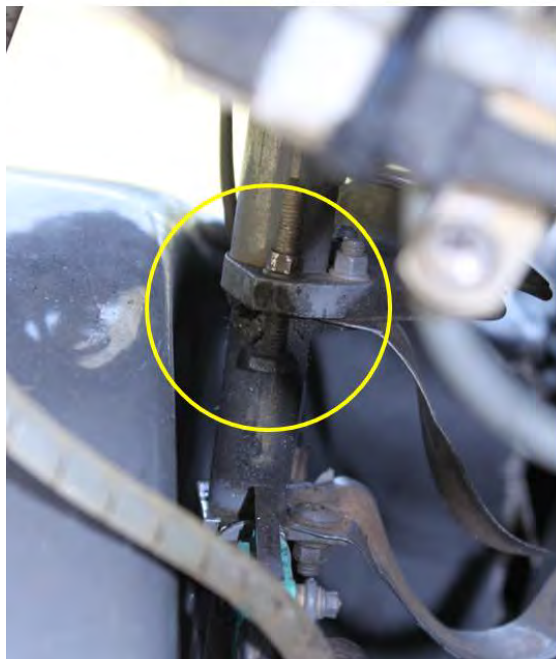
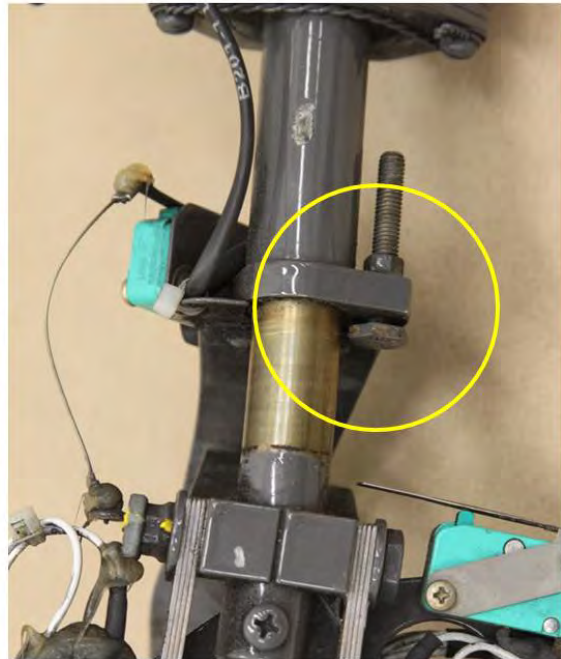
**Figure 7: Clutch down stop comparison**

Both sheaves were in good condition and the free-running clutch within the upper sheave responded appropriately to manual rotation in both directions. The clutch actuator had almost fully extended to the point where the over-travel limit micro switch, which was damaged, would be expected to stop it. The clutch down stop was in an extended position (Figure 7A), which was not consistent with the reported position on release from the recent 100-hour inspection (Figure 7B).

It is probable that during that period the pilot adjusted the clutch actuator down limit stop screw to reduce the amount of v-belt slack and thus the time for the rotor blades to turn after clutch engagement. This was consistent with the pilot's advice to the station owner that he was adjusting the v-belts, and the down limit stop having been extended significantly since noted at the 100-hour inspection.

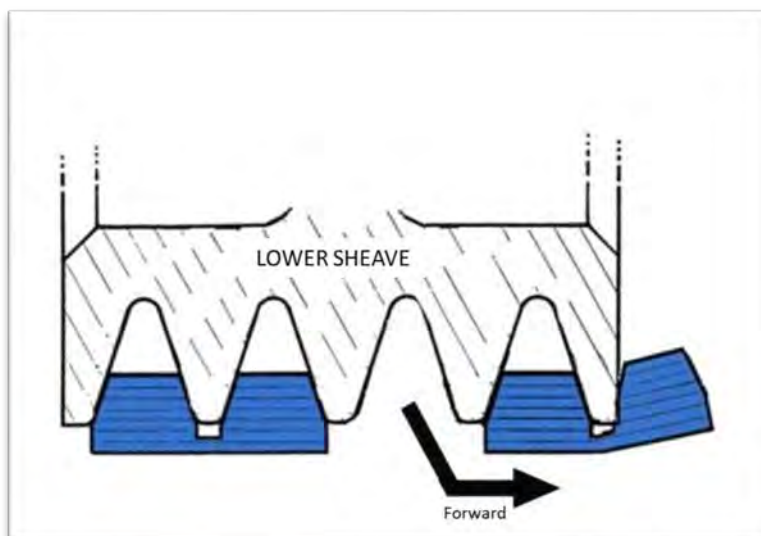
**Figure 6: Diagrammatic representation of belt displacement**

Whatever the case, when the pilot first started the engine and engaged the clutch, the disposition of the v-belts probably allowed one (or both) rotor drive v-belts to move on the lower sheave so that the forward belt was only partially in contact with the sheave (Figure 8). That partial contact would contribute to the longer clutch engagement time periods reported to the station owner by the pilot.
