Collision during landing involving a GA8 Gippsland Airvan, VH-XHV

Pinjarra Skydiving Airstrip, 19 km SSE of Murray Field Airport, Western Australia
24 August 2014

ATSB Transport Safety Report
Aviation Occurrence Investigation
AO-2014-143
Final – 23 December 2014

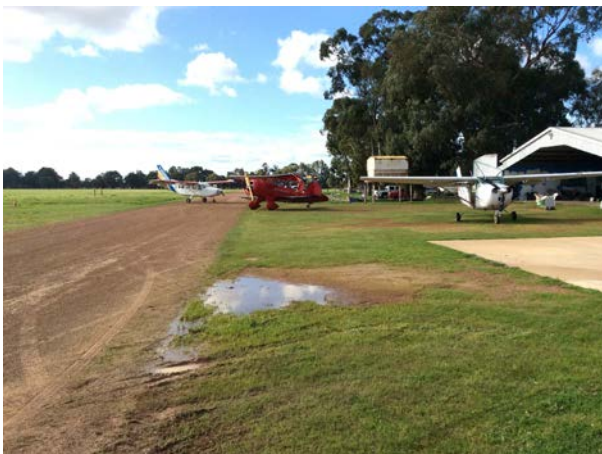
Figure 1: Apron area

The pilot applied intermittent gentle pressure on the brakes, but was mindful of the potential for skidding on the gravel surface if too much braking was applied. As the Airvan approached the hangar area (Figure 1) the pilot noticed a Cessna 182 aircraft on its regular hard stand, and when a little closer again, noticed the operator's Classic Aircraft Corporation WACO YMF5 aircraft behind it (Figures 1 and 3). The left wing of the WACO was over the runway. Reluctant to apply any stronger brake pressure, the pilot applied left rudder to manoeuvre the Airvan around the WACO.

Almost immediately the right wing of the Airvan struck the left wing of the parked WACO and the Airvan spun rapidly. The propeller struck a parked trailer, and the left wing went through the window of an unoccupied 4WD vehicle, before coming to rest. During this sequence, at least two people on the ground had to expedite themselves from the vicinity. The pilot shut down the aircraft and, still in shock, remained in the aircraft while ground personnel moved the Airvan back from the vehicle. The pilot was not injured, however two people nearby sustained minor injuries. The Airvan and the WACO were both substantially damaged.

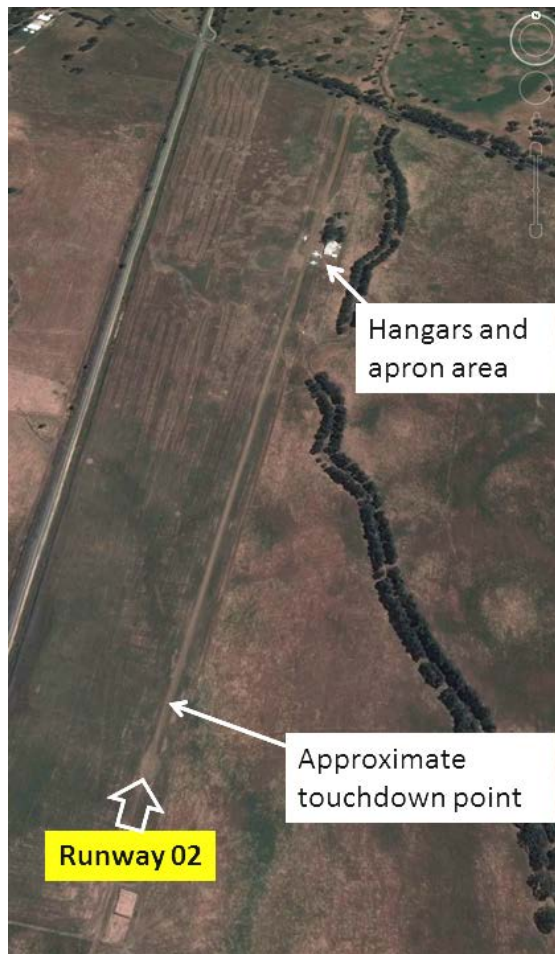
Figure 2: Runway 02

Runway 02 is 1,250 m long, however depending on the operational need of the day, normally 836 m south of the hangars was kept for take-off and landings. The runway surface was compacted gravel.

There are two hangars located about 374 metres from the northern end of 02, set back about 26 m east of the runway centreline. The area between the hangars and the runway is apron area. In front of the hangars is a fenced off spectator area. On the eastern side of the runway, a spoon drain runs south from the hangars for about 170 m.

There is a displaced landing threshold for runway 20 about 60 m south of the apron hangar area.

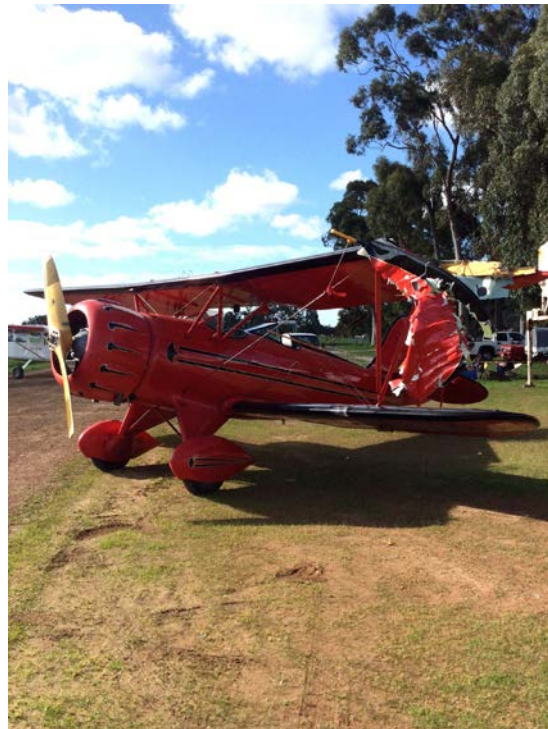
Figure 3: Damaged Classic Aircraft Corporation WACO

He feels a gust of wind may have resulted in the WACO weather-cocking, leaving the left wing closer to the runway centreline. He stated he was surprised that the much larger WACO was not visible from the runway.
