Engine failure involving a Beech Aircraft Corp D17-S, VH-FNS

12 km ESE of Bunbury Airport, Western Australia on 31 May 2014

ATSB Transport Safety Report
Aviation Occurrence Investigation
AO-2014-098
Final – 27 January 2015

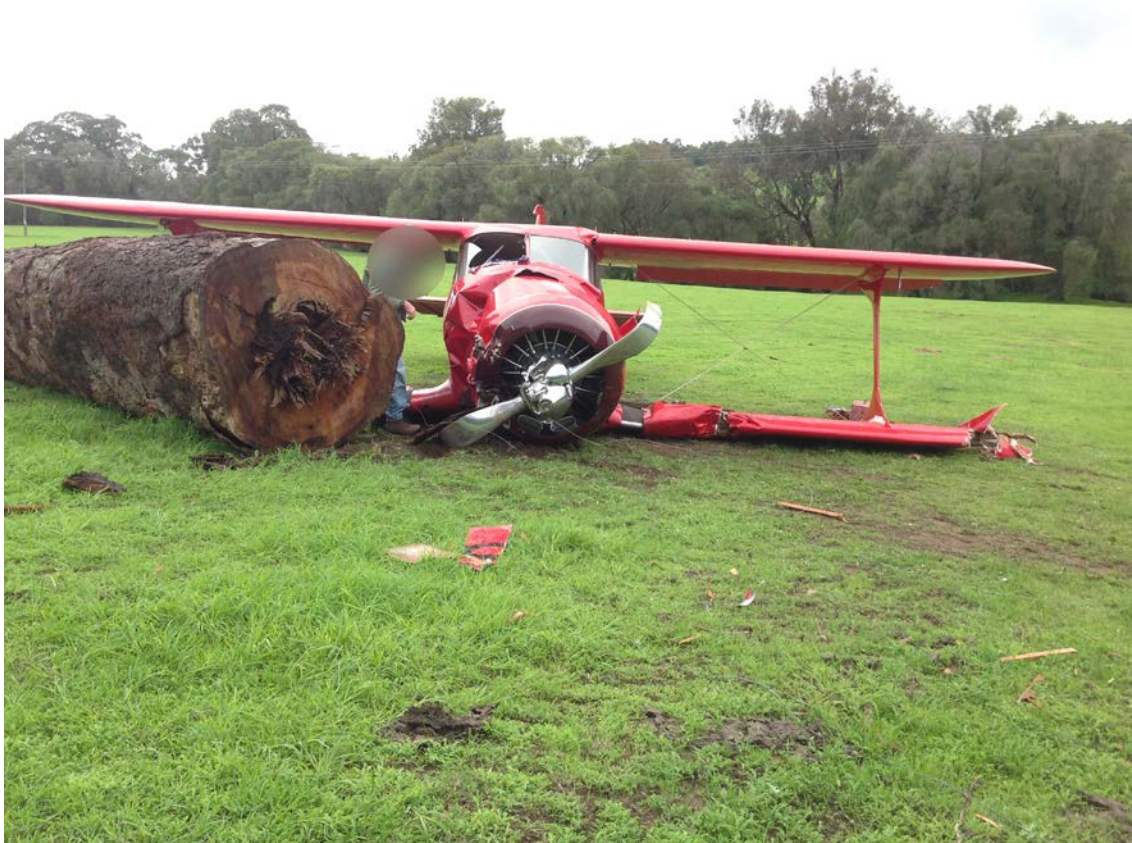
After departure, the pilot tracked FNS in a northerly direction and climbed to an altitude of about 2,500 feet above mean sea level (AMSL). About a minute after setting the engine to cruise power, the pilot felt a violent vibration with an associated decrease in engine power. The pilot described the engine as 'surging' and 'back-firing'. The pilot conducted initial troubleshooting and was unable to identify a reason for the engine malfunction. The vibration ceased and the engine was no longer producing power but the propeller was windmilling. The pilot elected to leave the landing gear retracted and set up a glide approach tracking to the north-east to locate a more suitable landing area to conduct a forced landing. A suitable paddock was identified that was near a house. The aircraft flew over a line of tall trees and then clipped a fence that was next to a private road leading to the house, went through a second fence on the other side of the road, which partially arrested the aircraft. It then impacted a large log and came to rest (Figure 1). A passer-by assisted the pilot to evacuate the aircraft. The pilot was seriously injured and transported to hospital and the aircraft was substantially damaged.

Figure 1: Accident site
