# Collision with terrain involving a Cessna 206, VH-KRR

33 km west of Nowra Airport, New South Wales, on 16 October 2014

**ATSB Transport Safety Report**  
Aviation Occurrence Investigation  
AO-2014-168  
Final – 27 January 2015

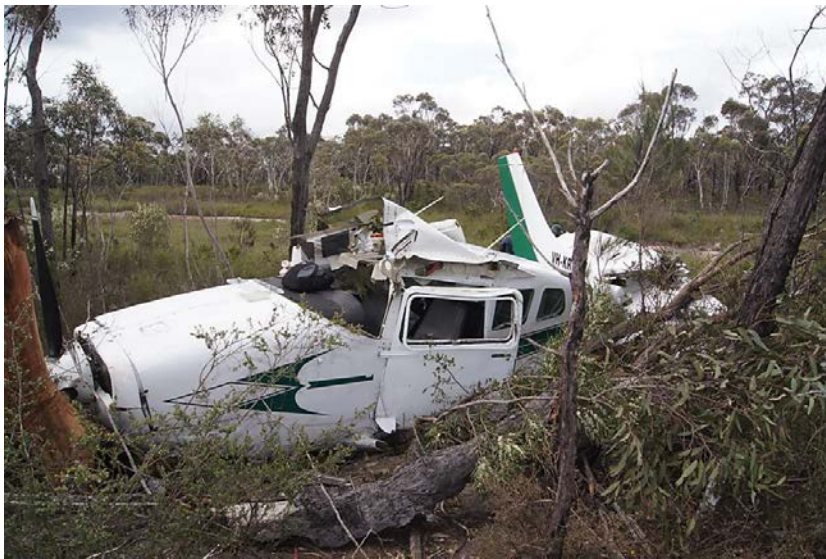
**Figure 2: Damage to VH-KRR**

At about 1114, and when at about 5,500 feet above mean sea level, the aircraft's engine surged and then stopped. The pilot conducted some emergency checks including an attempt to restart the engine, but did not select the fuel pump ON or change the selected fuel tank. The pilot broadcast a Mayday<sup>1</sup> call, assumed a glide speed of about 75 knots and looked for a suitable landing area. Initially the pilot observed only heavily treed areas, but when passing about 3,500 feet on descent, he sighted a clearing ahead. The pilot did not extend the flaps, so as to increase the glide range of the aircraft, and reduced the airspeed to about 65 knots just prior to impact. The aircraft collided with trees about 50 metres short of the intended landing site and was substantially damaged (Figure 2). The pilot sustained a minor injury.

The aircraft owners attended the accident site on Friday 17 October. They reported that about 7 litres of (unusable) fuel remained in the right tank and none in the left. The fuel bladders appeared to be intact and they did not observe any evidence of spilled fuel. The left fuel tank was selected and the master and magneto switches were ON. The engine casing was intact and there was no evidence of catastrophic engine damage.
