Loss of control during landing, involving a Bell 206B3, VH-CLR

9 km south-east of Cooktown Airport, (Mount Cook) Queensland, 07 October 2014

ATSB Transport Safety Report
Aviation Occurrence Investigation
AO-2014-161
Final— 27 January 2015

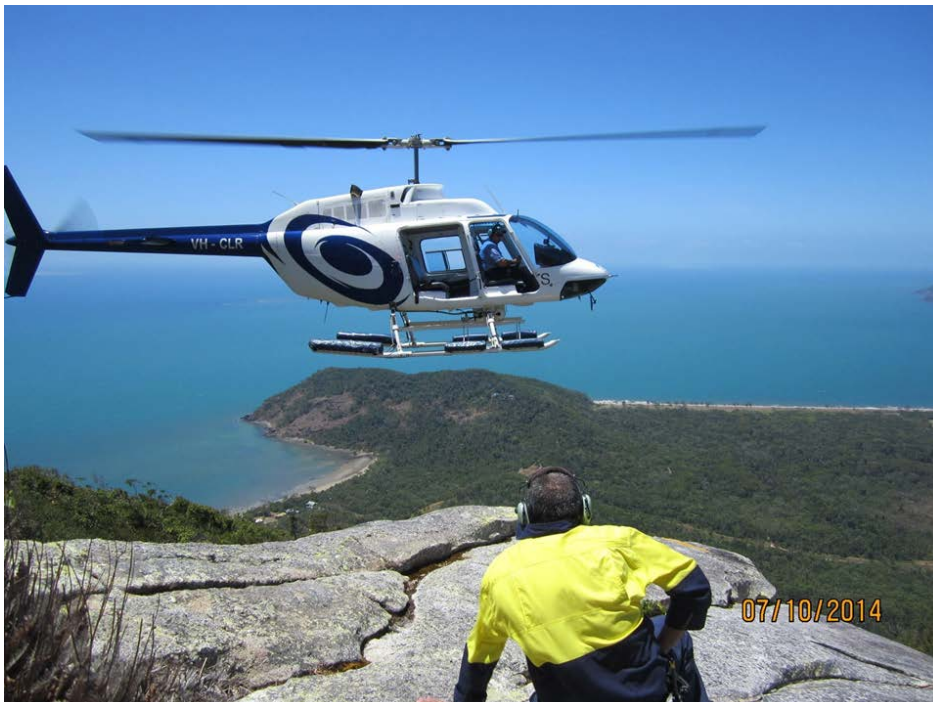
As the pilot had not used the landing area previously, he conducted an aerial reconnaissance of Mount Cook prior to arriving at Cooktown Airport to pick up the remaining passengers. In order to assess the conditions, he made 3-4 practice approaches and a practice landing, touching down with the right skid onto the ledge. He assessed that stabilising the helicopter with the right skid for the embarking and disembarking of the passengers would be preferable to the previously decided method of using both skids on the uneven surface. The landing area was a rocky ledge jutting out from the south-eastern side near the top of Mount Cook (Figure 1).

Figure 1: Approaching to land on Mount Cook (Ground co-ordinator in foreground)

During the approach to land, the pilot reported that he felt the helicopter was stable and appeared unaffected by the increased wind. He was guided into the landing area by the charter client's ground co-ordinator, who remained in radio contact with him. The ground co-ordinator also managed the loading and unloading of passengers. Although all five people on the ground had initially remained clear, as the helicopter prepared to touchdown, both the ground co-ordinator and one of the passengers planning to board moved closer (Figure 1).

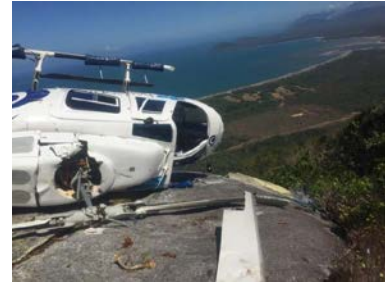
VH-CLR on Mount Cook

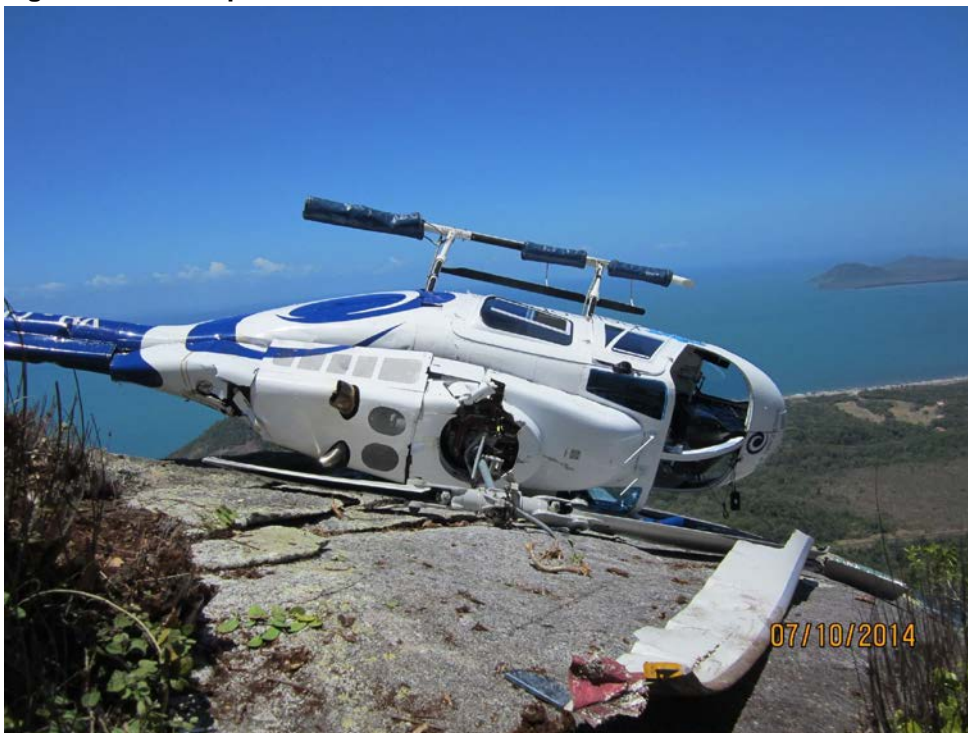
Just prior to stabilising the helicopter and touching down on the right skid, the pilot felt it momentarily lift, most likely from a gust of wind, and drift to the right. The right skid then scraped along the rock ledge. The helicopter rolled rapidly onto its right side and slid a short distance forward, prior to coming to rest.

The pilot and one passenger sustained minor injuries and the ground controller was seriously injured. The helicopter was substantially damaged (Figure 2).

Figure 2: VH-CLR post accident

Operations at Mount Cook will cease until a helicopter landing pad compliant with Civil Aviation Advisory Publication 92.2.2 (2) has been installed and inspected for use. A review of the register containing all the company HLS will be undertaken.

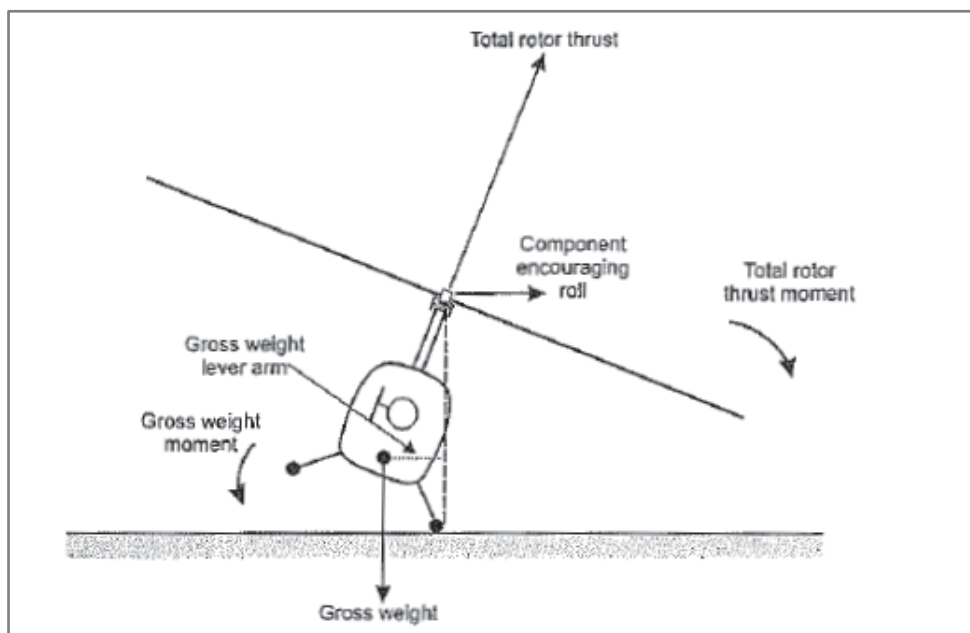
The roll onto the right side by the helicopter is consistent with the phenomenon known as dynamic rollover.

Figure 2 shows the forces involved in dynamic rollover. A moment is produced by the horizontal component of total rotor thrust about the point of ground contact of the skid. This moment is opposed by the weight of the helicopter and decreases as the helicopter is placed in progressively steeper banks. The horizontal component of total rotor thrust is related to the angle of bank or roll. Beyond a specific angle of bank it is impossible to stop further roll, and if the helicopter is kept in contact with the ground, it will fall. This angle is known as the critical angle.

Figure 2: Dynamic rollover

The rate at which the roll takes place influences the critical angle. When the right skid is on the ground, tail rotor drift to the right encourages further roll that results in the critical angle being smaller. Any crosswind from the left which causes disc blow-back to the right exacerbates the problem. (Principles of Helicopter Flight, 2nd ed., W.J. Wagtendonk)
