# Wirestrike involving Maule M-5, VH-HOG

50 km WSW of Casino, New South Wales | 12 April 2014

**ATSB Transport Safety Report**  
Aviation Occurrence Investigation  
AO-2014-068  
Final – 29 January 2015

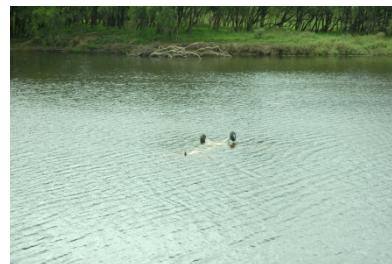
Submerged aircraft in river

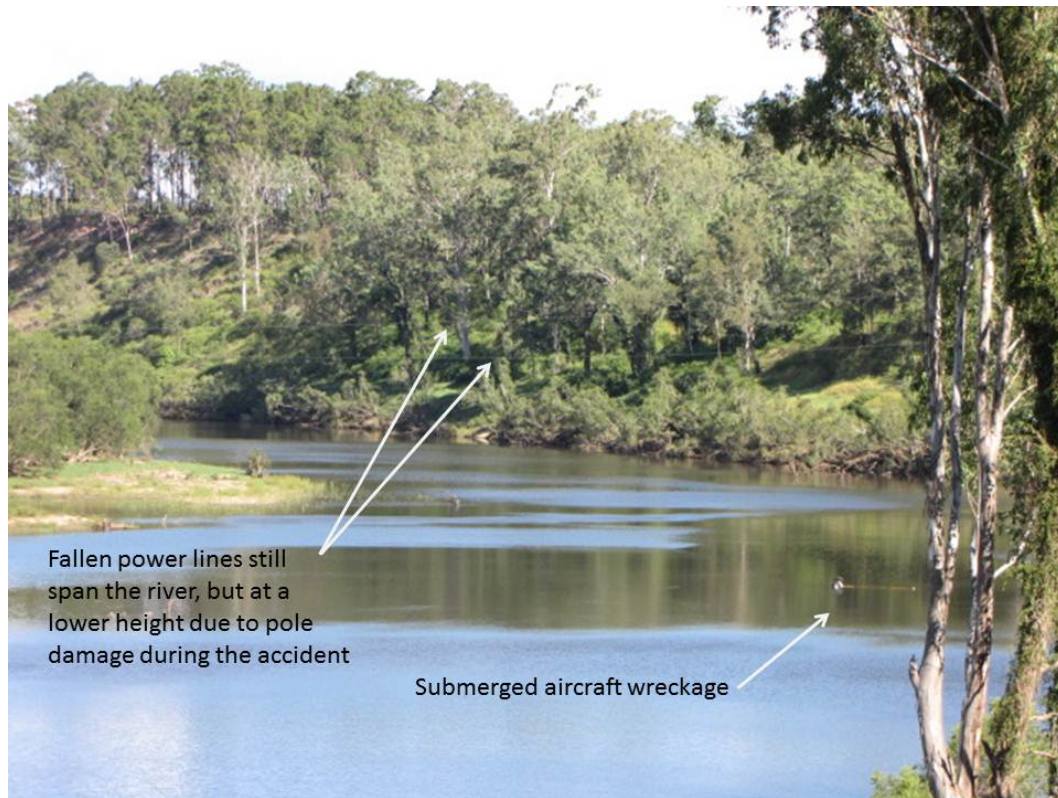
**Figure 2: Looking south towards river bend and showing the elevated west bank**

The pilot recalled that as the aircraft approached a sharp westerly bend in the river he pulled up, climbing to about 400–500 ft above the ground. He recalled then making a spur of the moment decision to descend back down to tree-top height and fly further north along the river. This included a section of the river with which he was less familiar and along which the terrain on the west bank was slightly higher than the eastern bank (Figure 2).

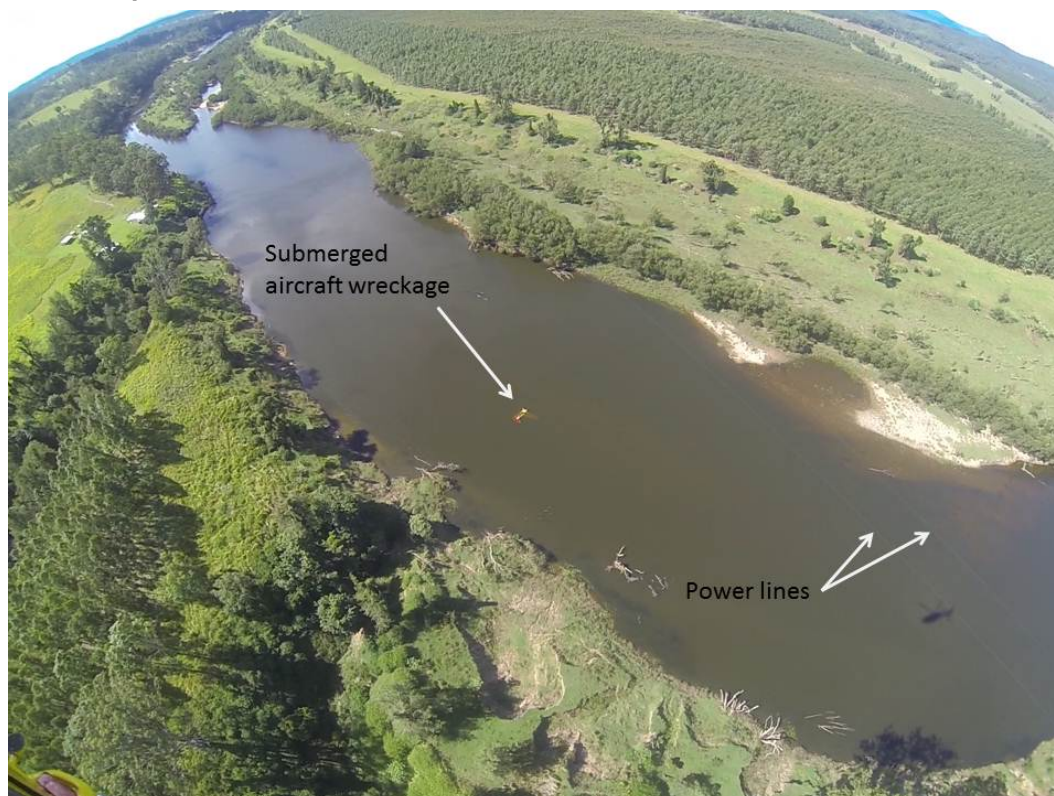
**Figure 3: Image captured from a rescue helicopter crew member's head-mounted camera,<sup>2</sup> with the aircraft wreckage to the north-east of the helicopter's position**

The pilot stated that, soon after descending back to tree-top height, he glimpsed wires immediately ahead of the aircraft but was unable to avoid a wirestrike. Control of the aircraft was lost and it impacted the water, coming to rest upside down a short distance from the powerline (Figure 3).

The ATSB did not attend the accident site. A review of photographs taken at the site by the New South Wales Police Force indicated damage consistent with the left wing striking cables at two different locations along the leading edge. The relative movement between the cables and the wing had partially cut through the structure of the wing's outboard leading edge (Figure 4), and also the mid-section leading edge and wing support strut (Figure 5). The orientation of the damage along the leading edge of the wing was consistent with the wing striking two cables whilst banked to the right. This accorded with the pilot manoeuvring the aircraft to follow the course of the river, which turned to the north-east in the vicinity of the powerline (Figure 3).

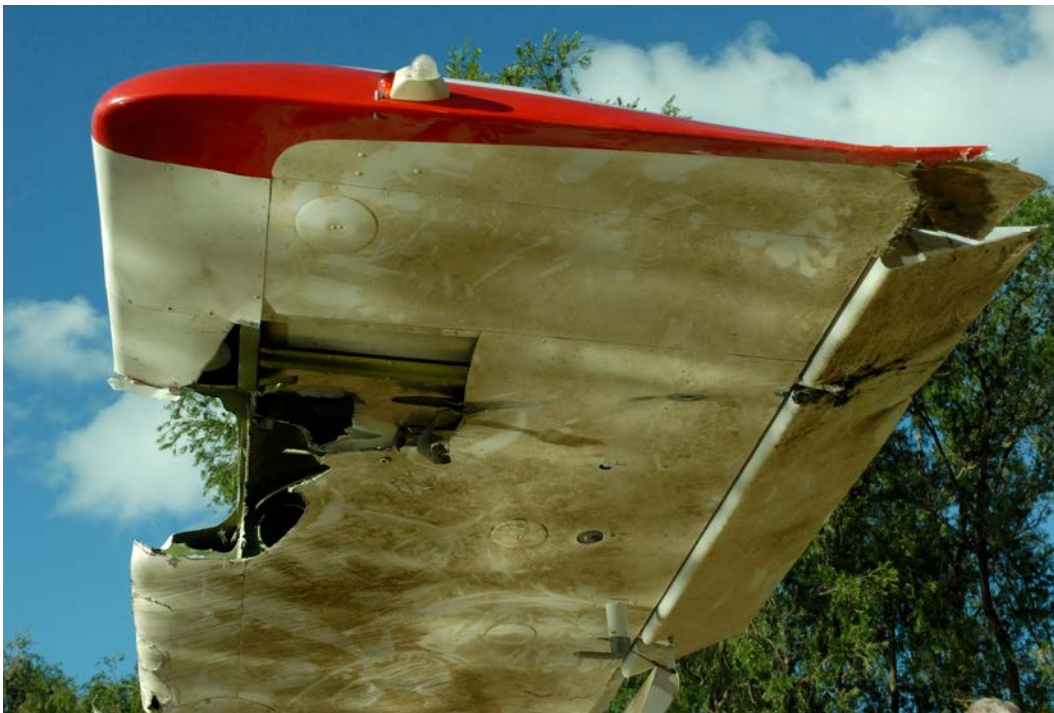
**Figure 4: Damage to the left wing outboard leading edge**

The pilot was following the course of the river and banking right when the first cable struck the left wing. The drag from this cable would have significantly reduced the speed of the wing relative to the rest of the aircraft, yawing the nose of the aircraft such that the second cable then impacted the wing leading edge inboard of the first strike. The asymmetric drag of the unbroken cables on the left wing and significant loss of airspeed resulted in the loss of control of the aircraft and the subsequent collision with the water. Even if the cables had broken, it was likely the significant damage sustained by the left wing would have resulted in a similar outcome.

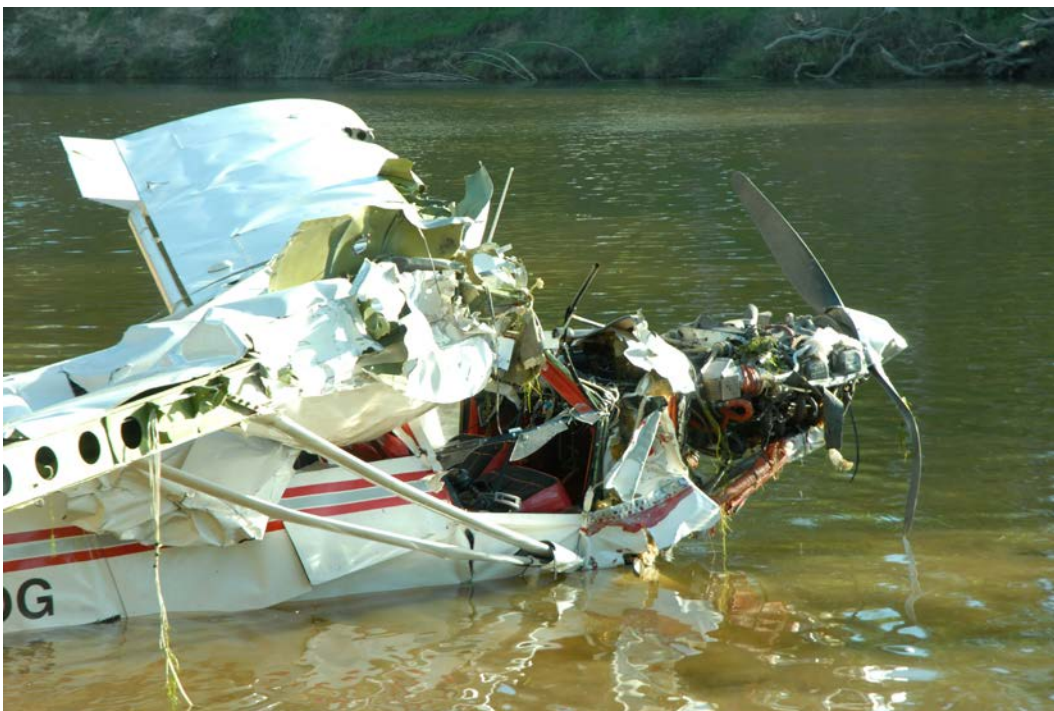
**Figure 6: Damage to right wing and also in proximity to the right rear cabin door**

The submerged, flooded and inverted cabin increased the difficulty experienced by the occupants in exiting the aircraft. Furthermore, impact damage sustained by the right wing likely rendered the rear-right cabin door unusable as an emergency exit, delaying the recovery of the rear-seat passenger.

The aircraft's windscreen had shattered and there was substantial damage to the forward cockpit section, consistent with the uncontrolled impact with the water. The leading edge of the right wing also sustained significant damage as a result of this impact, with the wing folded rearwards and the lower inboard wing skin and structural components obstructing the area adjacent to the rear cabin door (Figure 6). Both rear seatbelts were found unfastened after the recovery of the aircraft from the river.

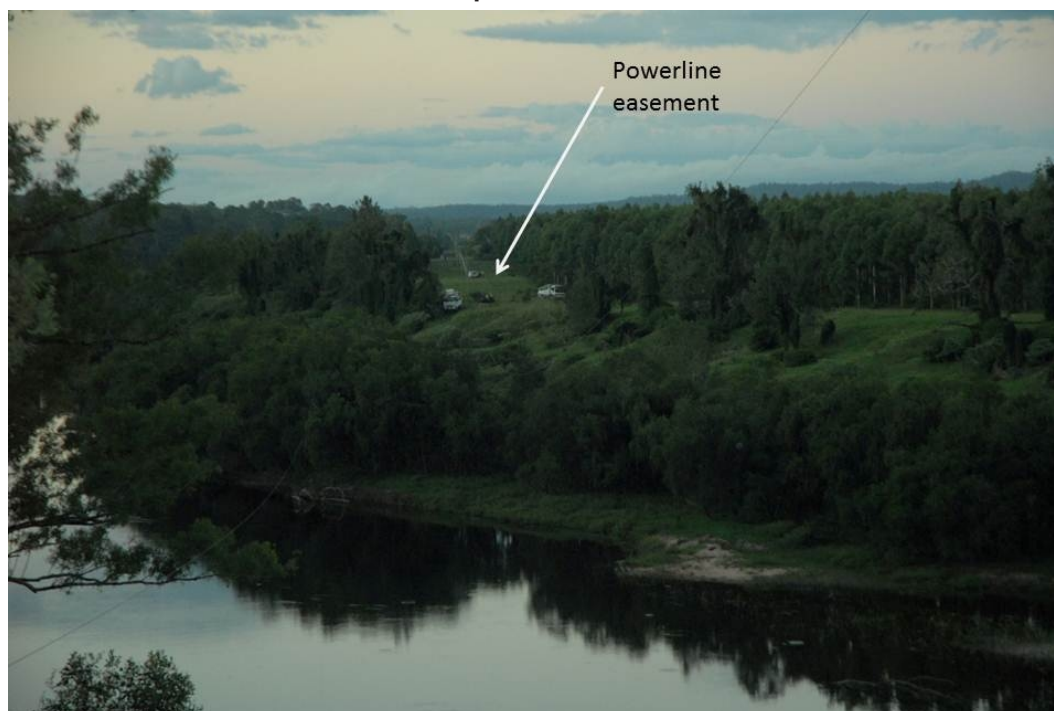
**Figure 7: Photograph from the western bank of the river, looking north-east across the river in the direction of the powerline**

The conductor cables spanned a distance of 665 m between supporting poles that were situated on each river bank (Figure 7). The height of the cables overhead the river varied from 16.2 m (53 ft) above the waterline on the eastern bank to 25.0 m (82 ft) above the waterline on the western bank. The cable conductors themselves had a weathered and dull-grey appearance.

The powerline was not in the vicinity of an aerodrome or an aircraft landing area and the flight was not part of an approved low-level operation. In this case, the requirements for permanent marking of overhead cables and their supporting structures were detailed in Australian Standard AS 3891.1 - *Air navigation—Cables and their supporting structures-Marking and safety requirements*. In general terms, this standard recommended permanent marking of overhead cables that exceeded a height of 90 m (295 ft). Consequently, the relevant standard did not require permanent marking of the conductor cables spanning the river at the accident site.

Although the aircraft did not break either of the conductor cables, several power poles and their associated infrastructure were damaged and a significant amount of cable dislodged from the poles. The powerline network was equipped with high-voltage protection devices at numerous locations. One of these devices, about 3 km from the accident site, detected a fault in the power supply at 1102 and isolated the power. The time of that power interruption broadly corresponded with the aircraft's collision with the powerline and dislodgement of cables.
