# Runway undershoot involving a Pilatus PC-12, VH-HIG

Coober Pedy Aerodrome, South Australia, 23 September 2014

**ATSB Transport Safety Report**  
Aviation Occurrence Investigation  
AO-2014-156  
Final – 26 February 2015

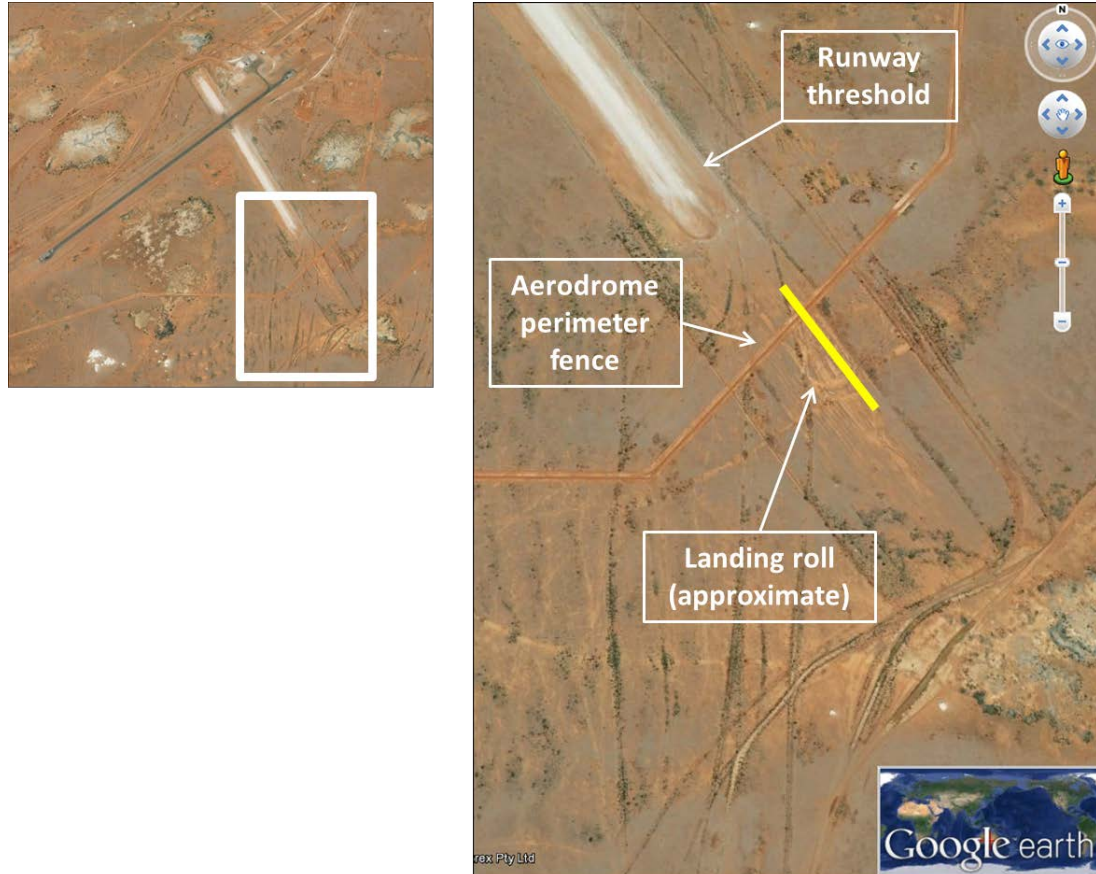
**Figure 1: Coober Pedy aerodrome with approximate position of the aircraft ground roll relative to the aerodrome perimeter fence and runway threshold**

The pilot reacted by pulling the control column back, in an effort to reduce the severity of what he felt was imminent ground impact. The aircraft touched down short of the runway threshold and to the right of the runway centre-line, on a firm surface that was once part of the runway strip. The aircraft passed through a wire aerodrome perimeter fence, and came to a stop after a ground roll of around 150 m (Figure 1). The aircraft also passed through a mound of loose dirt, and clipped a steel post, both associated with the wire fence (Figure 2).

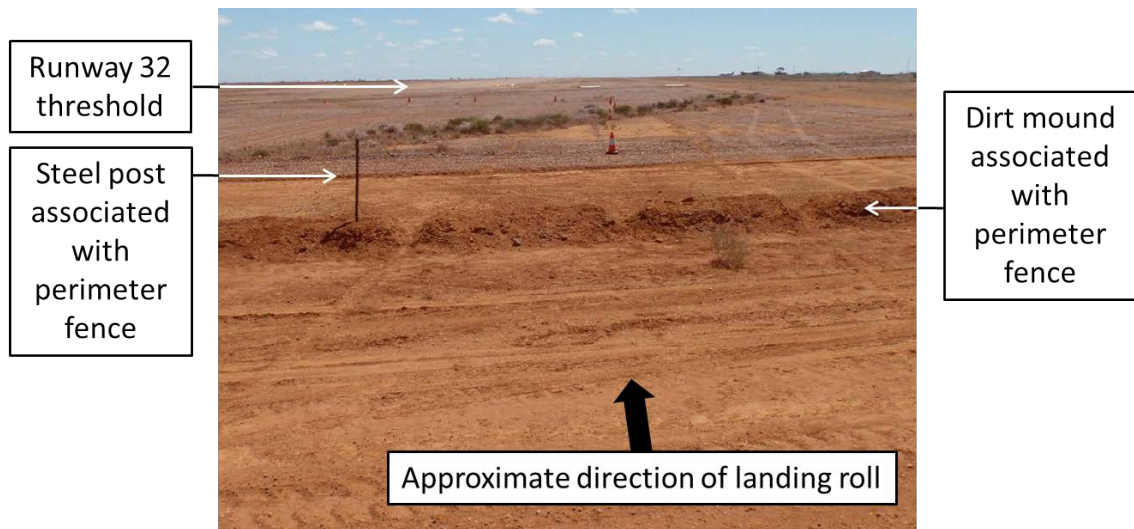
**Figure 2: Aircraft track through aerodrome perimeter fence**

Initial inspection of the aircraft following the flight identified that a micro-switch adjustment was required to address the nose landing gear indication problem. Closer inspection however revealed some damage in the area where the nose landing gear meets the aircraft structure, and scoring damage to the underside of the left wing and flap surface, just outboard from the left main landing gear. Scoring damage to the underside of the left wing and flap surface was probably the result of the wing and flap contacting the steel post visible to the left of the wheel track marks in Figure 2.
