# Safeworking breaches involving Absolute Signal Blocking

Blackheath, NSW, 13 June 2013  
Newcastle, NSW, 13 July 2013  
Wollstonecraft, NSW, 17 July 2013

**ATSB Transport Safety Report**  
Rail Occurrence Investigation  
RO-2013-018  
Final – 2 March 2015

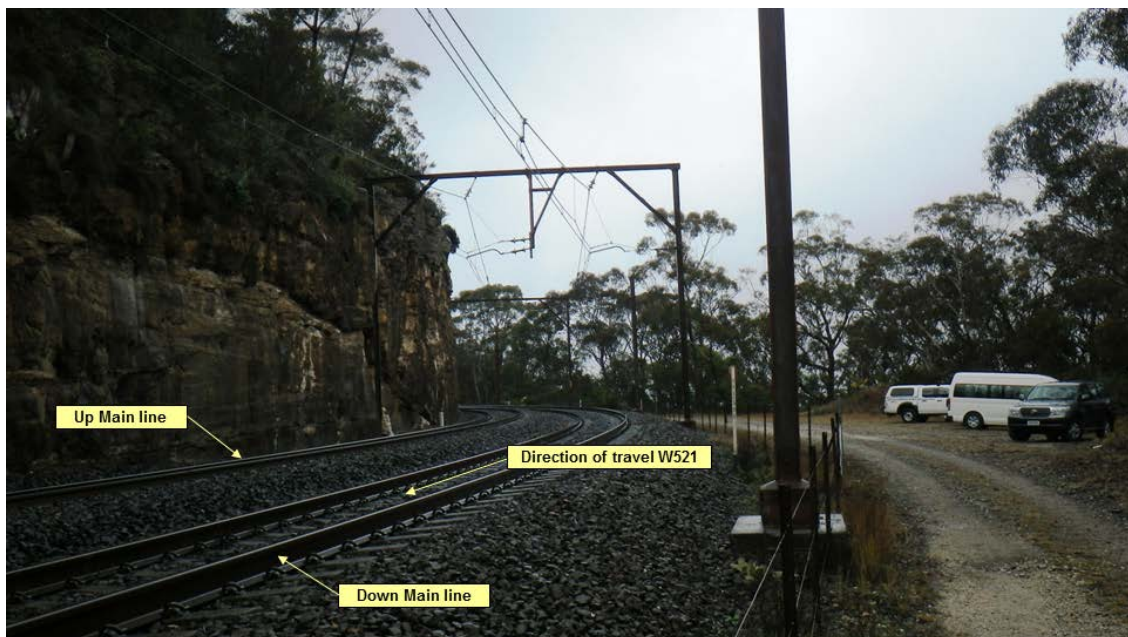
**Figure 2: Worksite at Blackheath**

The worksite was located at the 123.456 km point on a 280 metre right hand curve with a gradient of 1:80.

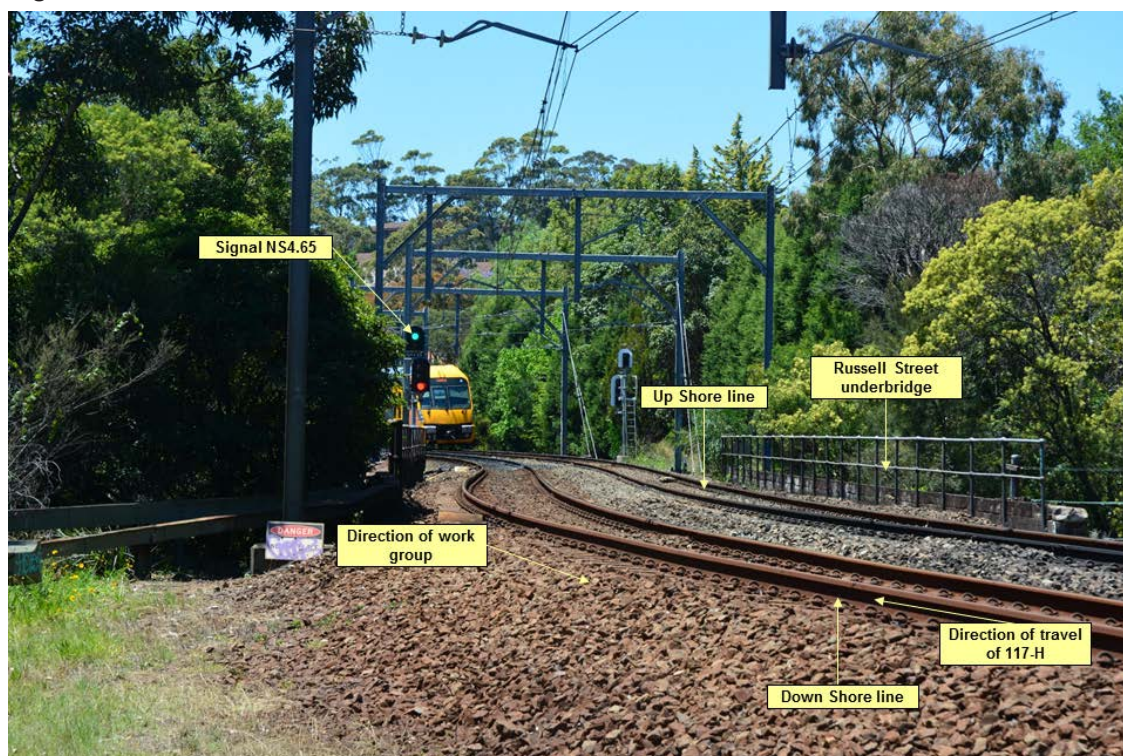
**Figure 4: Worksite at Wollstonecraft**

The workgroup cleared the track to signal NS4.65 which is located about 20 metres past the northern (St Leonards) end of the bridge at the 7.519 km point.

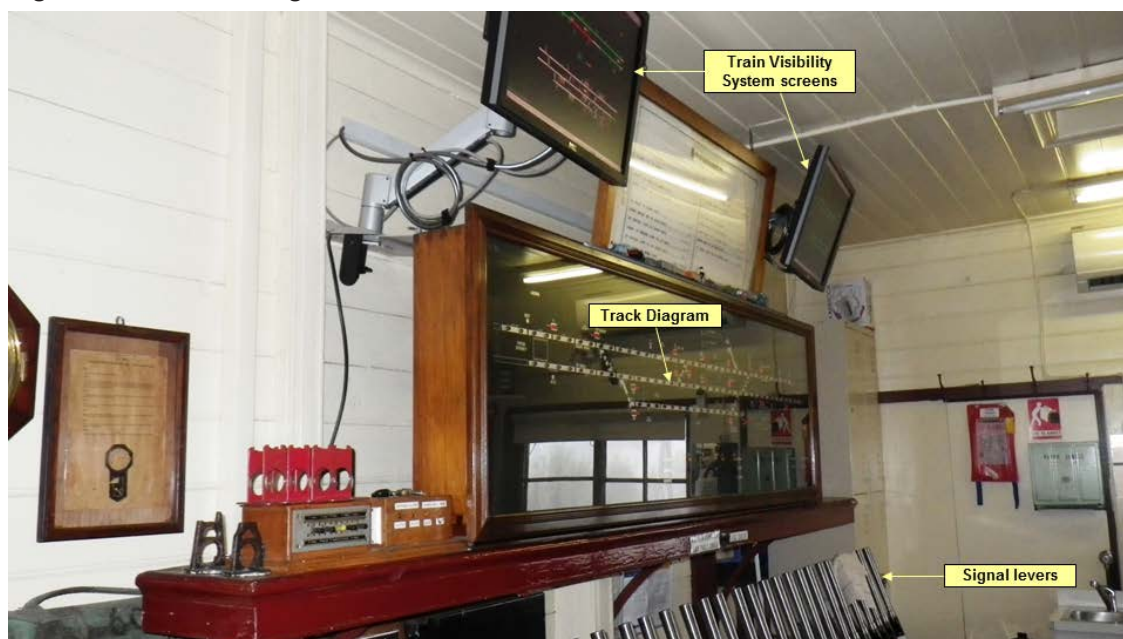
**Figure 5: Katoomba signal box**

The TVS at Katoomba (Figure 5) is a non-vital indication system<sup>11</sup> designed to provide Signallers with visibility of trains in the long, permissive signalled sections on the Blue Mountains. The system was installed in response to a recommendation stemming from the judicial inquiry into the Glenbrook accident which occurred in December 1999. The accident happened when an interurban train collided with the rear of the *Indian Pacific* killing 7 passengers and injuring 51 others.

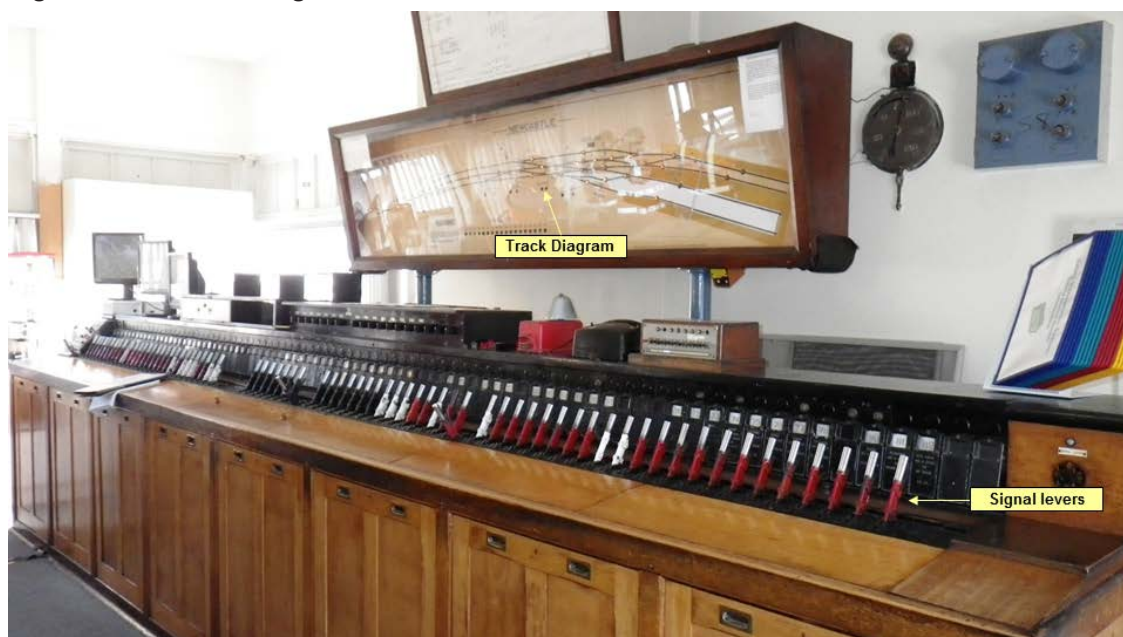
**Figure 6: Newcastle Signal Box**

Both Katoomba and Newcastle Signal Boxes (Figure 6) are equipped with track diagrams to provide signallers with information regarding the location of trains and the status of track circuits, absolute signals and points in their area of control. Although the diagrams are simplistic, they are permitted for use in safeworking as they indicate the actual location of trains and the state of the equipment controlled by the signal box.

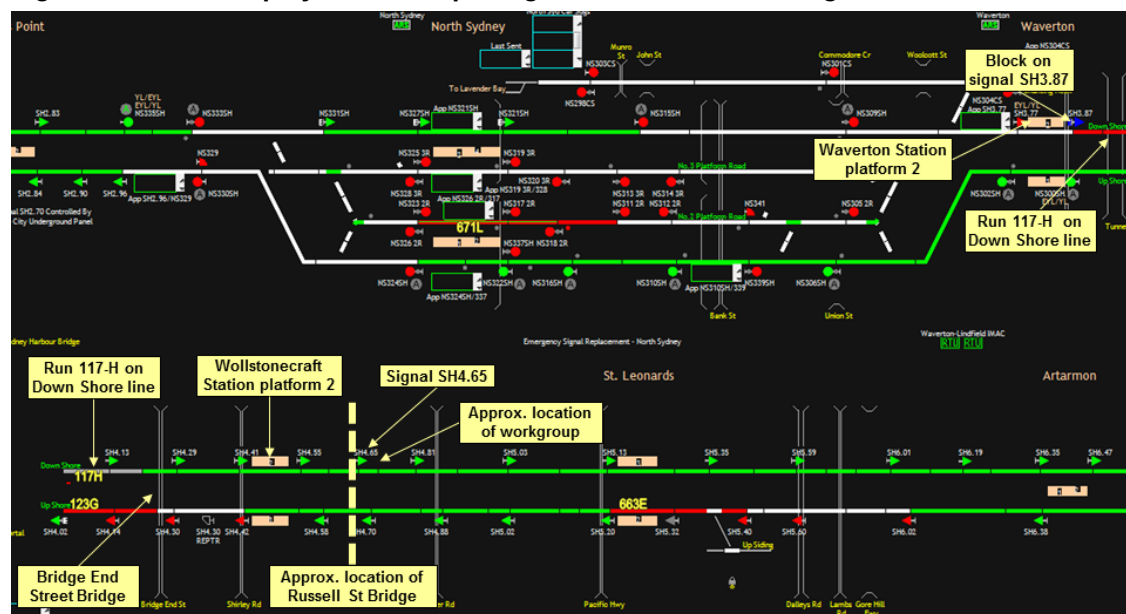
**Figure 8: ATRICS replay at 1256 depicting status of trains and signals at Wollstonecraft**

intending to cross the bridge at Bridge End Street (6.822 km point) near Waverton. Observing that this was the first bridge marked on the ATRICS screen after Signal SH3.87 he assumed that the train would have completely passed the workgroup and the bridge by the time the ASB was granted.

While four road overbridges and the Waverton Tunnel are marked on the ATRICS screen, the Russell Street road underbridge is not. At interview the Area Controller stated that he was unaware of the existence of the Russell Street bridge or the workgroup's intention to cross it. He also stated that he was unaware of any other infrastructure in the section other than that marked on the screen as he had not undergone any familiarisation in the field.
