# Power plant failures in turbofan-powered aircraft

2008 to 2012

**ATSB Transport Safety Report**  
Aviation Research Report  
AR-2013-002  
Final – 19 June 2014

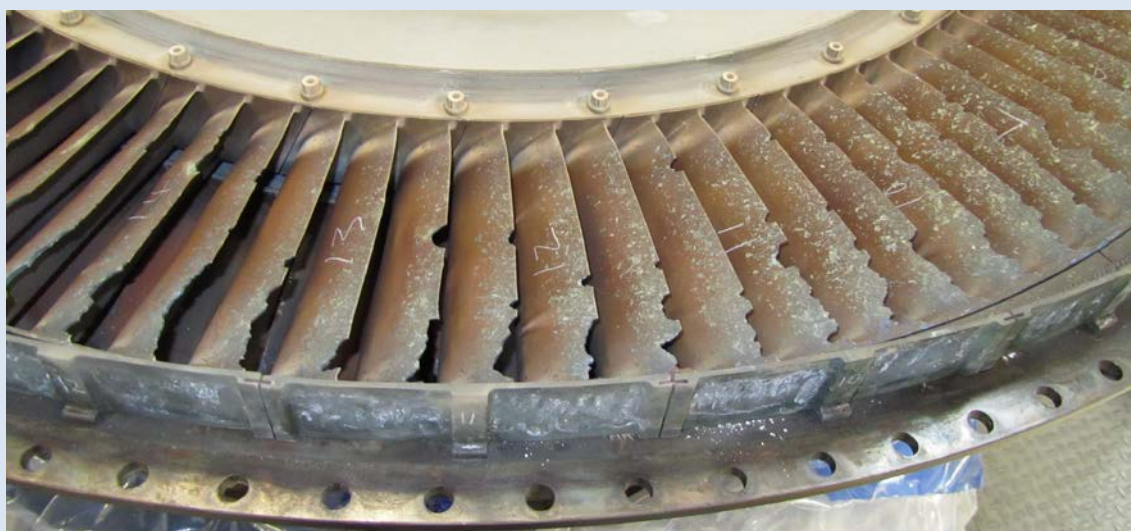
The increase in the exhaust gas temperature and vibration from the No. 4 engine was a direct result of the failure and separation of a single intermediate-pressure turbine blade. The turbine blade had fractured following the initiation and growth of a fatigue crack from an origin area near the blade inner root platform. Detailed modelling and analysis was undertaken by the engine manufacturer, Rolls-Royce, following the occurrence, and while the root cause for the intermediate pressure turbine blade failure was not fully identified at the time of this report, it was considered that the wear and loss of material from the turbine blade outer interlocking shrouds had reduced the rigidity and damping effects of the shroud and may have contributed to the high-cycle fatigue cracking and failure. The engine manufacturer has advised that they are continuing work to understand the underlying mechanism of the failure and will advise the ATSB if any further information is obtained.

Turbine blades from the damaged Rolls-Royce RB211-524G2-T

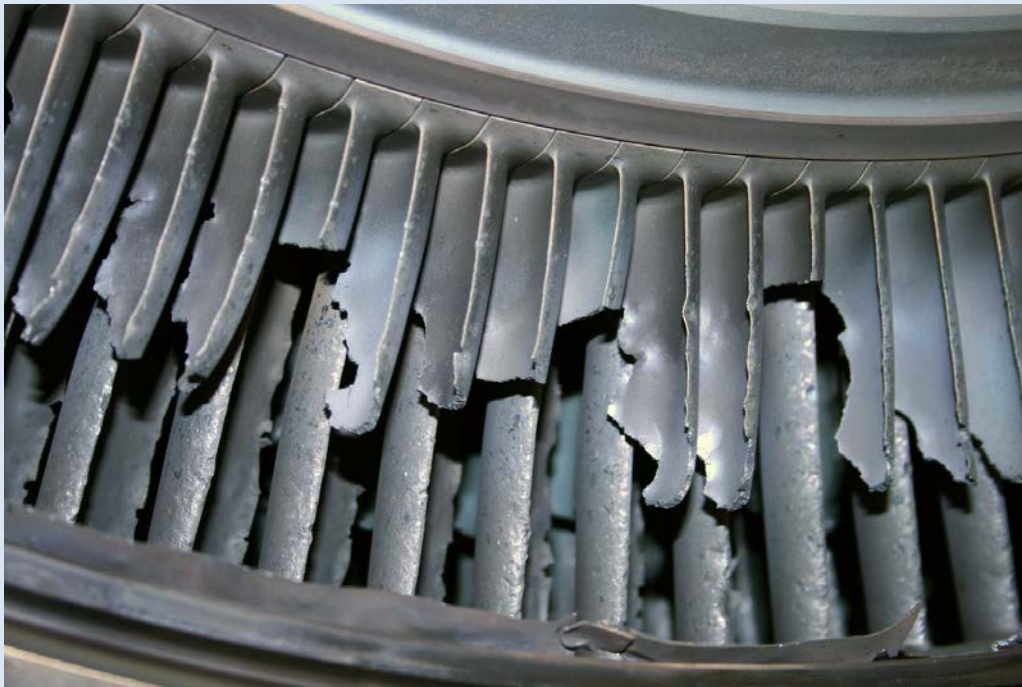
A preliminary inspection by the operator's engineering staff revealed significant damage to the low pressure turbine (LPT) assembly. The CFM56-3C-1 engine was subsequently returned to an overhaul facility for disassembly and inspection, overseen by ATSB investigators.

Creep rupture was identified as the likely failure mechanism in previous stage-1 LPT blade failures in this engine type investigated by the ATSB and the engine manufacturer. As a result of this occurrence, the engine manufacturer revised service bulletin SB 72-1113 to expand the range of blade manufacturing batch numbers that had previously been identified as being predisposed to creep-related failure. Blades in the identified batches were to be withdrawn from service as soon as they are next removed from the engine.

LPT stage 1 blades on the damaged CFM56

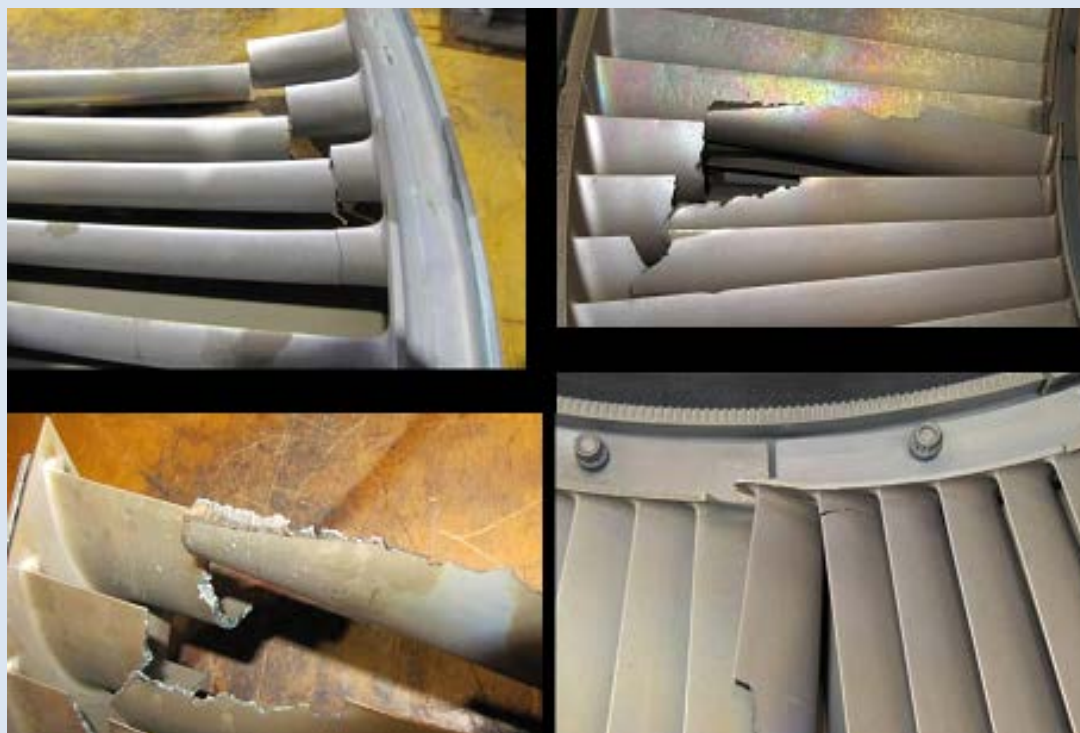
The aircraft operator carried out an initial examination of the aircraft and engine. The engine was found to have seized and metal pieces were found in the tail pipe. The engine was replaced and the aircraft returned to service. The engine manufacturer conducted an investigation into the failure of the LPT stage 3 nozzle segments. The investigation identified that the most probable reason for the failure was a transient mean stress of the segments during take-off, coupled with other operational stress and mechanical factors.

The damaged General Electric CF6-80C2 engine

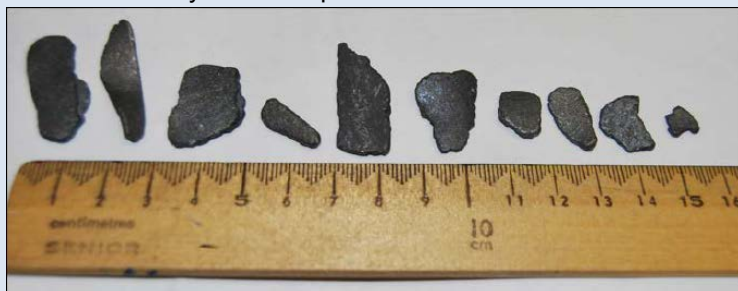
A witness to the event reported hearing a distant bang on the night of the occurrence, followed by impact noises on the tile roof of their property in NSW. Pieces of suspected engine debris were later collected by the NSW police service.

Pieces of engine debris recovered from Riverstone, NSW. Source: NSW Police

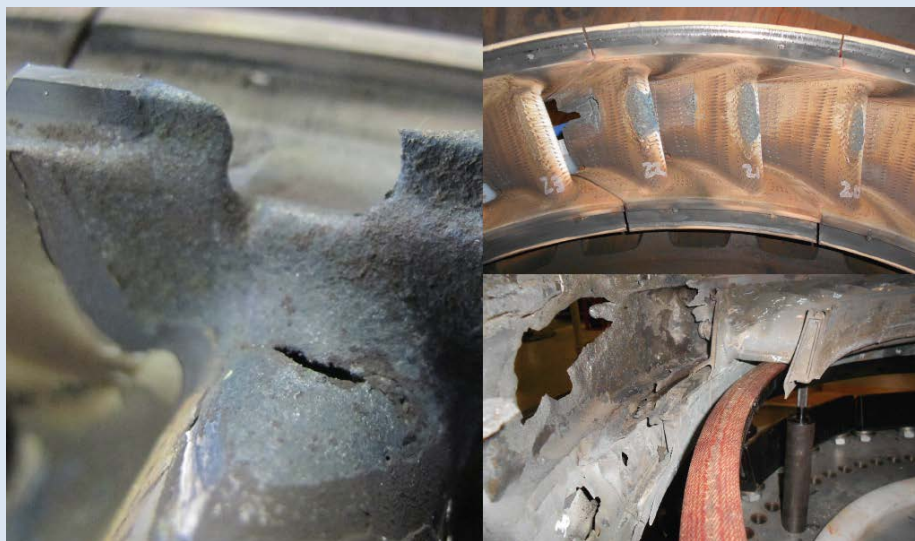
The investigation found that the increase in the exhaust gas temperature and subsequent engine shut down was a result of significant internal damage that had initiated within the high pressure turbine (HPT) module. The damage had resulted from the effects of HPT stage-2 nozzle distress, likely caused by exposure to hotter than expected operating temperatures. The nozzle distress led to eventual failure and separation into the gas flow path. Over the preceding weeks there were two other engines within the operator's fleet that had experienced a similar problem, and a number of steps had been taken by the manufacturer to address the issue, including the increased monitoring of distress development. During the previous flight, the engine health and trend monitoring program had identified a performance trend shift with this particular engine, and it was due to be inspected upon return to the main base in Dubai.

The damaged Engine Alliance<sup>15</sup> GP7200. Clockwise from left; HPT stage-2 nozzle distress, HPT stage-1 nozzles (forward looking aft), Hole in HPT case and missing stage-2 nozzles
