Runway excursion involving a Cessna 150M, VH-EAV

Tyabb (ALA), Victoria, 19 March 2014

ATSB Transport Safety Report
Aviation Occurrence Investigation
AO-2014-050
Final

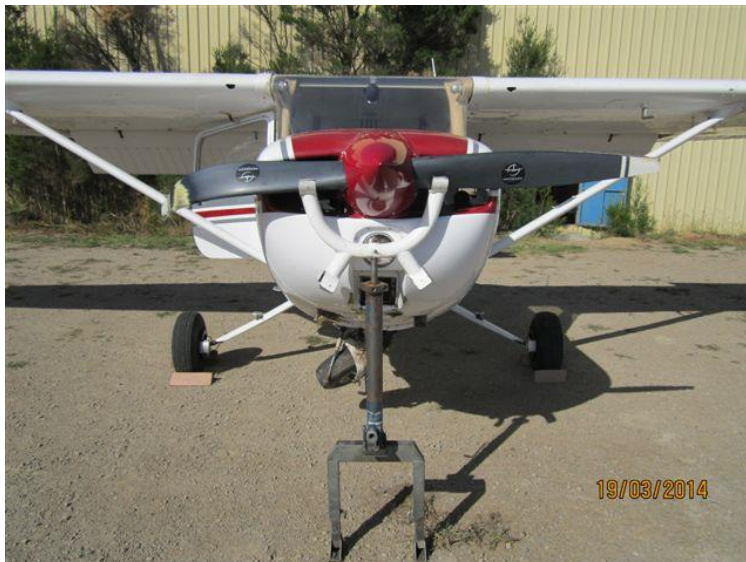
Figure 1: Damage to VH-EAV

The aircraft veered off the runway to the left, rolled down the slope to the eastern side, and collided with a tyre marking the location of a drain. The aircraft continued into the culvert and the nose landing gear subsequently collapsed. The propeller struck the ground, resulting in substantial damage (Figure 1) and the aircraft came to rest on the grass.
