# Contact with the wharf by *Big Glory*

Cape Flattery, Queensland | 20 November 2014

**ATSB Transport Safety Report**  
Marine Occurrence Investigation  
317-MO-2014-014  
Final – 5 March 2015

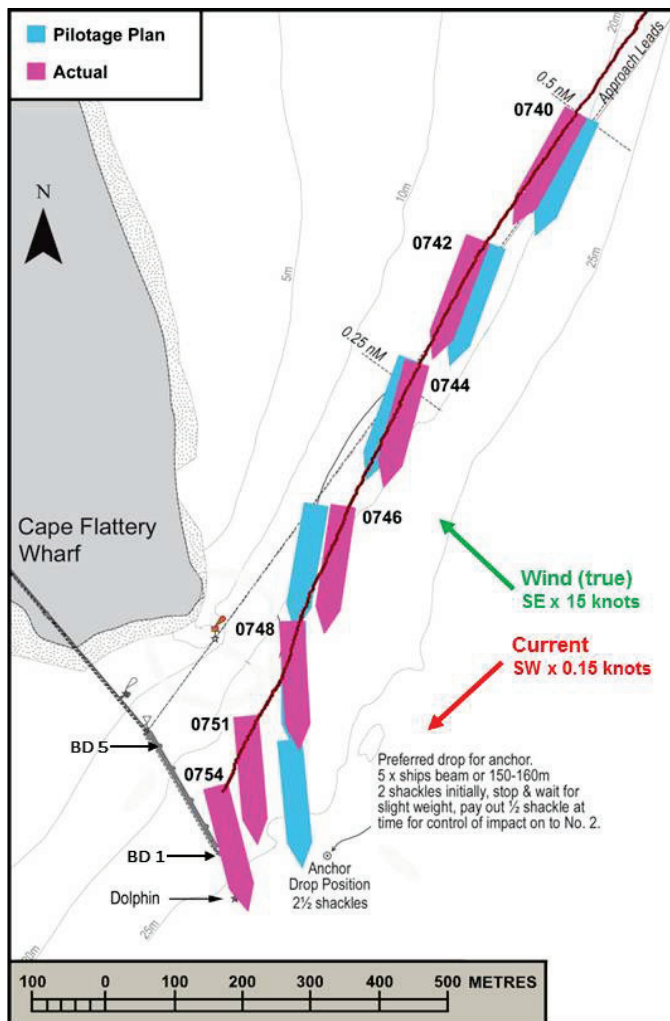
**Figure 2: *Big Glory*'s planned and actual positions**

At 0749, the main engine was stopped and the ship was no longer moving ahead. At about this time, the wharf supervisor reported to the pilot that the bow was in line with BD1 (Figure 2). The pilot asked the master to have the crew standby to let go the port anchor.

A few seconds after 0749, the main engine was run ahead in an attempt to gain headway and manoeuvre *Big Glory* to the planned anchor let go position some 150 m ahead. The engine was run ahead at up to half power until shortly before 0751, when it was stopped. The ship's bow was now about 60 m from the wharf and about 100 m away from the planned anchor let go position.

As *Big Glory* approached the planned anchor let go position, astern propulsion was used for 90 seconds because the pilot felt that the ship's speed was not decreasing. However, its speed was decreasing, and the ship stopped 150 m short of the anchor let go position. Ahead propulsion was then used for 90 seconds before the port anchor was let go in a position much closer to the wharf than planned (60 m instead of 150-160 m). The particular combination of the ships' main engine and rudder movements in the prevailing wind and current resulted in a lateral movement (to starboard) towards the wharf. The use of two shackles of anchor cable as planned suggests that adjusting anchor/cable use to recover from the uncontrolled situation was not considered. Subsequently, the ship's hull contacted the mooring dolphin with sufficient force to damage its shell plating and the dolphin. The pilot's perception of the ship's movement during the critical stages of the approach to the wharf is indicative of his situational awareness at the time.

- A review of the Cape Flattery pilotage plan to include an 'abort' position and a more accurate track to the 'anchor position'.
- Portable pilotage unit (PPU) usage to be made compulsory for all Cape Flattery berthings.
- A requirement for pilots returning from leave exceeding 4 months to complete at least three mentored trips (inward) before undergoing a check pilotage.

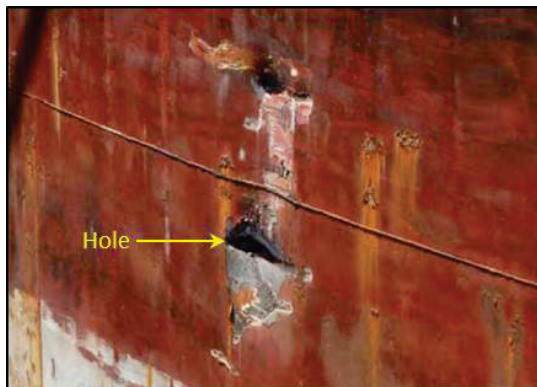
**Figure 3: Damage to the ship's hull**

At about 0754, *Big Glory* made contact with the dolphin (Figures 2 and 4). The ship's hull, at the aft end of number one cargo hold, was damaged about 1.5 m above the ballast water line. The shell plating was set-in in two locations about 1 m apart (Figure 3). Part of a steel bracket on the dolphin penetrated the plating leaving a hole about 180 mm x 60 mm. The bracket was partially torn off and the deck plating on the dolphin was dislodged (Figure 4).

On 25 November, temporary repairs to *Big Glory*'s hull to allow it to sail on the next voyage were completed. Subsequently, the ship loaded its cargo.
