Taxiing collision involving a Cessna 172S, VH-EOT and a Cessna 172S, VH-EOP

Moorabbin Airport, Victoria, 29 January 2015

ATSB Transport Safety Report
Aviation Occurrence Investigation
AO-2015-011
Final – 22 April 2015

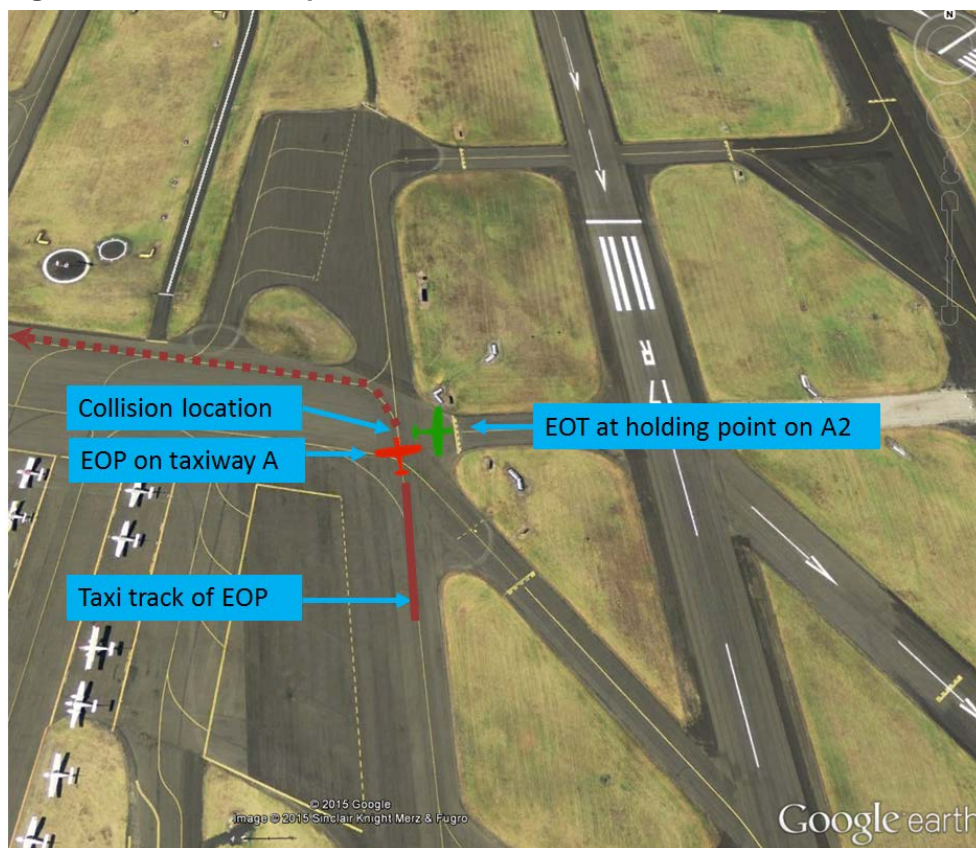
Figure 2: Moorabbin Airport, EOP taxi route and location of EOT

As EOP passed the 'A2' taxiway, the right wingtip struck the rudder of another Cessna 172S aircraft, registered VH-EOT, which was stationary at the holding point for runway 13 Right (13R) on the 'A2' taxiway, and less than half a metre behind the marked holding line (Figure 2). The student pilot of EOP was unaware of the collision and continued to taxi to the holding point for runway 13L. A flight instructor on board EOT advised ATC of the collision and the controller directed the pilot of EOP to taxi back to the run-up bay. He was then advised of the collision and the instructor of EOT inspected both aircraft for damage. EOP was undamaged and EOT sustained minor damage to the rudder.

The student pilot of EOP reported that he taxied on the yellow marked taxi line and assumed that this would provide adequate clearance from the stationary aircraft.

He subsequently had a taxi lesson focused on maintaining adequate clearance from other aircraft and obstacles, which he believed would be valuable training for all student pilots.
