Collision after landing involving a Fletcher FU-24, VH-KXT and a Gippsland GA-200, VH-AGZ

13 km SW of Cootamundra, New South Wales, on 27 February 2015

ATSB Transport Safety Report
Aviation Occurrence Investigation
AO-2015-023
Final – 22 April 2015

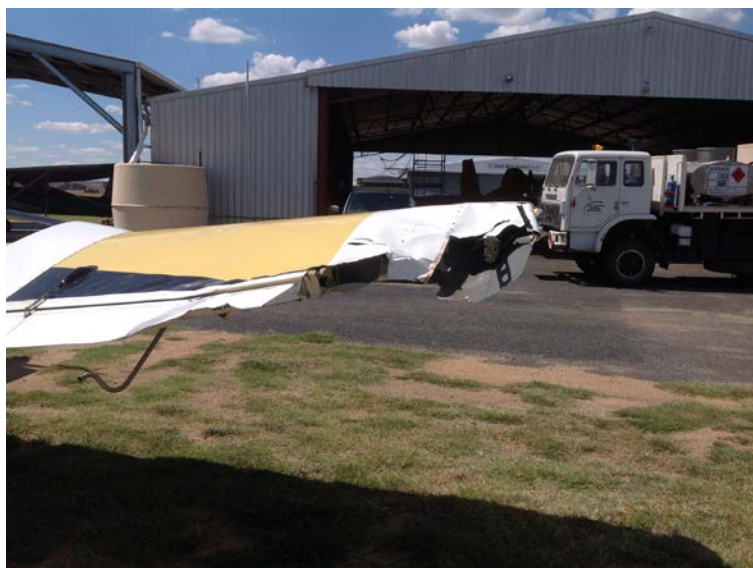
Figure 2: Damage to VH-AGZ

As KXT landed, the pilot observed the loader truck near the fence, which was not the normal loading position. He was momentarily distracted, as he became concerned that the truck had broken down. The loader driver had observed both aircraft approaching on different runways and had moved to a position from which he could load whichever aircraft arrived first. AGZ was in the landing roll on runway 24, and about 50 m from the loader truck when the pilot sighted KXT about 10 m from his right wing. KXT was then in the landing roll on runway 19 and the pilot of KXT returned his gaze from the loader to the front of the aircraft, just as the propeller collided with the right wingtip and then the tail of AGZ (Figure 2).

Both aircraft sustained substantial damage and the pilots were not injured.

The pilot of KXT commented that this incident highlights the importance of a thorough briefing between pilots prior to commencing operations. He also suggested that fitting aircraft with strobes or other light reflectors may improve the ability of pilots of other aircraft to sight them.
