# Collision with terrain involving a Liberty XL-2, VH-CZT

Moorabbin Airport, Victoria on 27 February 2015

**ATSB Transport Safety Report**  
Aviation Occurrence Investigation  
AO-2015-024  
Final – 22 April 2015

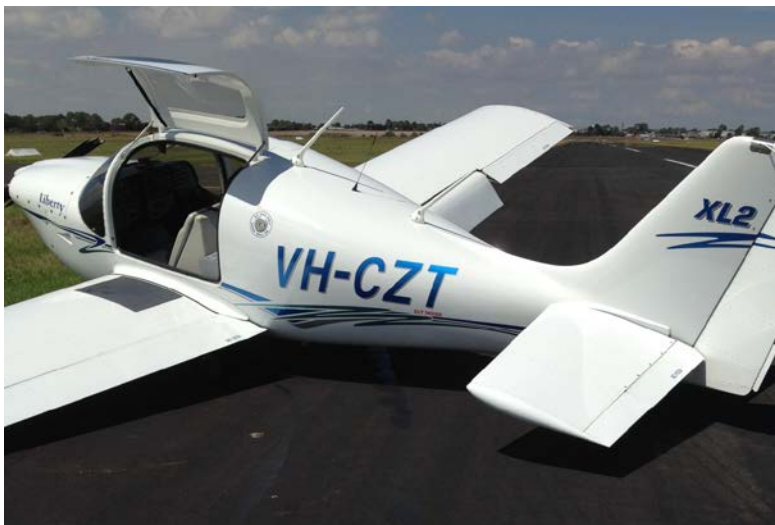
**Figure 1: Damage to VH-CZT**

During the accident sequence, the main landing gear collapsed and the propeller and left wingtip struck the runway, resulting in substantial damage (Figure 1). The pilot was not injured.

**Damage to VH-CZT**
