Aviation Short Investigations Bulletin

Issue 31

ATSB Transport Safety Report
Aviation Short Investigations
AB-2014-085
Final – 17 June 2014

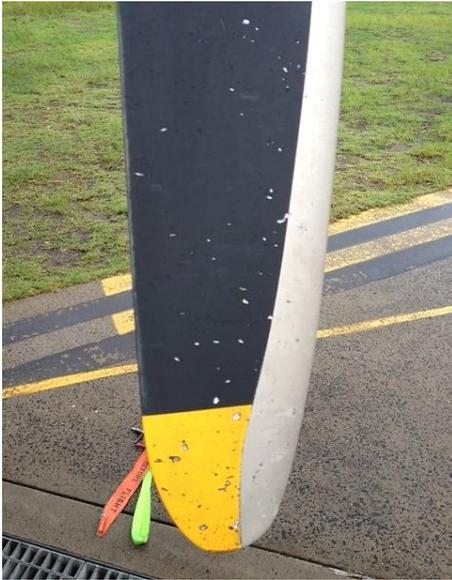
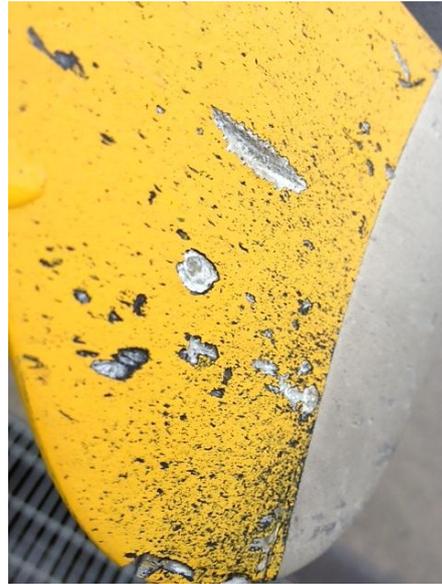
Figure 1: Propeller blade damage

The next day the flight to Grafton was conducted, with the required external inspections of the aircraft conducted by the FO. The aircraft then returned to Sydney, at which time maintenance personnel conducted an inspection of the aircraft and observed damage to the left propeller blades. All four blades had sustained stone damage predominantly on the back (reverse) of the blades (Figure 1). Individual blade damage repairs may have been carried out with the blades remaining in place; however, the four blades were all replaced in order to allow effective repair processes to be completed.

- He had conducted a thorough visual inspection of the left landing gear and top surface of the left propeller blades. When conducting his inspection, he stood facing the propellers and turned the blades in an anti-clockwise direction. This was suitable for sighting the front surface of the blades, but not the reverse side. He had also conducted a tactile inspection of the leading edge of the blades. He had got out of the habit of inspecting the surface of the reverse side of the blades and consequently did not see the damage.

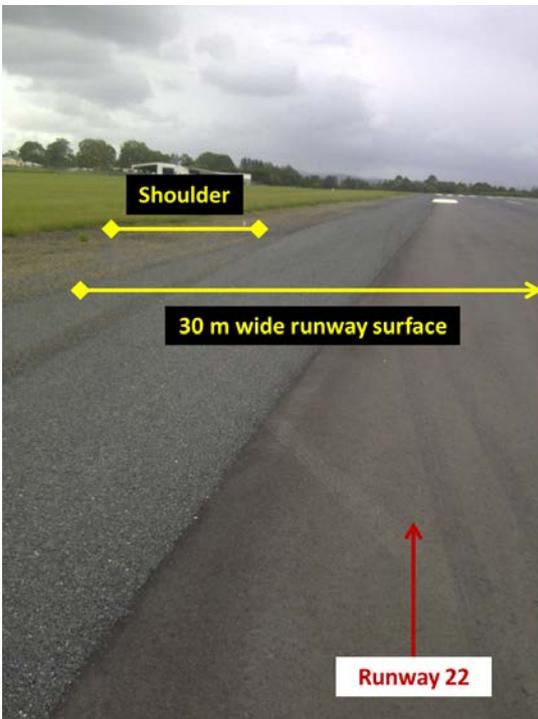
Figure 2: Runway surface

Runway 04/22 at Taree consisted of a 30 m wide runway with a 3-4m wide soil and gravel shoulder either side (Figure 2). A subsequent runway inspection during daylight hours determined that the aircraft had veered onto the runway shoulder (Figure 3).

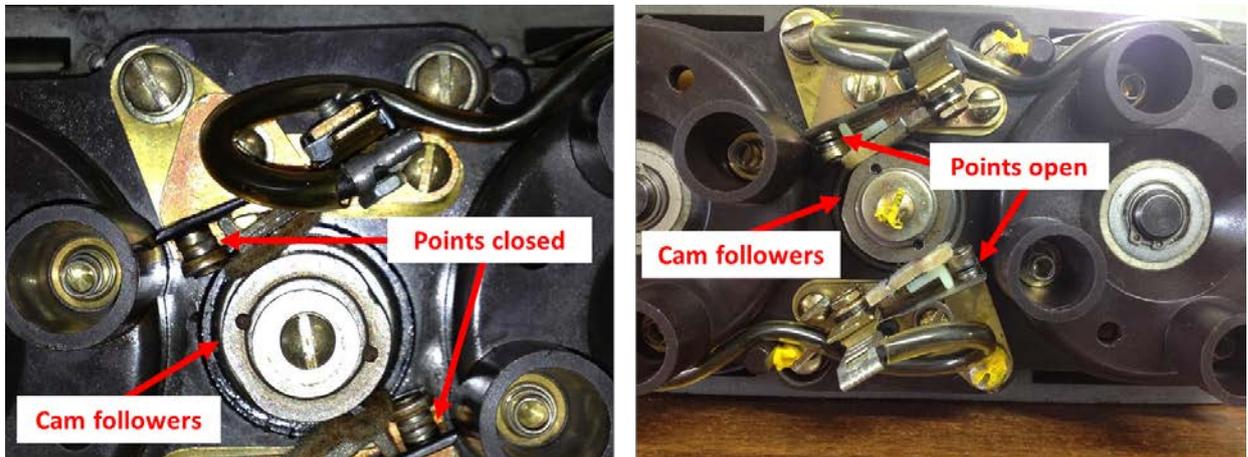
An examination was conducted of the aircraft engine and the magneto cam followers were found damaged, resulting in the left and right magneto breaker points being failed closed (Figure 1). The operator found that the magneto cap was not grounded and suspected faulty magneto capacitors, resulting in the aircraft engine power loss and subsequent failure. The operator reported that the magneto was installed on the new engine by the manufacturer and at the time of the incident the engine had operated for 283 hours.

Figure 1: YTT magneto with points failed closed New magneto showing the points open

- The program of maintenance for the TB10 aircraft will include a visual inspection of the magneto ‘cam followers’ at more regular intervals.
- The TOSB “Take-off Safety Brief” should not only consider an engine failure, but also possible actions if a partial power loss is experienced.
- Two other TB10 aircraft with new engines had similar components; these aircraft were subsequently removed from service and the magnetos were replaced. There was no evidence to suggest that the components removed from either of these aircraft had a similar defect or problem.

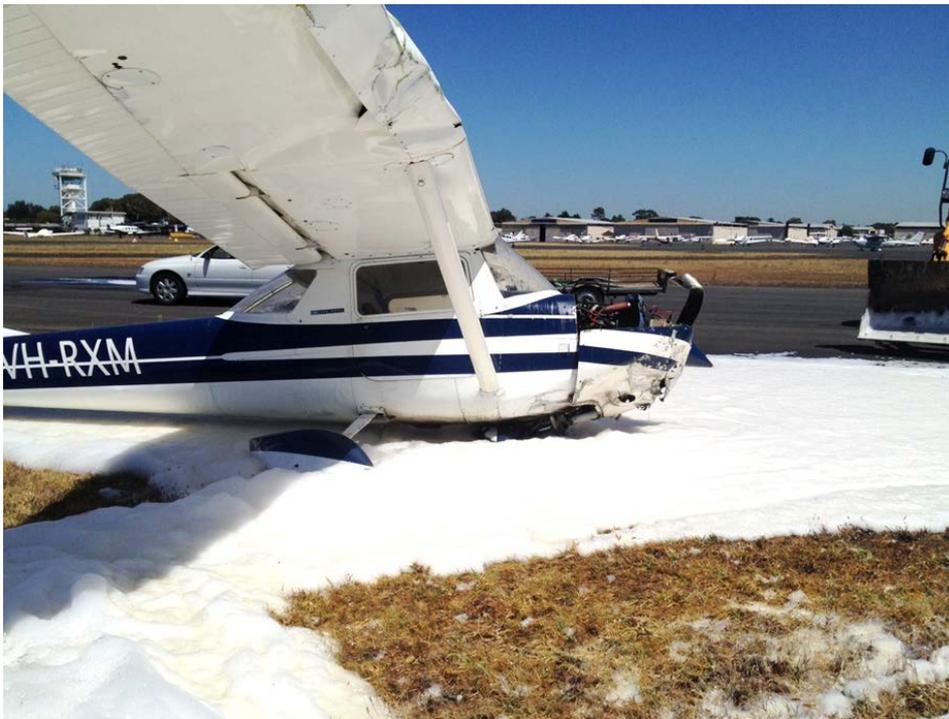
Soon after, emergency services arrived. The pilot and passenger sustained minor injuries, and the aircraft was substantially damaged.

Figure 1: VH-RXM side view of damage

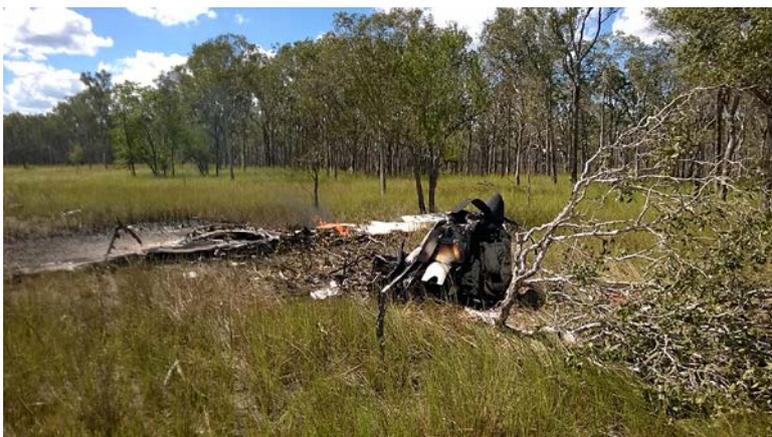
The pilot and passenger were rescued about 3 hours later by a helicopter crew. Both sustained serious injuries and the aircraft was destroyed (Figure 1). Due to memory loss incurred as a result of the accident, the pilot had limited recollection of the events.

Figure 1: Accident site and aircraft wreckage

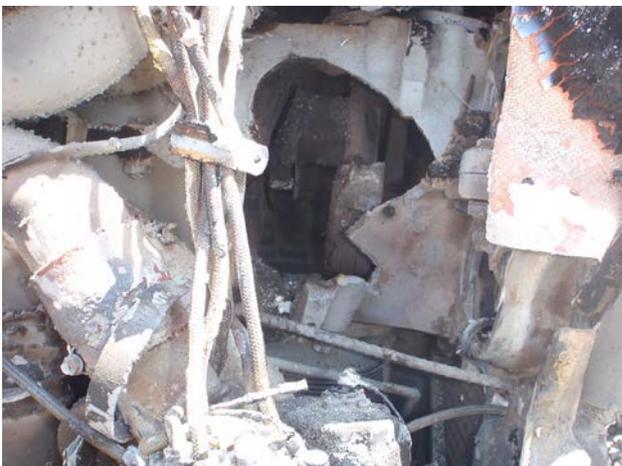
From the photographs provided by the operator (Figure 2), the ATSB assessed that a connecting rod appeared to have broken and separated from the crankshaft, resulting in a hole in the crankcase. This precipitated a catastrophic engine failure. The smoke entering the cockpit was likely to have been from burning oil.

Figure 2: Engine damage to VH-HGZ

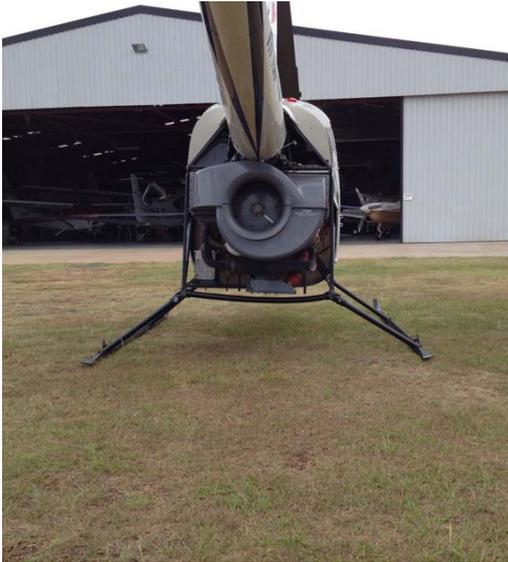
Figure 1: Damage to VH-YZO
