VFR into IMC involving a Piper PA-28R, VH-TBB

100 km S of Warwick, Queensland, 21 February 2014

ATSB Transport Safety Report
Aviation Occurrence Investigation
AO-2014-029
Final – 14 July 2014

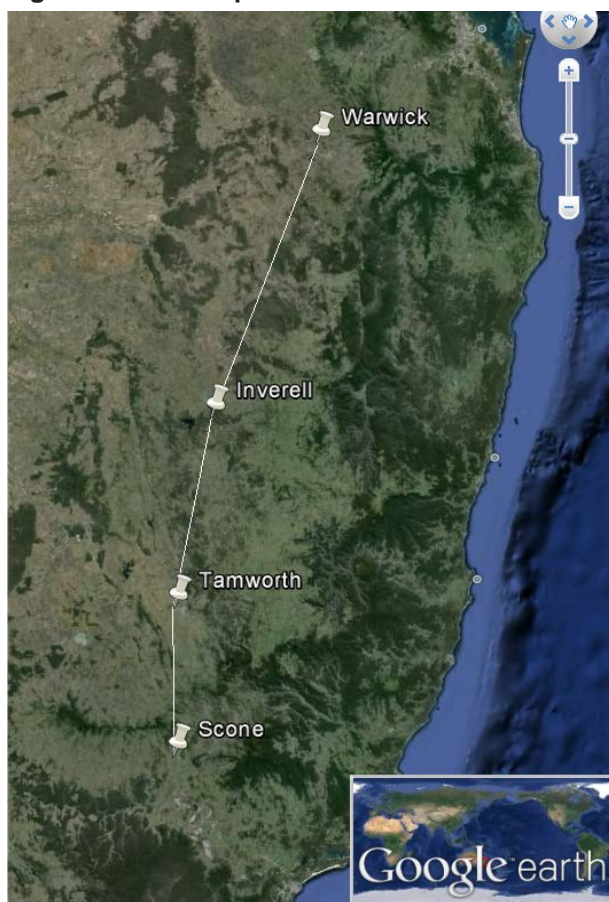
Figure 1: VH-TBB planned route

On 21 February 2014, the pilot of a Piper PA-28R aircraft, registered VH-TBB, departed Scone, New South Wales on a private flight to Warwick, Queensland. The flight was planned under the visual flight rules (VFR). The planned route took the aircraft overhead Tamworth and Inverell, then on to Warwick (Figure 1). The pilot was familiar with the route, having flown it many times before.
