Near collision involving a Piper PA-31, VH-XGW, and a Piper PA-28, VH-IBX

13 km W of Bankstown Airport, New South Wales, 1 April 2014

ATSB Transport Safety Report
Aviation Occurrence Investigation
AO-2014-067
Final – 14 July 2014

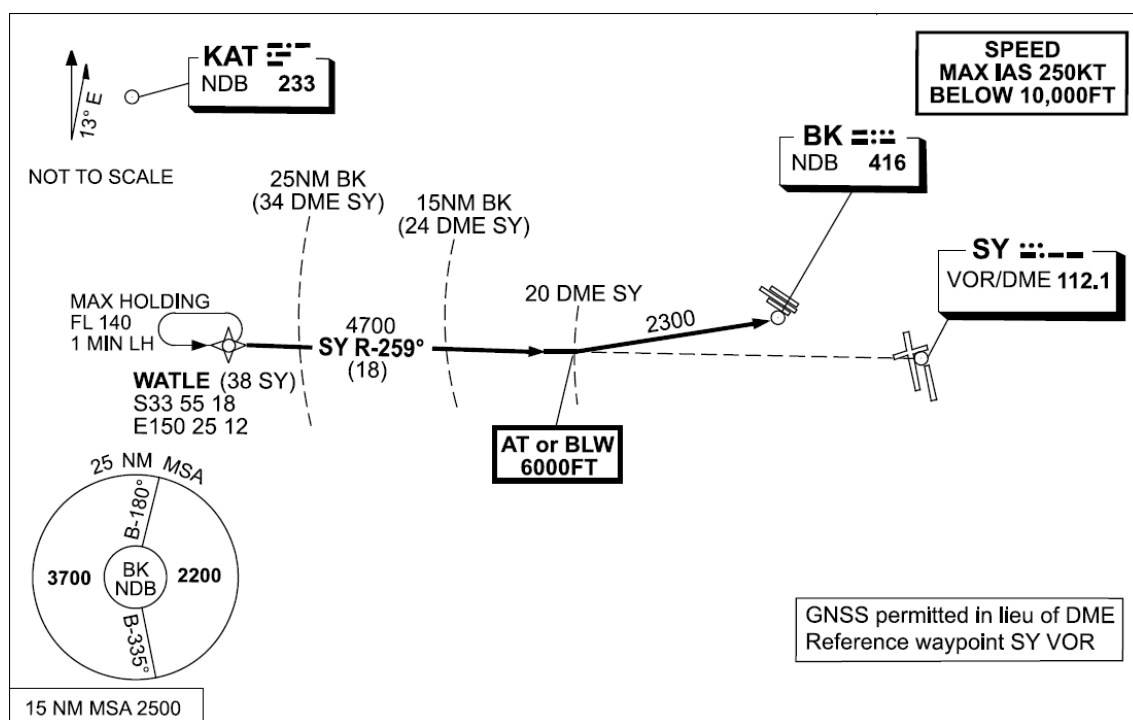
The pilot conducted a WATLE Five Arrival (Figure 1) to Bankstown, tracking on the Sydney 259 radial¹ until 20 NM from Sydney, and then turning to track direct to Bankstown.

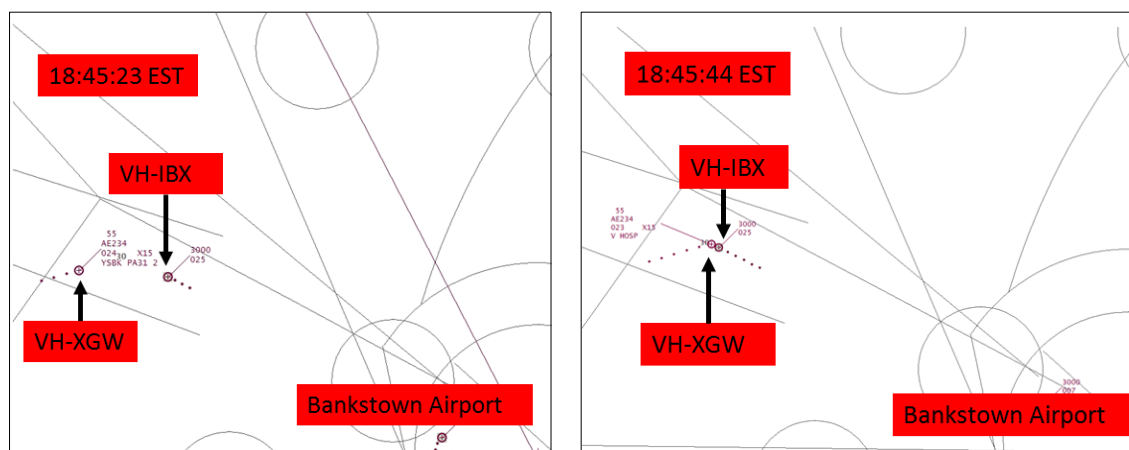
Figure 2: Radar plots of IBX and XGW

The controller then advised the pilot of XGW that departing traffic was a Cherokee in his '1 o'clock,² becoming 12 o'clock' about 2 NM away, and at 2,300 ft AMSL (Figure 2). The pilot of XGW replied that he had the traffic sighted.

The instructor of IBX then observed the landing light of XGW come on, immediately took control of IBX from the pilot-under-instruction, and conducted a climbing turn to the left. He sighted XGW pass about 200 ft below IBX. Radar data provided to the ATSB by Airservices Australia showed that the aircraft came within 200 ft vertically of each other and that IBX passed over XGW.
