Loss of control and collision with terrain involving Cessna 182 VH-AUT

Hamilton Airport, Victoria | 23 September 2013

ATSB Transport Safety Report
Aviation Occurrence Investigation
AO-2013-163
Final – 7 May 2015

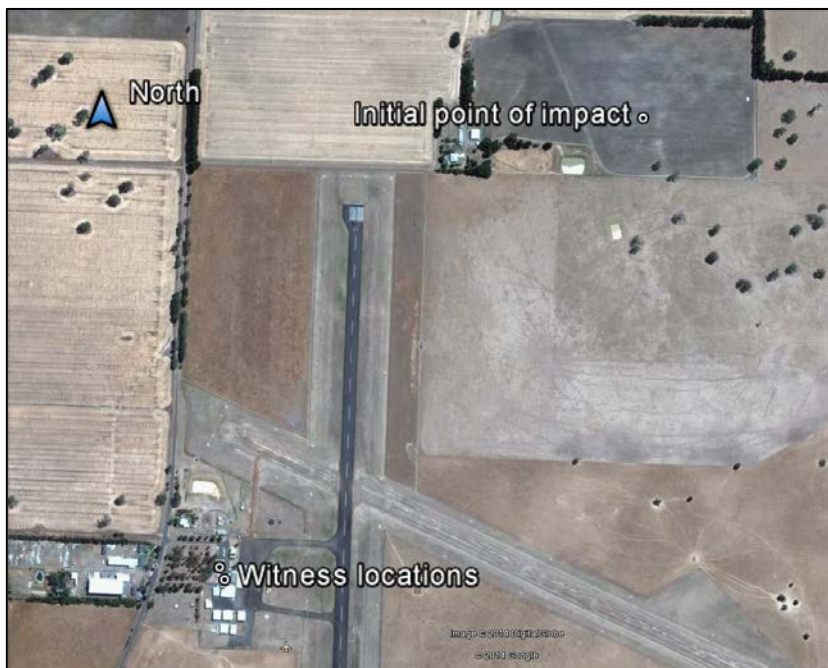
Figure 1: Image of runway 35 showing the location of the accident site and witnesses

At 1946, two other witnesses who were walking to the school from a nearby hangar observed an aircraft turning right with a descent angle of about 30°, followed by a collision with terrain (Figure 1). The pilot was not heard to make any distress call on the aircraft's radio.

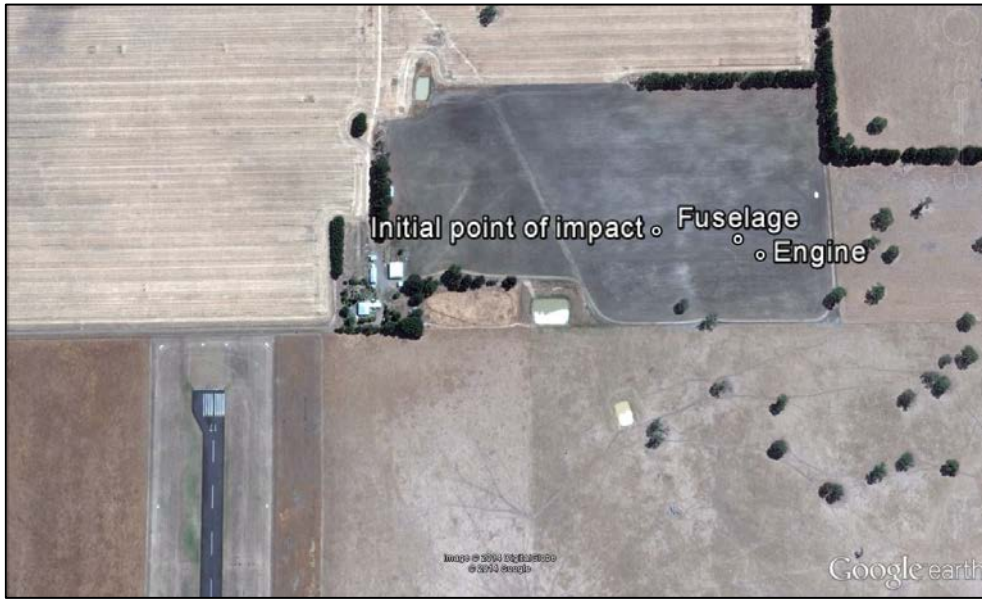
Figure 3: Accident site

The wreckage trail was oriented on a bearing of 086°, consistent with a right turn through 96° from the runway heading of 350° following the go-around (Figure 3). The first impact was 650 m from the upwind end of runway 35 on a bearing of 061°. Based on ground scar measurements, at impact the aircraft was descending and banked to the right, with a slightly nose-down attitude and at a minimum speed of 100 kt (185 km/h).

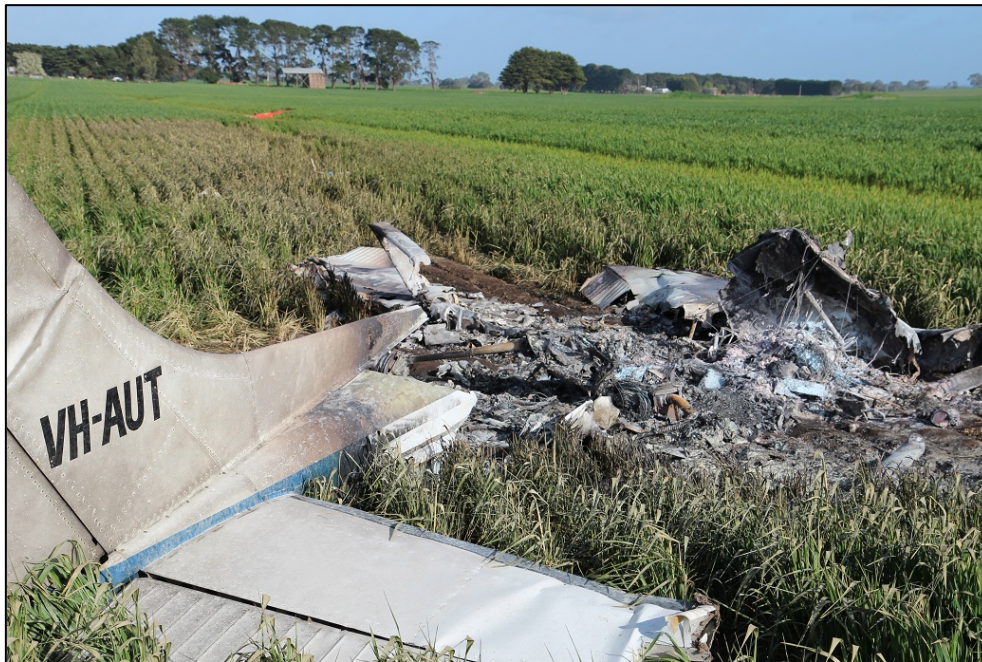
Figure 4: Aircraft wreckage

The aircraft came to rest 115 m after the first ground impact. The engine separated from the fuselage after impact and travelled 150 m on a bearing of 094°. The aircraft was severely damaged by a post-impact fire (Figure 4). No evidence was found of any pre-impact faults that could have influenced the accident, nor was there any indication of an in-flight break-up. Damage to the surrounding vegetation indicated that aviation fuel was liberated from the wreckage about 70 m after the first point of impact. All the major components of the aircraft were identified, except the nose wheel.

The engine separated from the fuselage during the impact sequence and was unaffected by fire. On-site examination of the engine did not identify any faults that would have prevented normal operation. Propeller damage was consistent with the engine producing significant power at impact.

The wing flap actuator was found to have been at the fully-extended position at impact. During normal circuit operations, the flaps would generally be fully retracted on the upwind leg of the circuit. The wing flap control system was unable to be examined due to damage sustained during the post-impact break-up and fire. The elevator trim tabs were found in a neutral position; however, due to the extensive disruption of the aircraft and its systems, the position of the trim at impact could not be determined.
