# Derailment of train ST24

near North Melbourne, Victoria | 11 July 2014

**ATSB Transport Safety Report**  
Rail Occurrence Investigation  
RO-2014-013  
Final – 14 May 2015

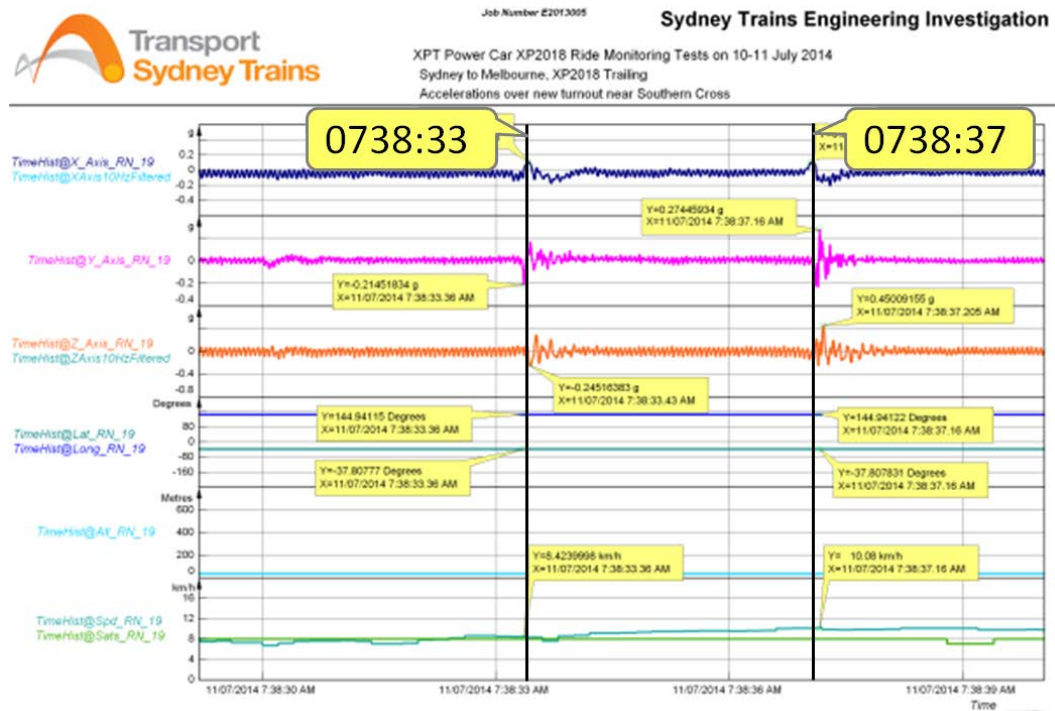
Figure 2: Accelerometer readings from XPT Power Car XP2018 at turnout MYD882

As the train traversed the turnout at a speed of 8 km/h, it bounced heavily (Figure 2).<sup>2</sup> The pilot described it as 'a short sharp dip in the track, similar to a short deep bog hole (mud hole)' and explained that if the train hadn't kept rolling, he would have thought they had derailed. The pilot immediately rang Southern Cross number 1 signal box and reported the occurrence. Number 1 signal box advised that they would arrange for a track inspection. The train continued into Southern Cross, where it was fuelled and joined by passengers and new crew, in readiness for the return journey to Sydney as train ST24. While the report had prompted the scheduling of a track inspection, an examination of turnout MYD882 and the rolling stock had not occurred at the time train ST24 departed Southern Cross station.

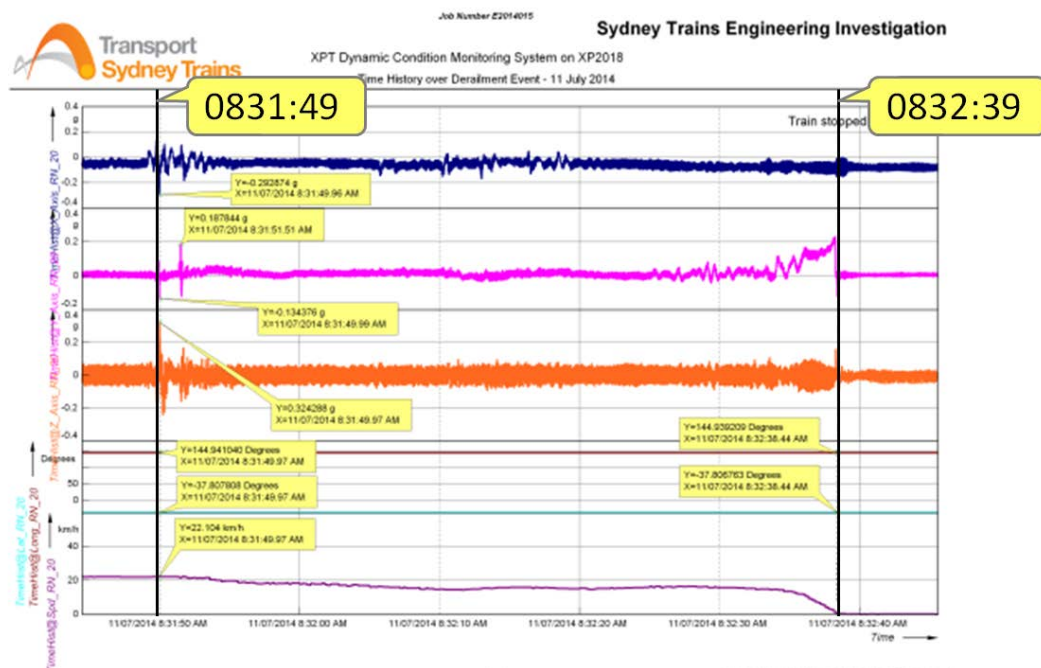
Figure 3: Accelerometer readings from XPT Power Car XP2018 at turnout MYD887

Shortly after 0831, as the train traversed the turnout at a speed of 22 km/h, the driver and pilot felt several large jolts (Figure 3), followed by a series of fault indications on the driver's display screen as the train came to a standstill.

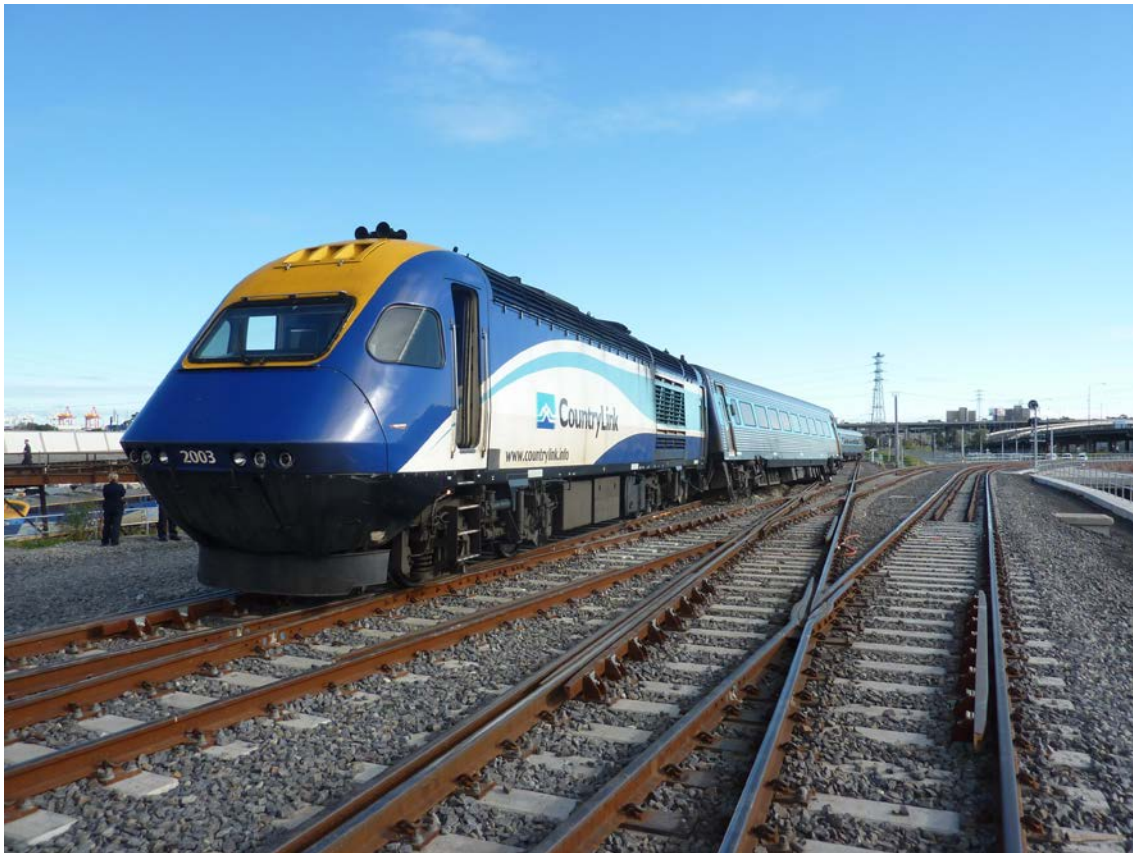
**Figure 4: Train ST24 trailing power car XP2003 and derailed carriage XAM2176**

The pilot rang the train controller and advised that train ST24 had come to a stand on the flyover and had probably derailed. When the site was secured, the driver walked back along the length of the train to determine/report the extent of the derailment and damage (Figure 4). He reported that there was minimal damage to track but passenger carriages XL2229 and XAM2176 had derailed all wheels.

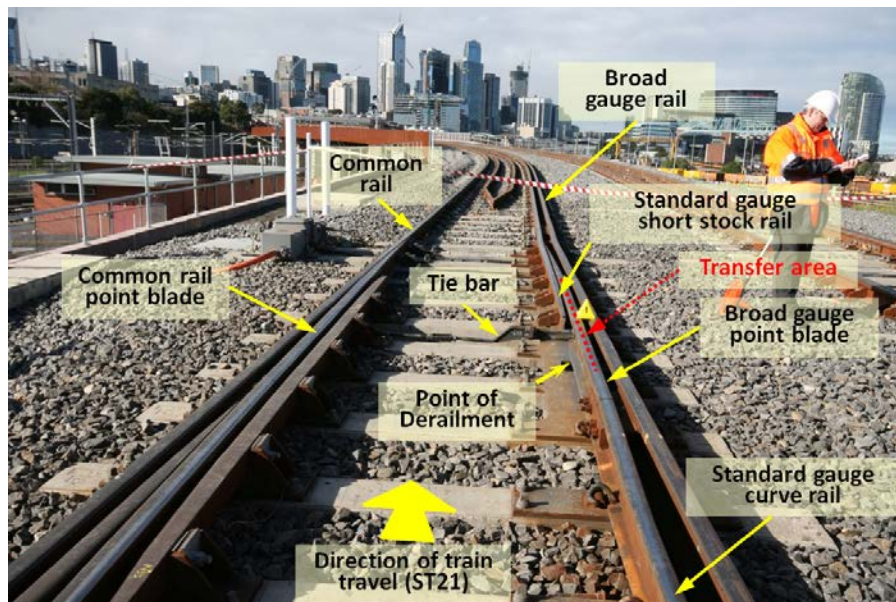
**Figure 7: Turnout MYD882 located on the up flyover track**

For a standard gauge train, such as ST21, the right wheels travel along the standard gauge curve rail (Figure 7) then transition onto the broad gauge point blade through the transfer area, before finally repositioning on the standard gauge short stock rail. By design, the gauge through the transfer area is wide, to allow broad gauge wheelsets to pass for trains coming from Kensington/Footscray and broad/standard gauge wheelsets to pass for trains coming from Sydney/South Dynon. For a standard gauge train (from Sydney/South Dynon), this results in reduced rim contact on the broad gauge point blade through the transfer area.

Inspection of turnout MYD882 established that several wheels from a train had derailed within the transfer area, dropping off the broad gauge point blade<sup>9</sup> into the four foot<sup>10</sup>, before striking the tie bar, then re-railing on the standard gauge short stock rail.

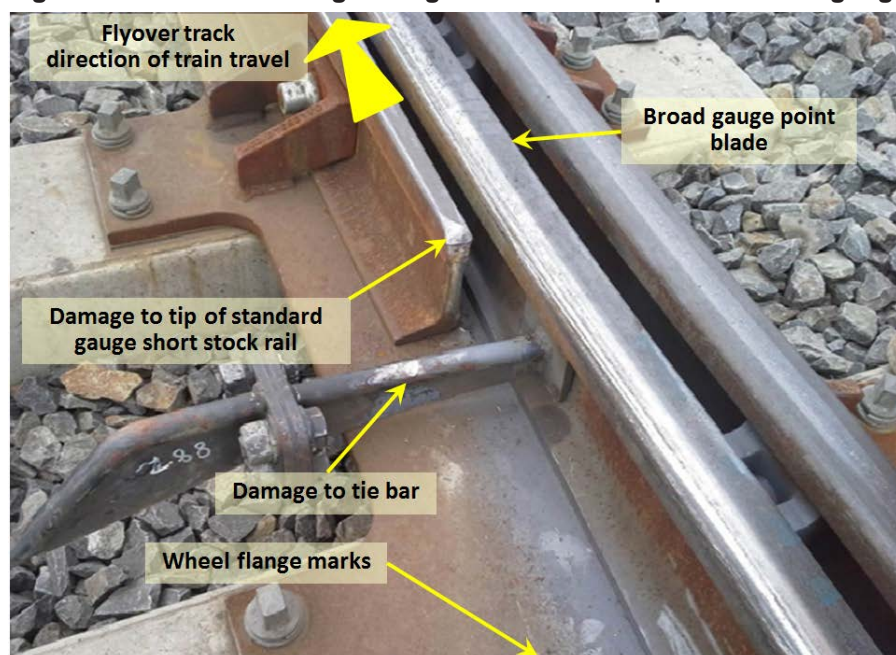
**Figure 8: MYD882 showing damage to tie bar and tip of standard gauge short stock rail**

Damage to turnout MYD882 (Figure 8) primarily comprised bruising to the tie bar and tip of the standard gauge short stock rail. This damage probably occurred when the earlier inward bound service (ST21) traversed the turnout. This was about the time the driver reported rough riding (heavy bounce) through the turnout, and is consistent with XPT accelerometer data (Figure 2) which shows evidence of significant events at 0738:33 and 0738:37.

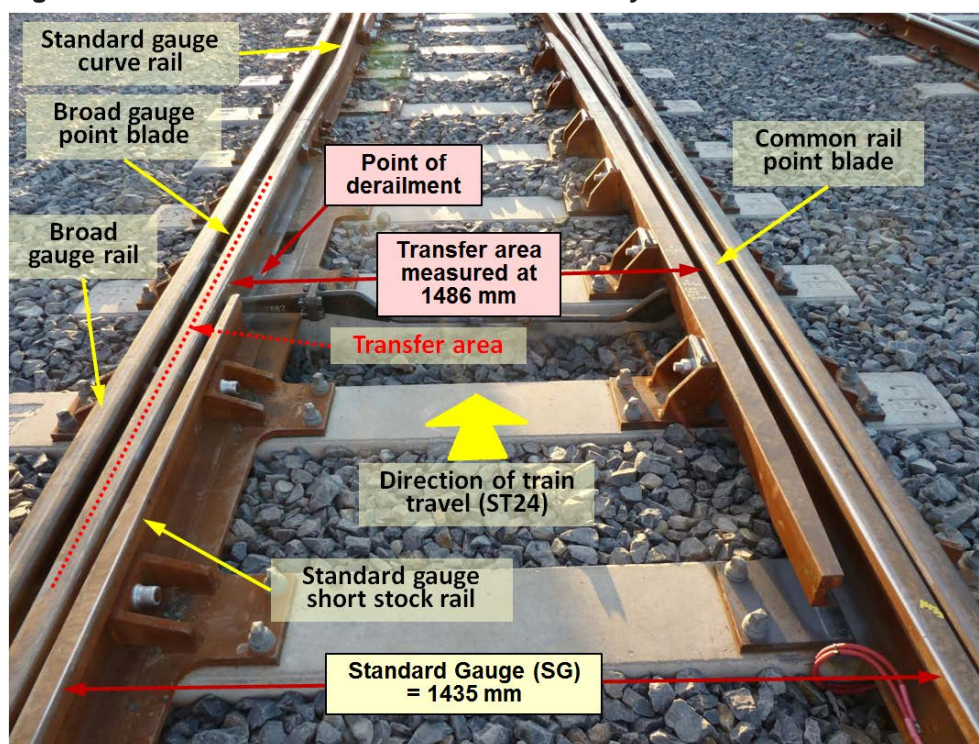
**Figure 9: Turnout MYD887 located on the down flyover track**

For a standard gauge train, such as ST24, the left wheels transfer from the standard gauge short stock rail onto the broad gauge point blade before continuing on the standard gauge curve rail. Like MYD882, the gauge through the transfer area is wide by design, allowing broad gauge wheelsets to pass for trains going to Kensington/Footscray and broad/standard gauge wheelsets to pass for trains going to Sydney/South Dynon. For a standard gauge train (to Sydney/South Dynon), this results in reduced rim contact on the rail head through the transfer area.

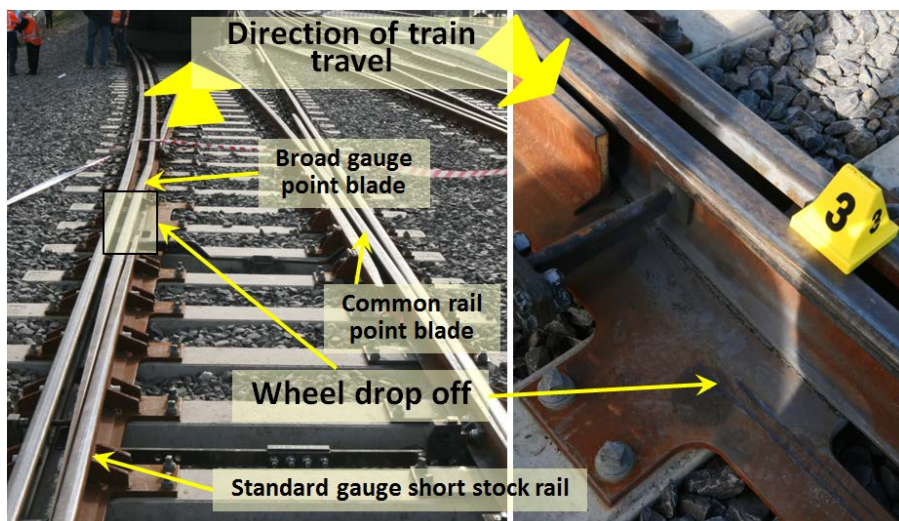
**Figure 10: Turnout MYD887 point of wheel drop and flange marks on turnout base plate**

Examination of turnout MYD887 established that, as the left wheel(s) of a carriage(s) from ST24 transitioned from the standard gauge short stock rail onto the broad gauge point blade<sup>11</sup>, a wheel, or wheels, dropped into the four foot. This is evident at Figure 10 (right side image), which shows bruising on the gauge face corner of the broad gauge point blade, and flange marks on the base plate at the bottom of the turnout.

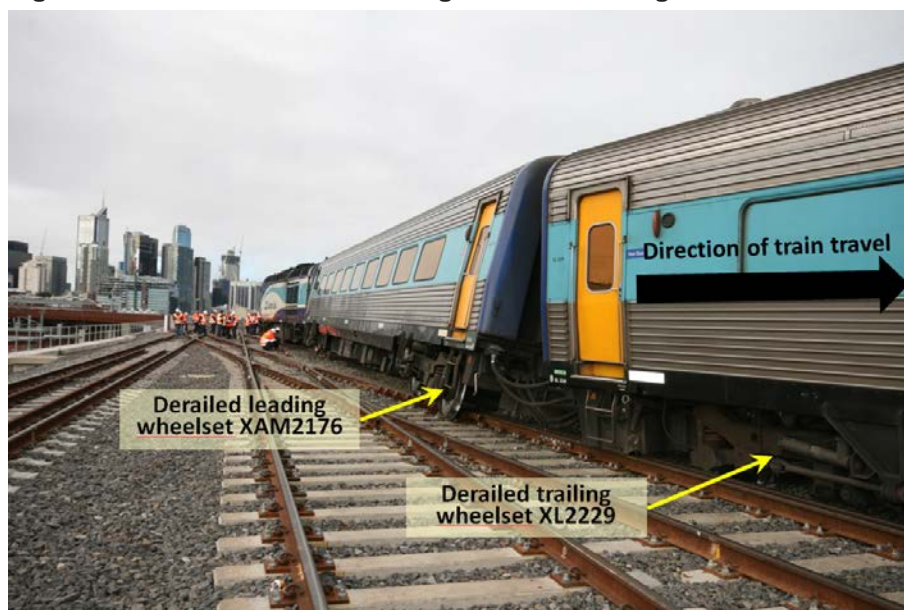
**Figure 11: Photo – Derailed leading wheelset carriage XAM2176**

The inspection also established that all wheelsets under the passenger carriages XL2229 and XAM2176 (Figure 11) had derailed. Bruising and damage to turnout MYD887 revealed that the derailment was initiated by one (or more) left wheels derailing to the right.

It was noted that the lead bogie of carriage XL2229 had derailed to the left. It was concluded that the lead bogie of carriage XL2229 derailing to the left was as a consequence of XL2229 (trailing bogie) and/or XAM2176 (lead bogie) derailing to the right, possibly accentuated by power car XP2003 operating in push mode.<sup>12,13</sup>

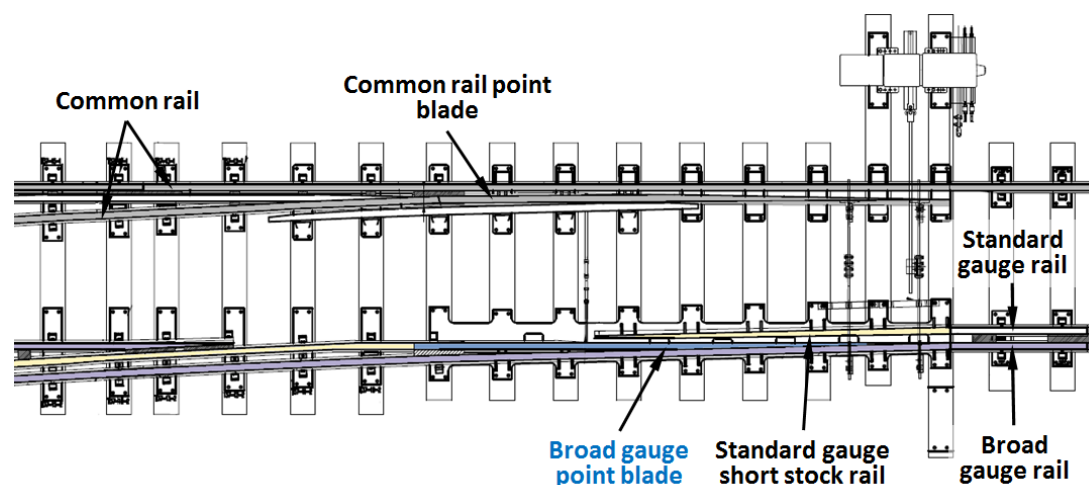
**Figure 15: General schematic – VCA type 37 turnout**

Post derailment measurements taken at turnout MYD887 established the widest point through the transfer area was 1,486 mm. This was 6 mm greater than the VCA design width of 1,480 mm but was probably gauge widening as a consequence of wheel(s) falling into the four foot.

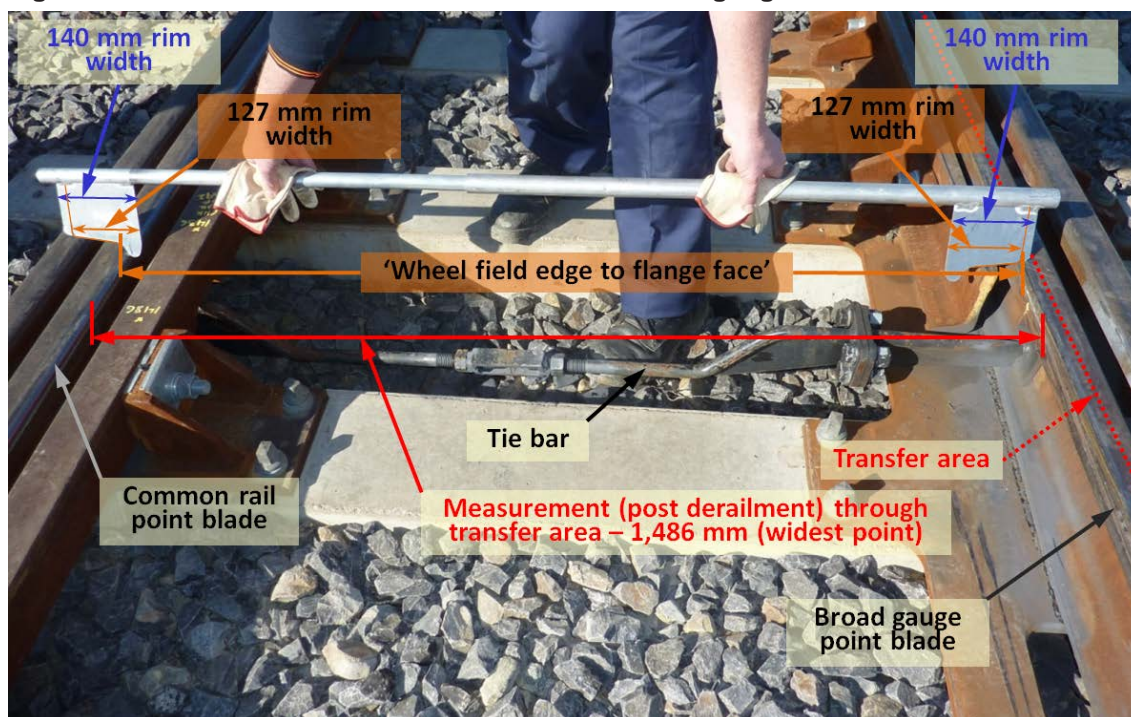
Figure 16: Turnout MYD887 transfer area with wheelset gauge overlaid

Overlaying a wheelset gauge on the turnout (Figure 16) through the transfer area clearly showed that a 127 mm wheel rim had marginal rim contact on the broad gauge point blade compared to a 140 mm rim. Post derailment computer modelling by VCA confirmed these observations.

As a result, when a 127 mm wheelset traversed the transfer area it imposed high forces on the left edge of the broad gauge point blade. Where the blade is insufficiently restrained, these forces would cause it to roll over and flex outwards (towards the broad gauge rail), increasing the likelihood of wheels dropping between the tracks. An examination of turnouts MYD882 and MYD887 established both trains had derailed as a result of wheelsets dropping in the four foot while traversing the transfer area. Subsequently, the investigation also established that the standard gauge test trains used during the commissioning of MYD882 and MYD887 had wheel rim widths of 140 mm and had traversed the turnouts without incident. XPT train ST21, returning to Sydney as ST24, had 127 mm rim widths which were not included as part of the commissioning process.

- The tie bar shown at Figure 16 helps maintain gauge through the transfer area by preventing the broad gauge point blade flexing outwards (towards the broad gauge rail) during the passage of a train. The tie bar for turnouts MYD882 and MYD887 had been modified from an original ARTC design which used a straight rod, to a rod with a set. This was to remove an identified tripping hazard. While theoretical analysis indicated that the modified tie bar would be fit for purpose, post derailment physical testing and finite element analysis (FEA)<sup>18</sup> identified that the modified tie bar could elastically elongate by as much as 10 mm under typical operating loads and hence allow the broad gauge point blade to roll and flex outward.

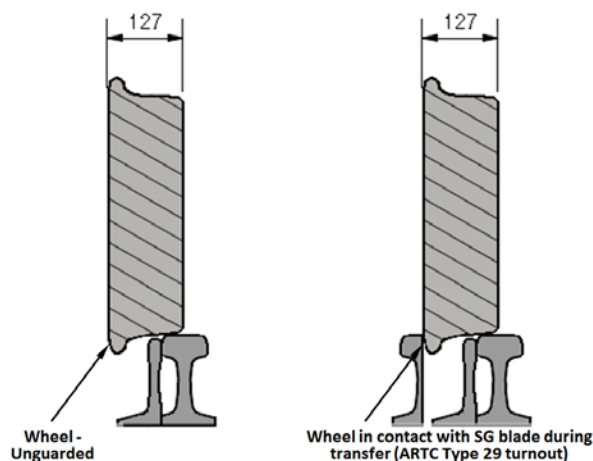
**Figure 17: Comparison of VCA type 37 and ARTC Type 29 wheel transfer zones**

safely negotiate a turnout, the removal of the standard gauge point blade, without providing guard rail protection, meant that the left wheel of a vehicle (carriage) could work off the broad gauge point blade and fall into the four foot. As such, it was evident that the removal of the standard gauge point blade without incorporating fixed guard rail protection (type 37), was probably a design oversight that increased the likelihood of the derailment of trains operating with 127 mm wheelsets.
