Unintentional release of the freefall lifeboat from *Aquarosa*

Indian Ocean | 1 March 2014

ATSB Transport Safety Report
Marine Occurrence Investigation
307-MO-2014-002
Final – 20 May 2015

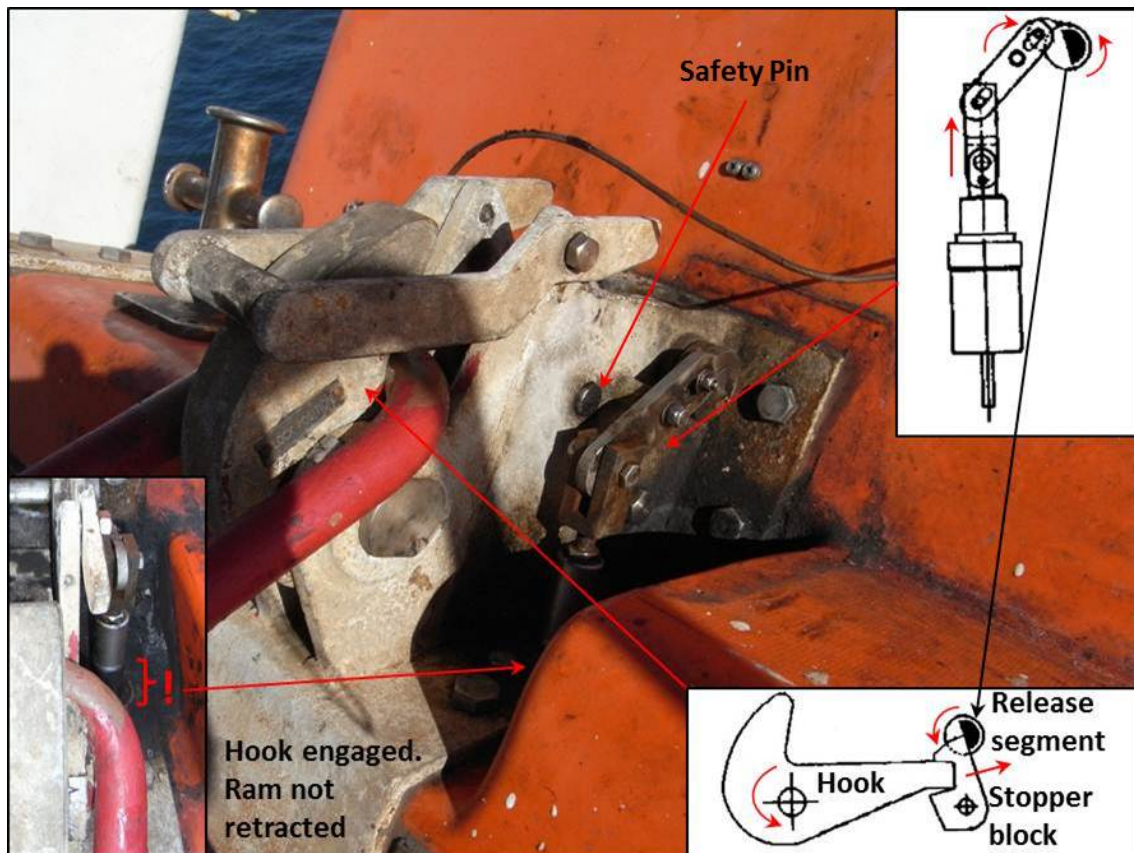
Figure 3: Freefall lifeboat on-load release

Under normal, ready for use, conditions, the freefall lifeboat was positioned with its side rails sitting on rollers on the ramp section of the launching appliance. The lifeboat was retained solely through ring links fitted between a fixed hook on the ship and the on-load release on the lifeboat (Figure 3 and Figure 4).

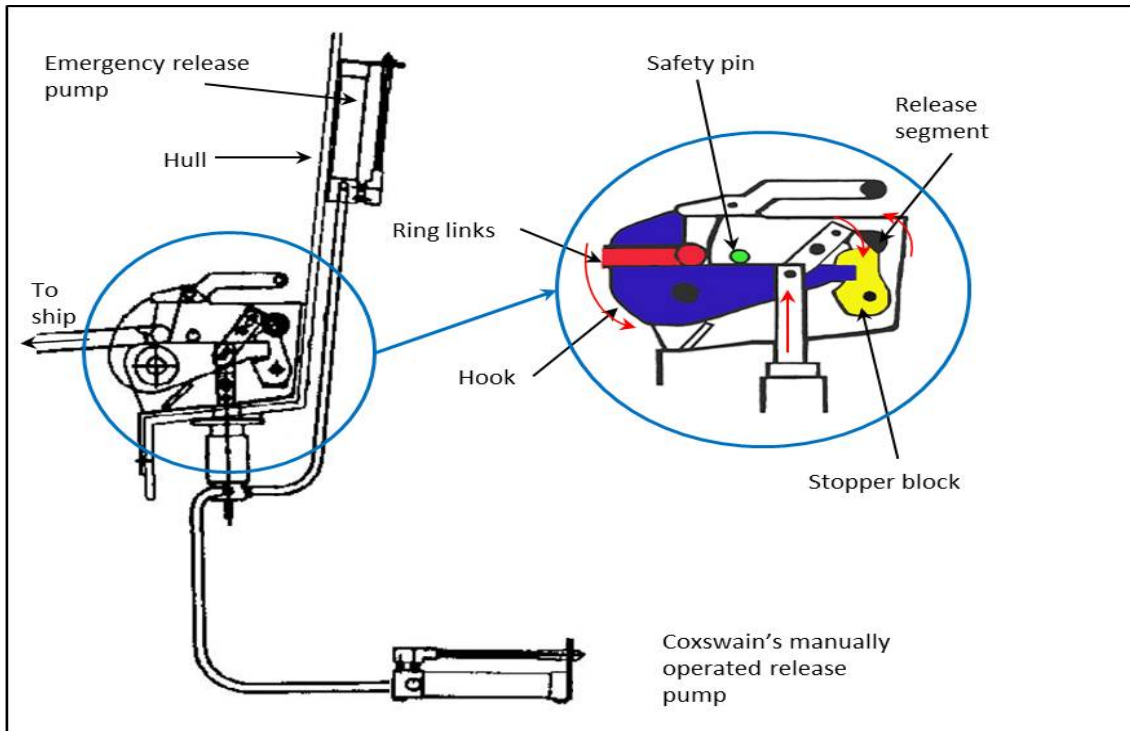
Figure 4: Freefall lifeboat hook release system

Resetting the on-load release and securing the lifeboat in place required the ring link to be positioned over the hook and then rotating it until its tail engaged in the stopper block. An alignment mark, on the side of the hook (Figure 6 and Figure 7), provided a visual confirmation that the hook was in the correct position. The release segment then had to be rotated into position, locking the stopper block in place, by opening the valve on the pump and the activating cylinder ram retracting. Once the on-load release was reset, the hydraulic pump's valve was closed. This locked the oil in the system and the linkages in position.

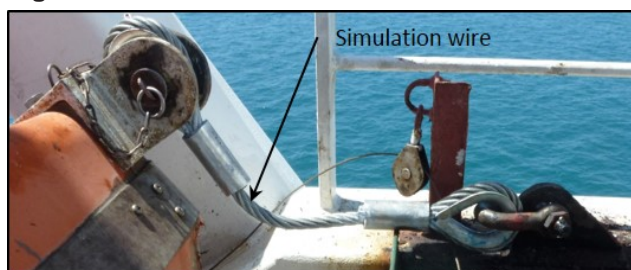
Figure 5: A new simulation wire

When the on-load release was tripped, the lifeboat should (as per the design) move 150–200 mm down the launch ramp. At this point, the slack in the simulation wires would be taken up and the lifeboat would be stopped. The lifeboat would then be repositioned using the A-frame davit and the on-load release reset.

Analysis of the failed wire slings by the ATSB indicated that their failure was consistent with gross overload. There was no evidence to indicate that the failure was the result of a defect, damage or corrosion.

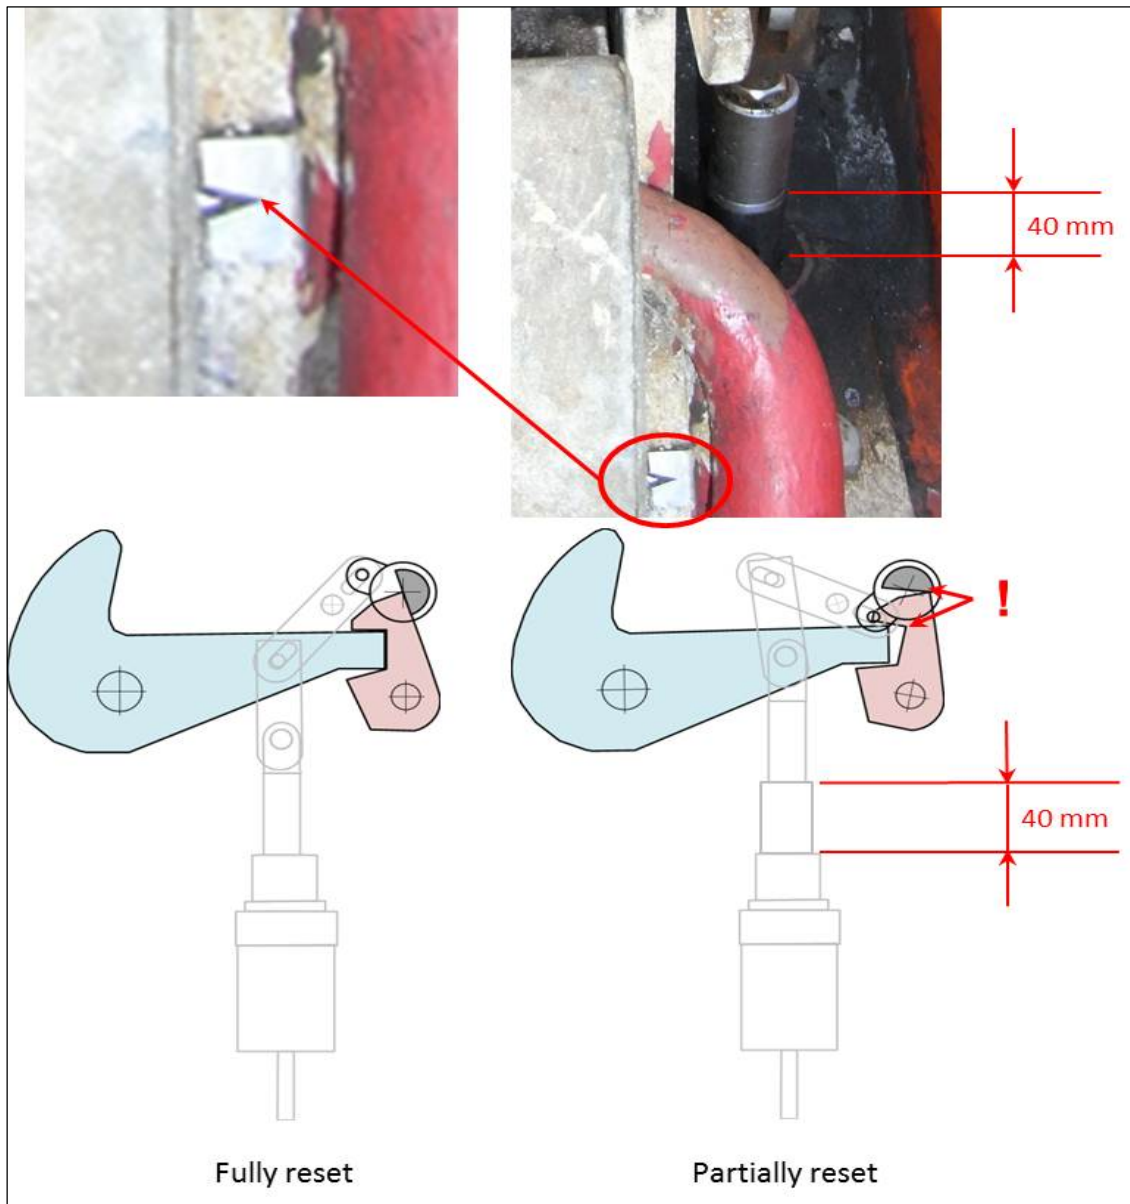
Figure 6: On-load release partial reset.

The on-load release had tripped unexpectedly because it did not properly reset when last operated. When the lifeboat was housed on completion of maintenance in the previous port, the activation cylinder ram had not fully retracted. This condition was not apparent because of a cover (Figure 7) fitted over the release mechanism and the lack of an indicator for the release linkage, which prevented a person being able to see that the ram had not fully retracted.

While the design of the on-load release system allowed the reset position of the hook to be visually confirmed, it did not allow for visual confirmation that the release segment and mechanism had been correctly reset. Consequently, the hook device could appear to be properly reset when it actually was not.

Safety action by the manufacturer included placing alignment marks on the release segment of new on-load releases mechanisms, to indicate when they are correctly reset. A lock-out 'maintenance pin' is also being provided for all new on-load releases to ensure the release cannot trip while maintenance is being performed.

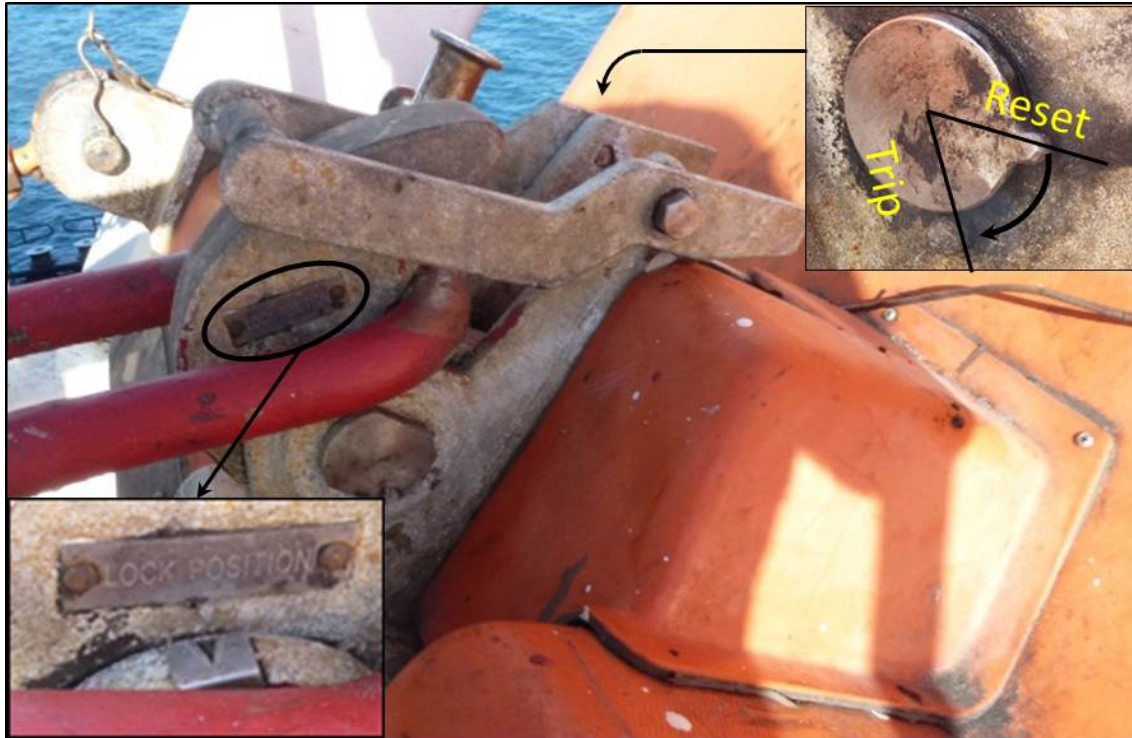
Figure 7: On-load release and indicators

The simulation wires were intended to stop the lifeboat's motion and were used, primarily, under shock loading conditions. Further, the lifeboat's operation and maintenance manual stated that maintenance on the release hook and system was to be carried out after a simulated release, once the boat's weight was being held by the wires.
