# Runway excursion involving a Cessna 404, VH-JOR

Pantijan (ALA), Western Australia, 12 April 2015

**ATSB Transport Safety Report**

AO-2015-038

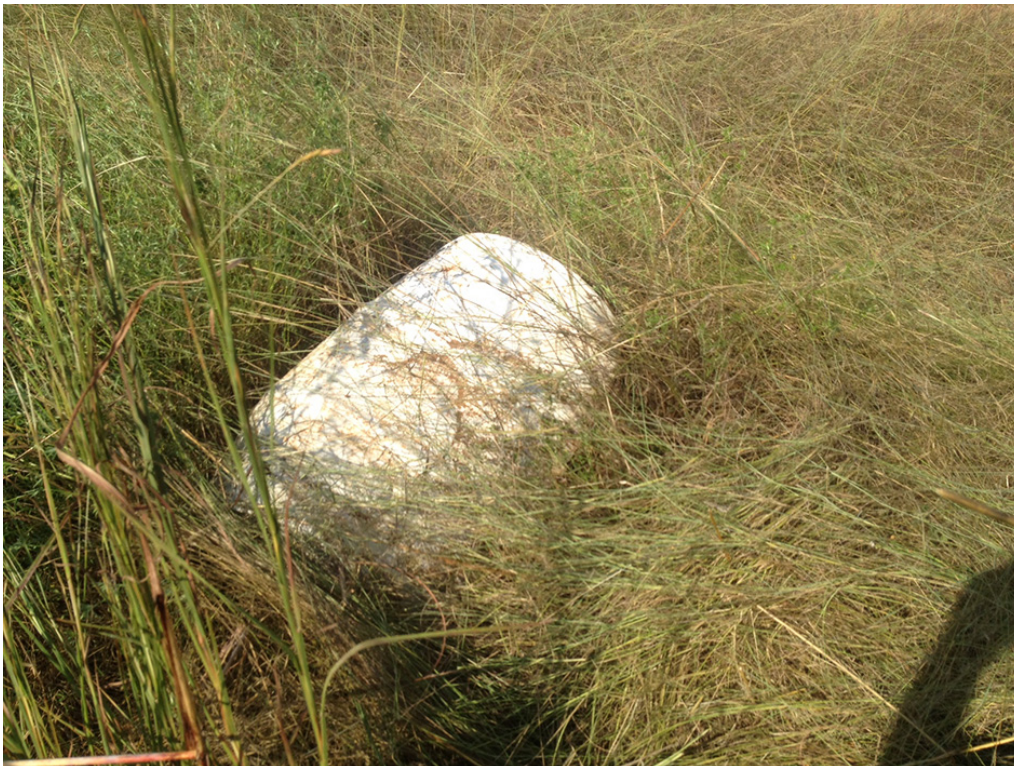
**Figure 3: Drum runway marker**

Following the accident, the pilot found that where he had commenced the left turn on the runway, the ground was soft and appeared to have previously held standing water, although the surface was dry at the time. The runway marker was a 44 gallon drum, cut in half longitudinally and laid on the ground and it was obscured by long grass (Figure 3).
