Collision with terrain involving a Schweizer 269C-1, VH-FTY

Parafield Airport, South Australia, 24 December 2014

ATSB Transport Safety Report
Aviation Occurrence Investigation
AO-2015-001
Final – 10 June 2015

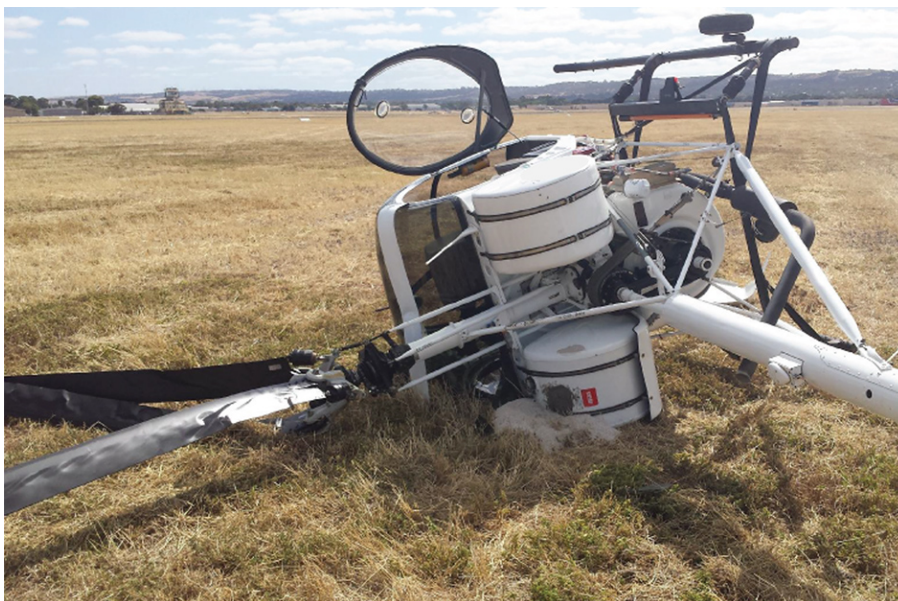
After the helicopter had rolled onto its side, the instructor switched the battery off and activated the Emergency Location Transmitter.³ The instructor directed the student to shut the fuel off, and then assisted the student to evacuate the helicopter through the right door. The instructor then evacuated the helicopter behind the student. Apart from some minor bruising, both the instructor and student were uninjured. The helicopter main rotor assembly and upper-left cabin area were damaged in the accident (Figure 1). The tail rotor also showed some evidence of having scuffed the ground during the accident sequence.

Figure 1: Orientation of helicopter following accident, facing to the north-east

Note: Absorbent material placed next to the fuel tank by emergency services personnel, and the panel on the ground visible in the photograph behind the helicopter, was removed by emergency services personnel following the accident.
