Derailment of TasRail train 135

Kimberley, Tasmania, 25 January 2015

ATSB Transport Safety Report

RO-2015-001

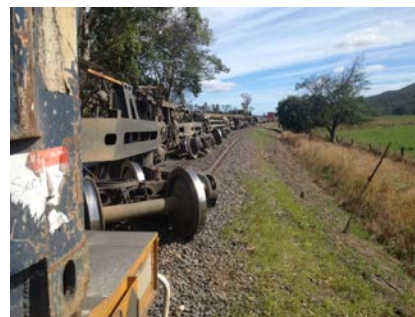
At about 2151, train 135 derailed near Kimberly (about 30 km south of Devonport) as it traversed an occupation crossing¹ at the (kilometre point) KP W99. As a result, 10 wagons derailed and 220 m of track was damaged. There were no injuries.

Train 135 and derailed wagons

It was concluded that the sequence of track defects (twist and alignment) initiated harmonic body roll of the QL class wagon. When combined with the high centre of gravity of loaded wagon QLE23/P, the harmonic behaviour likely resulted in wheel unloading, promoting flange climb and the subsequent derailment of train 135.

- Suspension of QL wagons from intermodal traffic pending outcome of investigation.
- Maintain a register of known track faults.
- Measure major track faults every 96 hour inspection of the infrastructure, for track deterioration.
- Review current condition monitoring methods and frequencies, and implement changes to detect and manage similar defects to those observed at the derailment location.
- Re-write / update Section B of the Freight Loading Manual regarding container loading restrictions and what wagons are applicable.
- Reduce the TSR speed where legacy wagons are in use and rail faults dictate.
- Check / update the Tasrail Operational Risk Register.
