Serious injury to crew on board *Happy Buccaneer*

Port Hedland, Western Australia | 23 February 2015

ATSB Transport Safety Report
Marine Occurrence Investigation
318-MO-2015-001
Final – 23 June 2015

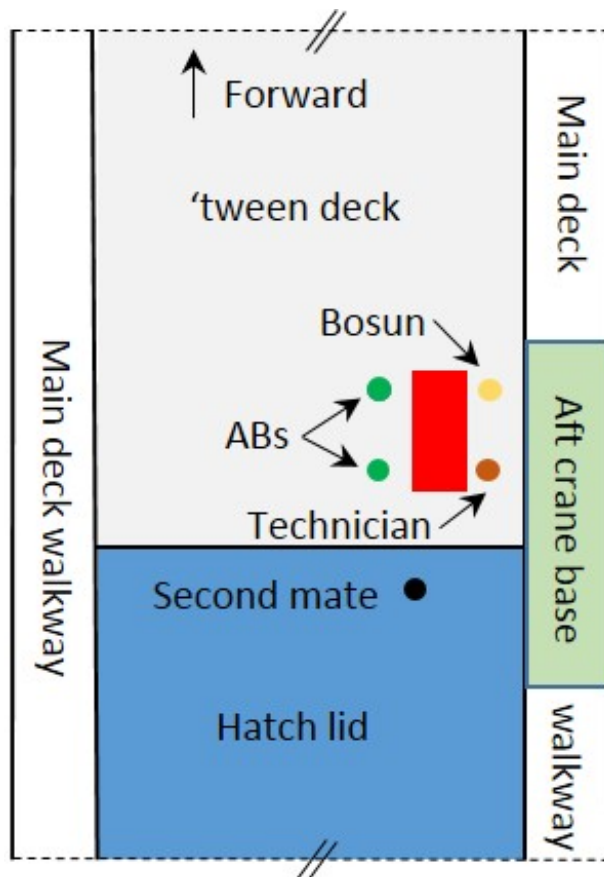
Figure 1: Positions of the crew.

At 0630, after a tool box talk,³ the crew started the work. Working with the second mate on deck were two able-bodied seamen (AB) tasked with hooking up the packs of load spreaders. The boatswain (bosun), the ship's technician and two Abs were on the 'tween deck (Figure 1), to position the packs and remove the sling hooks. All crew involved in the moving of the load spreaders had performed this task before and were familiar with the operation.

When the load spreader started sliding sideways, the bosun and technician were not clear of the pack. Further, their position between the pack and the side of the cargo hold restricted their ability to move away from the falling spreader.

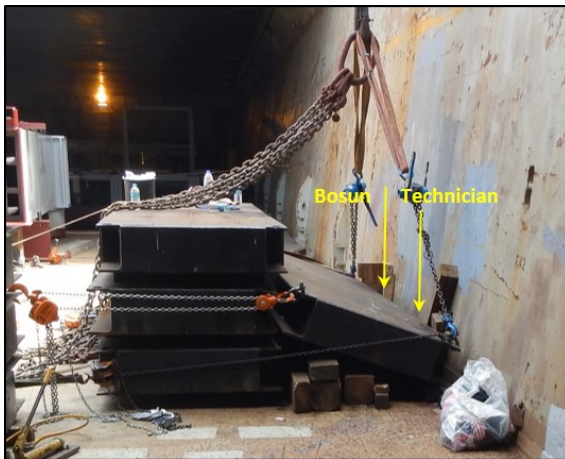
Figure 2: Fallen load spreader

When the chief mate arrived at the accident site, he saw the bosun and the technician lying in awkward positions on top of the load spreader (Figure 2). The technician's right leg was pinned under the load spreader and he had fractured both legs. The bosun was not trapped but had suffered fractures to his lower left leg. The chief mate updated the master as to the severity of the situation and began arranging first aid.

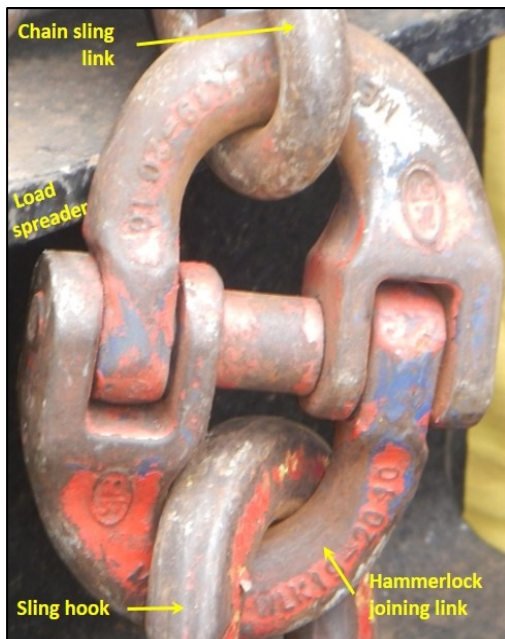
Figure 3: Hammerlock joining link

After releasing the chain hooks from the spreaders, the slings were left against the side of the pack. When raised, the chain hooks were dragged up the pack's side. In this instance, the hammerlock link (Figure 3), used to attach the sling's hook to the chain, probably caught on the lip of the topmost load spreader and lifted it to the point where it was able to slide sideways off the pack.

The crane's auxiliary hook winch was fitted with a soft start/stop feature to avoid shock loads. Therefore, when the remote control's lever was moved to the neutral position to stop the hook, it would take a few moments for the hook to slow and then stop. This feature meant the hook continued to lift the load spreader after the lever was placed in the stop position.

- *Hook speed during simultaneous crane movements*, and that the crane shall not be moved until there has been clear communications by hand, radio or other method.
- Crane operators, banksmen (dogmen) and assisting crew should be aware of each other's location and movement of suspended loads.
- Rigging gear shall be guided until it is free of obstacles and equipment should be made safe for lifting prior to the lift.
- Lifts, formed of multiple loose items, will be combined and secured to form a single unit prior to lifting.
