Australian Government  
Australian Transport Safety Bureau

# Aerial application safety

2014–2015 year in review

Research  
AR-2015-031

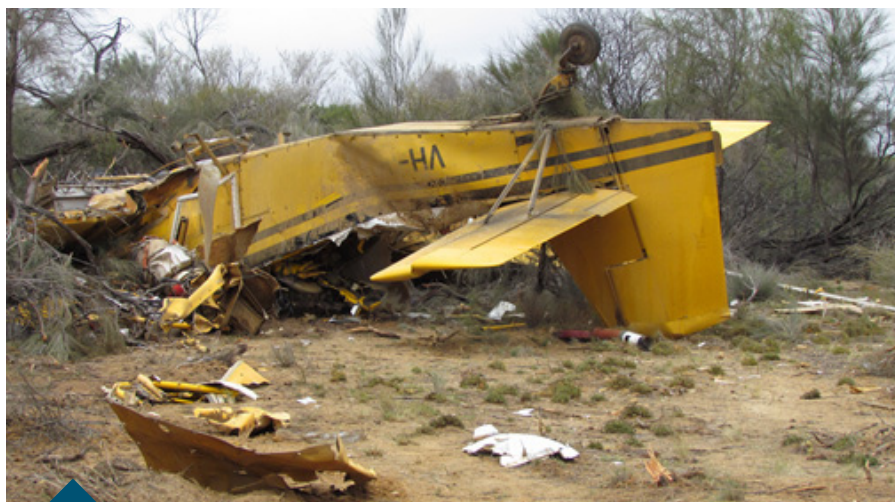
The ATSB found that the aircraft departed from controlled flight about a minute after take-off from which the pilot was unable to recover, leading to the collision with terrain. Based on the evidence, it was not possible to discern the cause of the loss of control. The aircraft came to rest about 16 m east of the initial contact point. The initial impact point contained two propeller blades as well as fibreglass and aluminium sections of the nose, engine cowling and hopper. The aircraft impacted the terrain while inverted, in a right wing low attitude. The aircraft wreckage was found soon after. The aircraft was destroyed and the pilot was fatally injured.

Accident site, facing the direction of travel

Although no definite reason for the loss of control was identified, there were two safety factors identified: using unapproved fuel mix and flying above the maximum take-off weight.

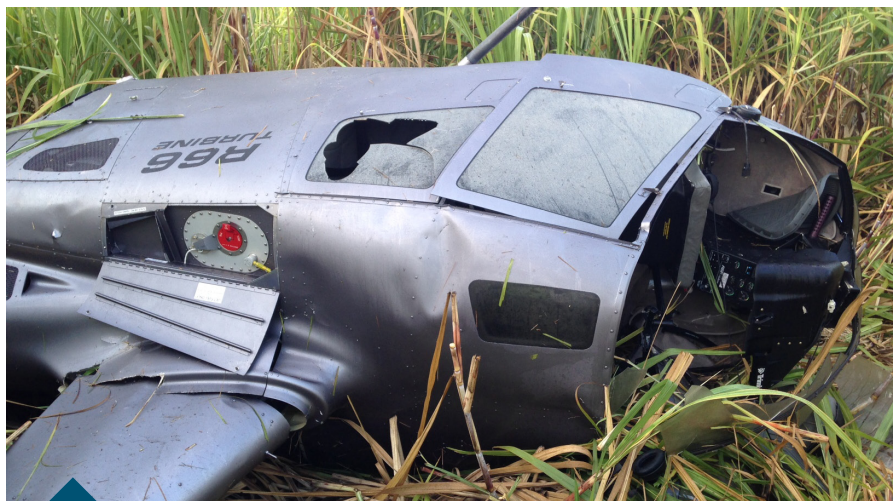
Damage to Robinson R66

them, so he decided to fly underneath the powerlines. Given that the paddock was full of corn crops that were 6ft tall, there was limited clearance between the helicopter and the powerline. Consequently, the helicopter's main rotor blade hub struck the powerlines. The resulting collision with the ground damaged the tail boom and tail rotor blades, front of the helicopter, Perspex, seats, skids and spray gear. The pilot managed to exit the helicopter with minor injuries.

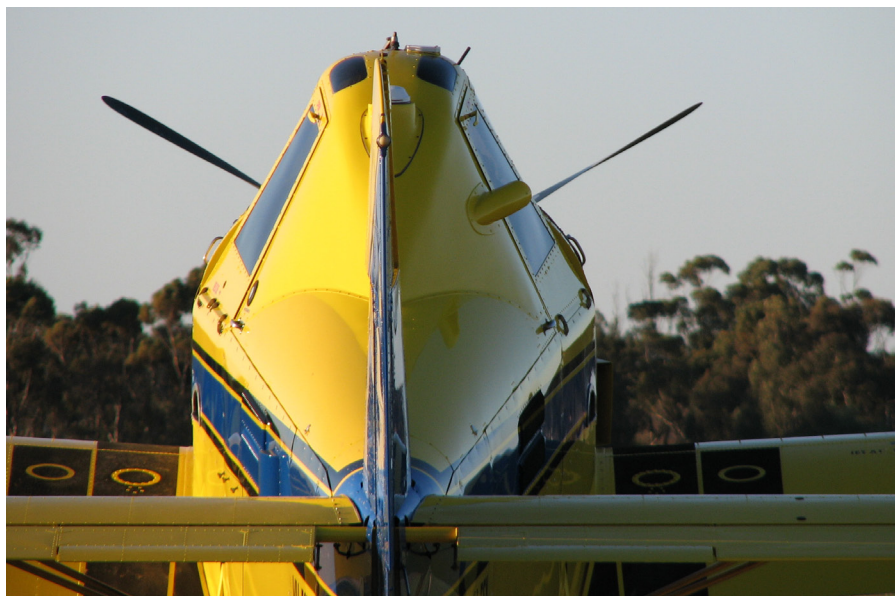
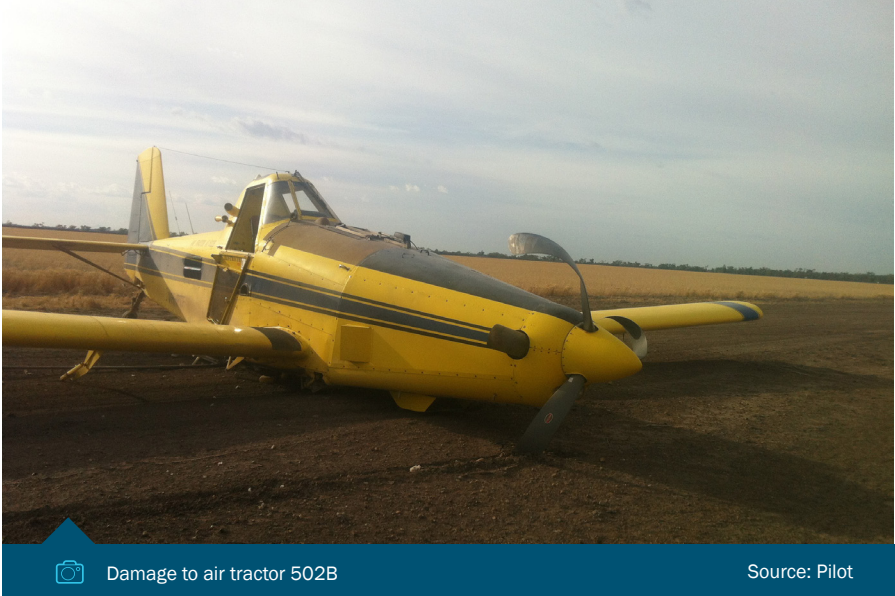
- In New South Wales, the pilot of an Air Tractor AT-502B was spraying cotton fields containing powerlines. At a junction, the pilot attempted to pass under two sets of powerlines but pulled up into the second set of powerlines. As a result, the propeller and spray boom were damaged and the three wires were severed. The powerlines

Damage to air tractor 502B

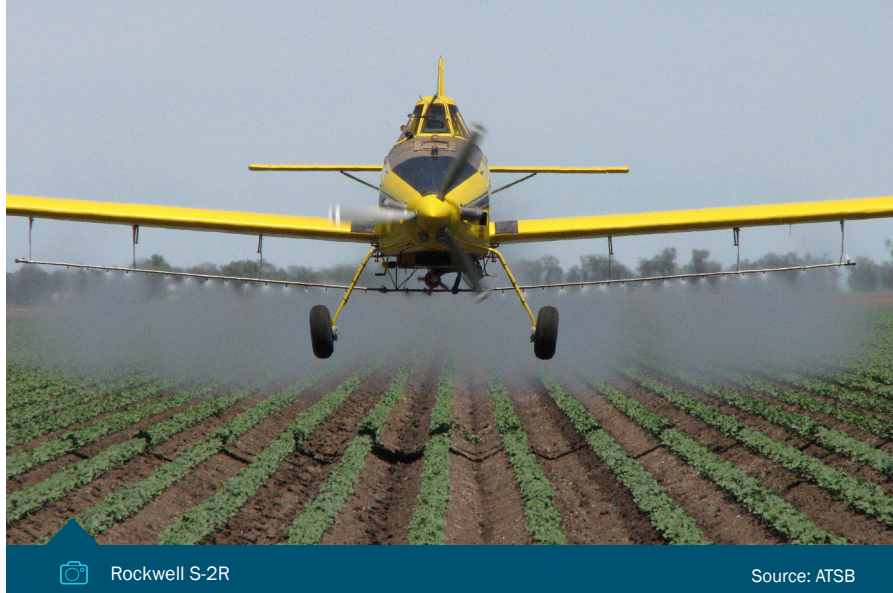
- During landing in Victoria, the pilot of the Rockwell S-2R (Thrush Commander) did not notice a car parked inappropriately at the end of the runway until the very short final approach. When it was noticed, the pilot tried to land left of the centre line to avoid flying low over the car. However, due to the runway surface having a new hot mix seal, braking was ineffective and the aircraft veered off the runway, running through a ditch and colliding with a fence resulting in damage to the propeller and landing gear. This occurrence highlights the importance of monitoring for unexpected hazards which will always be more difficult to notice in a timely manner than expected hazards (ATSB occurrence 201500601).

Rockwell S-2R

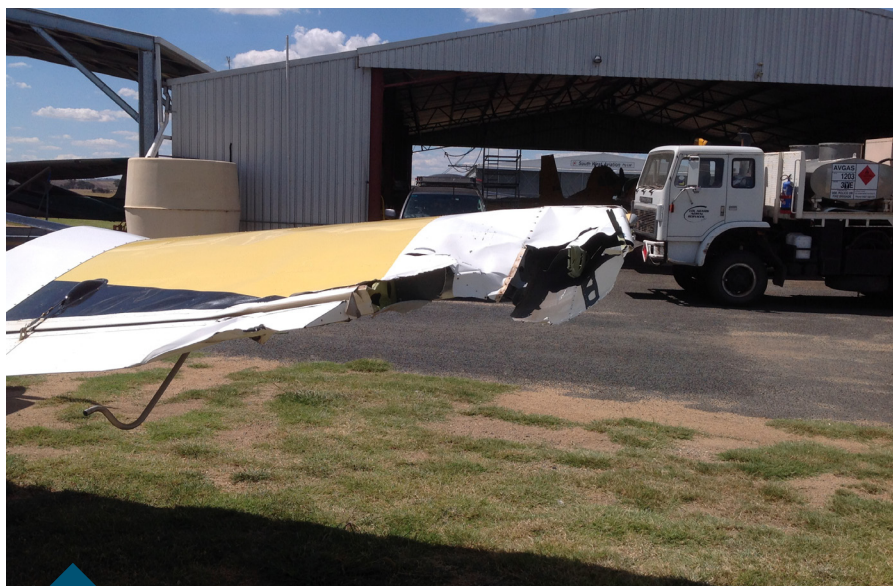
to the front of the aircraft just as the propeller collided with the right wingtip and tail of the GA 200. There was substantial damage to both the aircraft. There was damage to the propeller of the FU-24 and damage to the wing tip and tail of the GA-200. Both pilots were uninjured.

Damage to GA-200

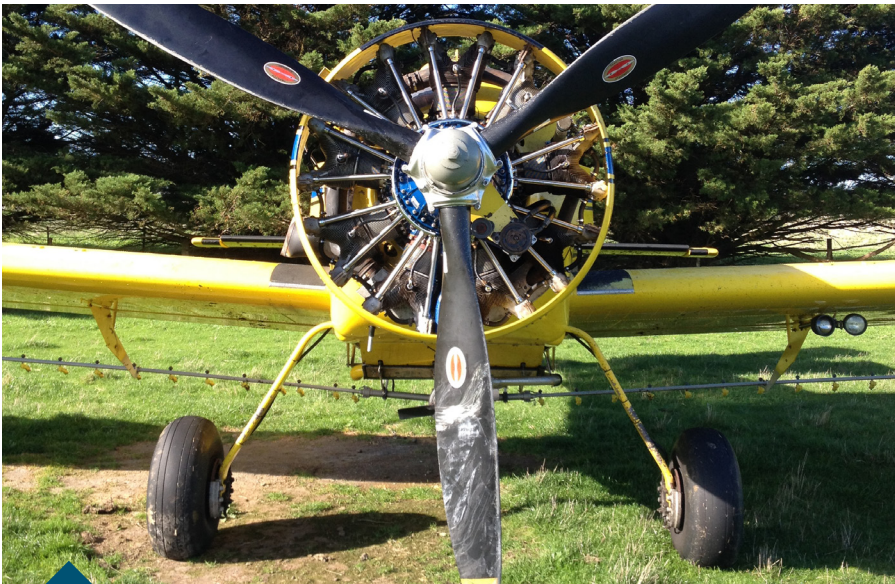
- During landing on a wet runway in Victoria, the pilot of an Air-Tractor AT-401B was unable to brake sufficiently and the aircraft collided with the loading vehicle resulting in propeller and engine damage to the aircraft (ATSB occurrence 201403849).
- During take-off on a runway with loose gravel in Queensland, the pilot of a Cessna T188C Ag Husky lost directional control of the aircraft. Subsequently the left wing struck sugar cane resulting in substantial damage to both wings, elevator and main landing gear. The pilot was uninjured (ATSB occurrence 201501206).
- During approach to the runway in Queensland, the hopper lid of an Ayres S2R-R1820 detached from the aircraft during turbulent weather conditions (ATSB occurrence 201407819).

Damage to Air Tractor AT-401B

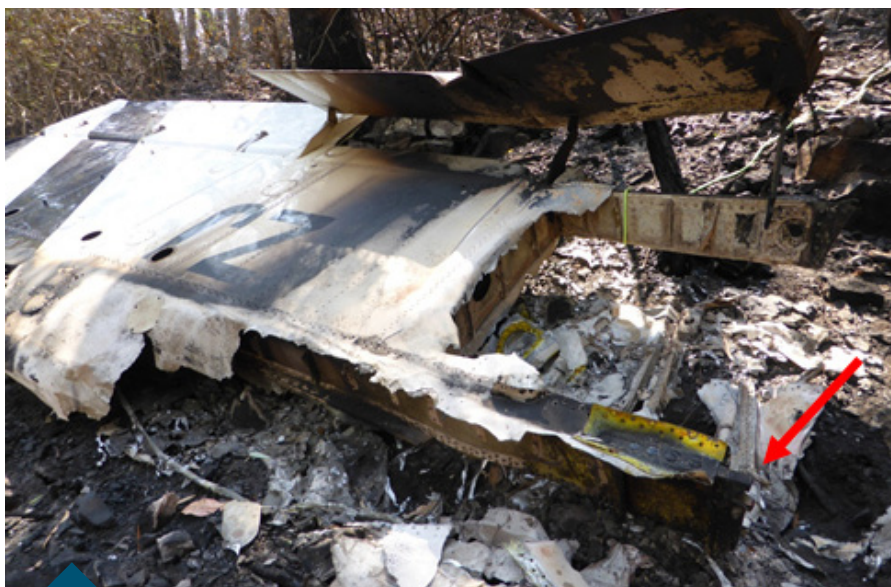
M18 Dromader outboard left wing (underside of wing visible, lower attach fitting arrowed)

On-site examination found the left wing had separated at the attachment joint between the outboard wing and centre wing sections. Preliminary examination of the attach fittings indicated that the left outboard wing lower attachment lug had fractured through an area of pre-existing fatigue cracking in the lug lower ligament. The fatigue cracking reduced the structural integrity of the fitting to the point where operational loads produced an overstress fracture of the remaining lug material.

Operators of some Australian M18 Dromaders, particularly those fitted with turbine engines and enlarged hoppers and those operating under Australian supplemental type certificate (STC) SVA521, have probably conducted flights at weights for which airframe life factoring was required but not applied. The result is that some of these aircraft could be close to or have exceeded their prescribed airframe life, increasing the risk of an in-flight failure of the aircraft's structure.

The Australian Transport Safety Bureau cautions M18 operators of the risks associated with not reliably applying service life factoring to any overweight operations in this aircraft type. It is suggested that operators review the extent to which their aircraft may have been operated above 4,700 kg, and whether the correct service life factoring has been applied to such operations throughout its full operational life.
