# Flight path management occurrence involving Boeing 737, VH-YIR

Sydney Airport, New South Wales | 4 June 2013

## ATSB Transport Safety Report

AO-2013-095

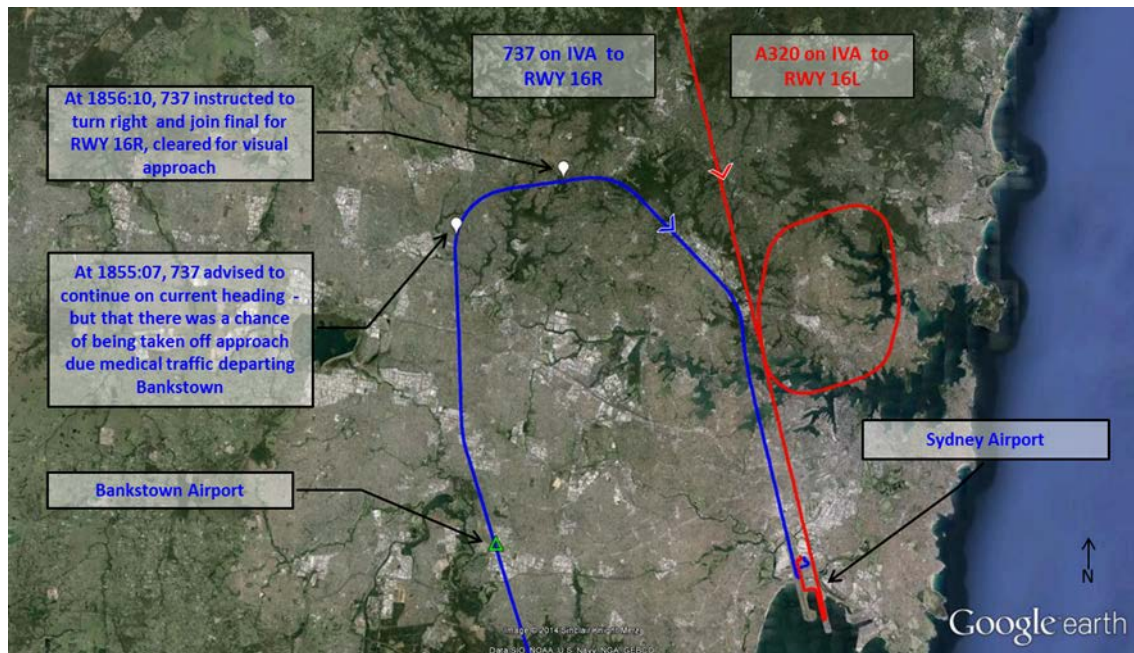
Figure 1: 737 and A320 approach paths for arrival at Sydney Airport

The Sydney Director<sup>6</sup> assigned the 737 flight crew a right turn heading 070° and descent to 3,000 ft at 1854:51. Shortly after at 1855:07, the Director instructed the crew to continue on their current heading and advised that there was a chance they may be taken off the approach as there was medical traffic heading north-east from Bankstown. Figure 1 illustrates the relative position and flight paths of the 737 and A320 to Bankstown Airport.

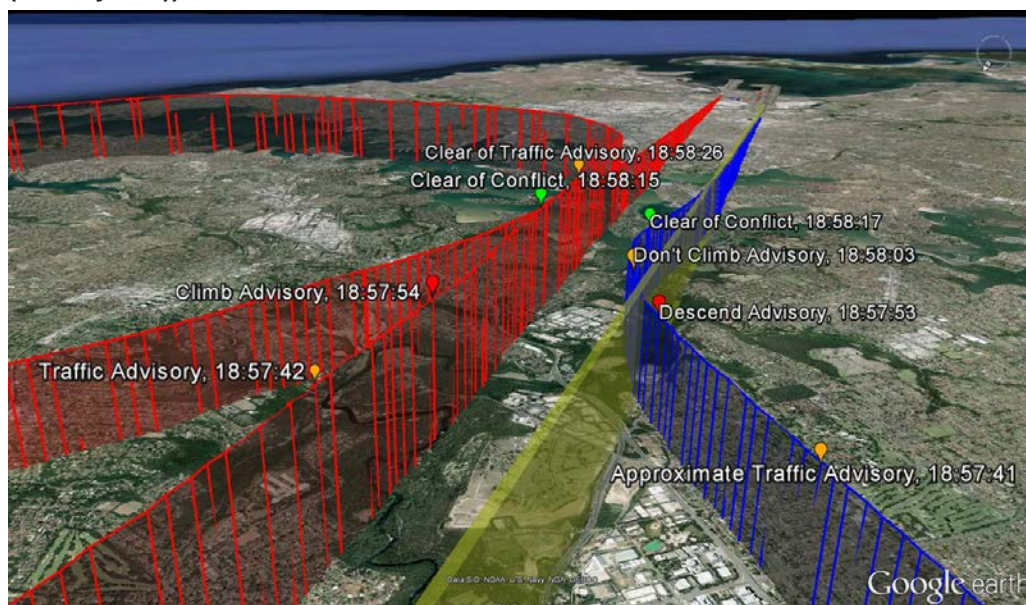
**Figure 2: Aircraft flight paths (737 shown in blue (runway 16R) and the A320 in red (runway 16L)) and TCAS events**

At the same time, the 737 passed through the extended centre-line for runway 16R and, at 1858:03, the RA changed from 'descend' to 'don't climb'. At 1858:12 the aircraft reached its maximum deviation (320 m) to the left of the runway 16R extended centre-line.

The aircraft flight paths during final approach and the sequence of recorded TCAS events for the 737 and A320 are shown in Figure 2.

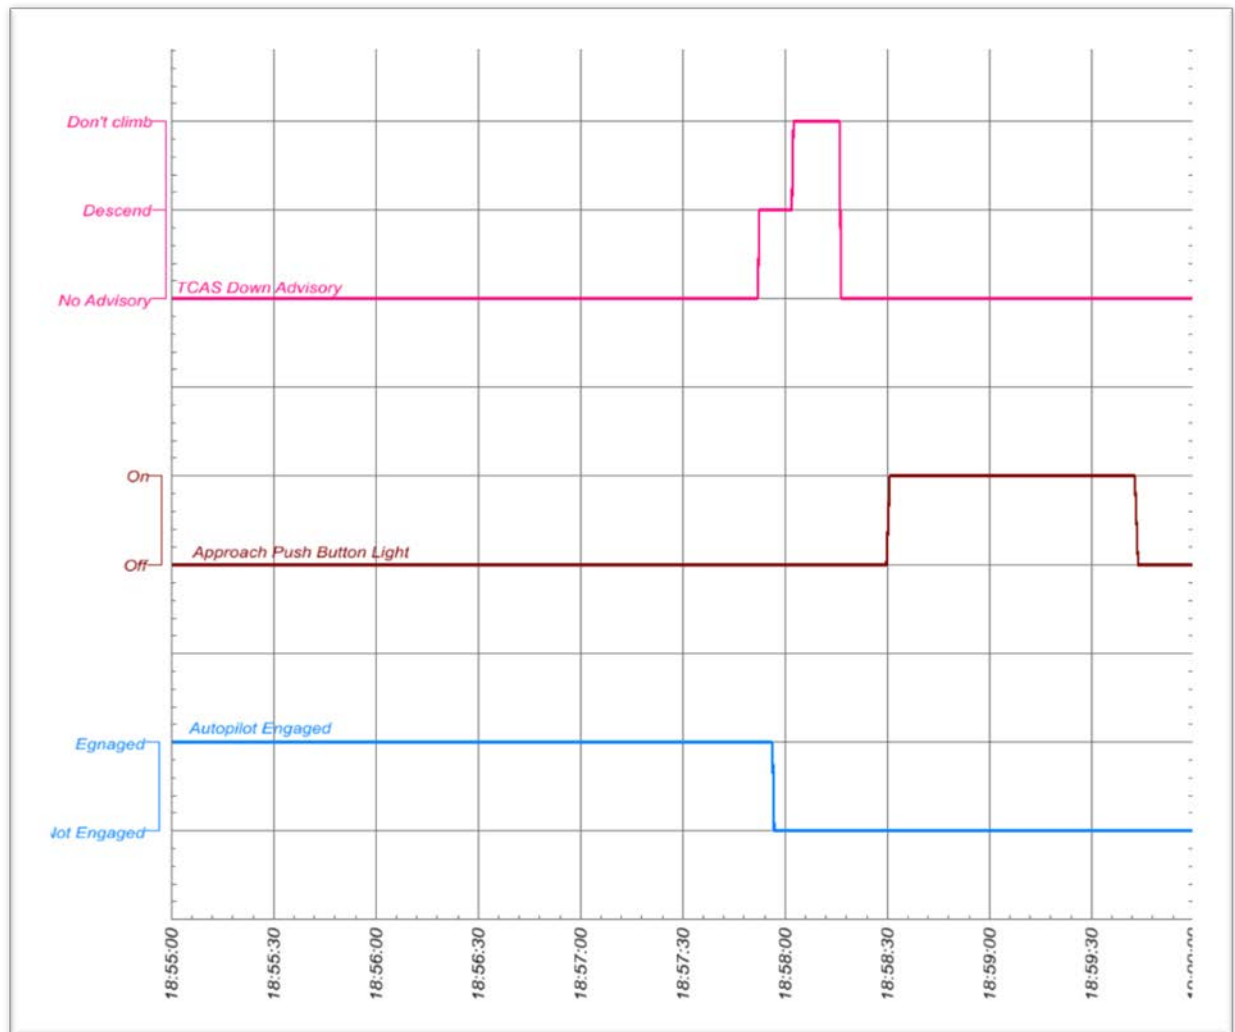
**Figure 3: Recorded flight data from the 737**

Flight data for selected parameters associated with approach mode selection and the TCAS advisories from the 737 are illustrated at Figure 3.

In this occurrence, it was found that, contrary to their intentions, the 737 flight crew did not arm the approach mode, probably as a result of applying insufficient force to the mode push-button. Subsequently, the crew's check/confirmation, if any, of the mode change using either the MCP or FMA was ineffective. This meant the crew's belief of their selection of the approach flight mode led to an incorrect expectation that the aircraft would automatically capture the localiser.

In response to this occurrence, Virgin introduced a flight policy requiring crews to verbally announce flight mode changes when operating above 500 ft.

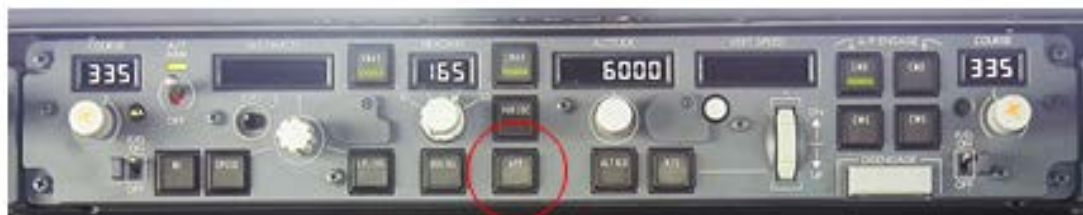
**Figure 4: Mode control panel with the location of the approach mode push-button highlighted in red**

- The flight crew applied insufficient force to the approach mode push-button on the mode control panel to arm the mode, which was not identified during their subsequent check of the flight mode annunciator.
- Due to their expectation that the aircraft approach mode was armed, and a subsequent degradation in monitoring the aircraft's systems, the flight crew did not anticipate that the aircraft's automated systems would not capture the runway 16R localiser and did not immediately detect the flight path deviation.
- The flight crew did not recognise that the traffic advisory alert provided by the aircraft's traffic collision avoidance system 12 seconds prior to the aircraft passing through the runway centre-line was a potential indication of a problem with the aircraft's flight path.

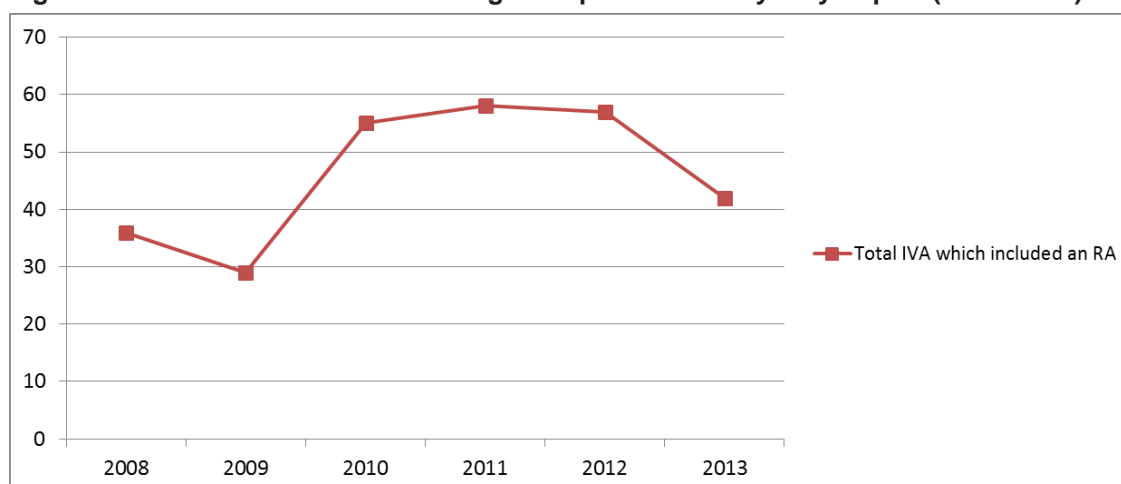
**Figure 9: TCAS RA occurrences during IVA operations at Sydney airport (2008–2013)**

A review of the ATSB and Airservices occurrence databases was undertaken to examine the number of TCAS RA occurrences during IVA operations at Sydney Airport in the period 2008-2013 (Figure 9). Based on the available information, in that period there were 277 reported RAs during IVA procedures.

Airservices advised that over the period 2008–2013, there were about 154,000 approaches per year at Sydney Airport, and that about 60 to 85 per cent involved IVAs. Given this broad range, it was not possible to determine whether there were any trends in the rate of RA occurrences (per approach) in recent years. The ATSB was unable to compare this alert rate against the US airports using similar procedures because there were more limited requirements for reporting TCAS RA occurrences in the US.
